## **MICROSTRUCTURE AND PROPERTIES OF THE COBALT BASE CLAD LAYERS AFTER LONG TIME SERVICE**

The cobalt base laser cladding layers were investigated after two years of service in two laboratory diesel engines. The microstructures of the clads after service did not demonstrated serious degradation process. Chemical compositions of the used layers and changes in hardness were described. These sorts of layers are suitable for long time service with out substantial damages.

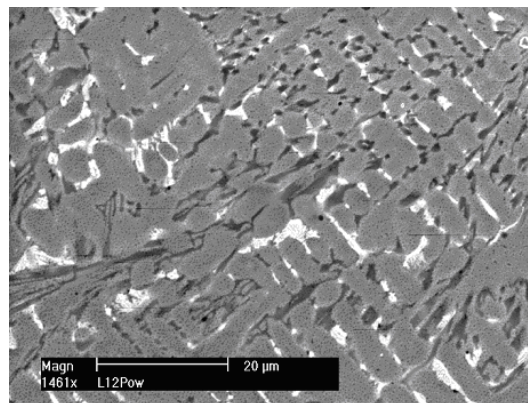
The laser deposited layers presented a typical surface welding solidification structure which is presented in the Fig. 1.

**Fig. 1.** SEM photograph of the cross-section of the clad layer close to the surface. The grey regions are dendritic while light and dark domains are placed in inter-dendritic regions, respectively

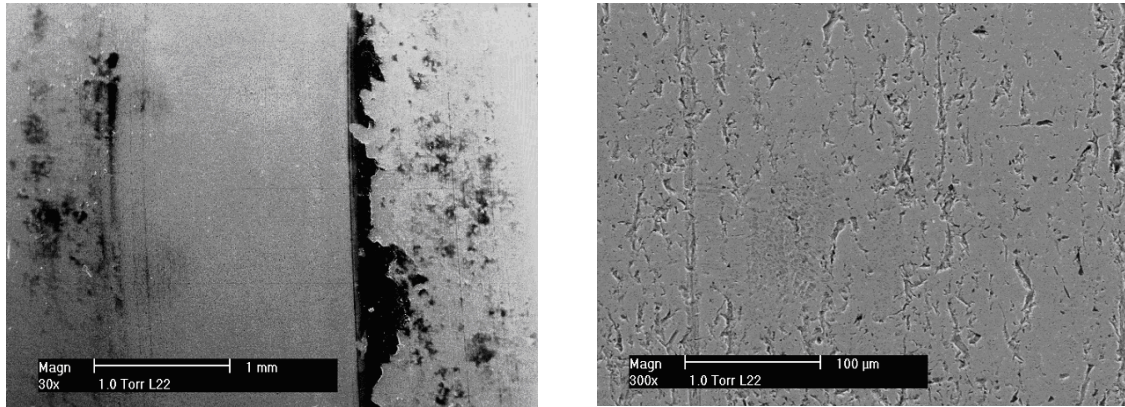
After service the surface of the faces of the both valve heads presented shining surfaces (Fig. 2) in the great deal but some dark “spots” on them were noticed (Fig. 3, 4). There were no visible damages. However SEM observations showed some results of wear. There were small amount of wear pits which were fill up with wear debris and possible the scale (Fig. 4).

**Fig.2.** SEM of the vale face after two years of service; valve head from L22 engine – shining region under different magnification

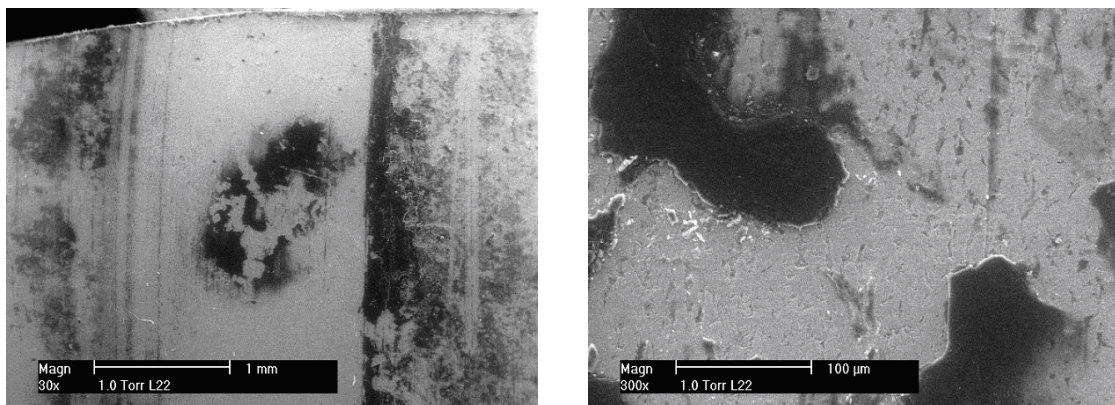
**Fig.3.** SEM of the vale face after two years of service; valve head from L22 engine – dark “spot” region under different magnification

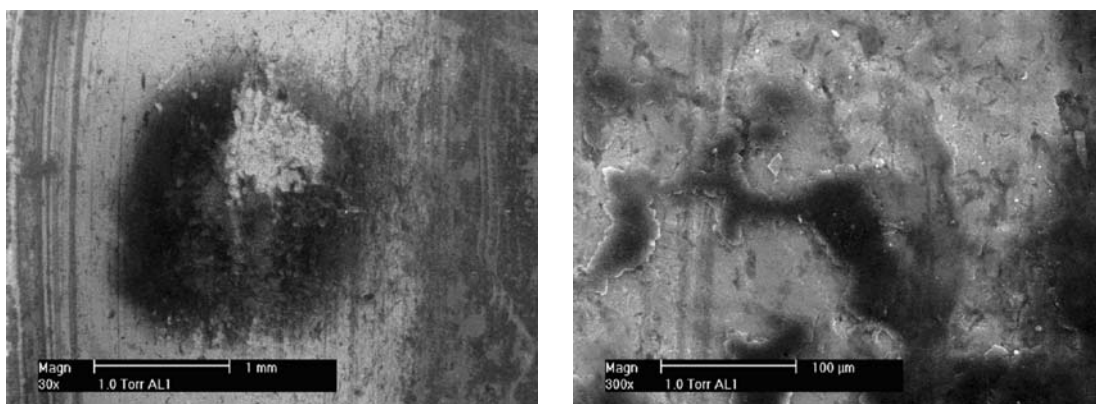
**Fig.4.** SEM of the vale face after two years of service; valve head from 3AL25 engine - - dark “spot” region under different magnification

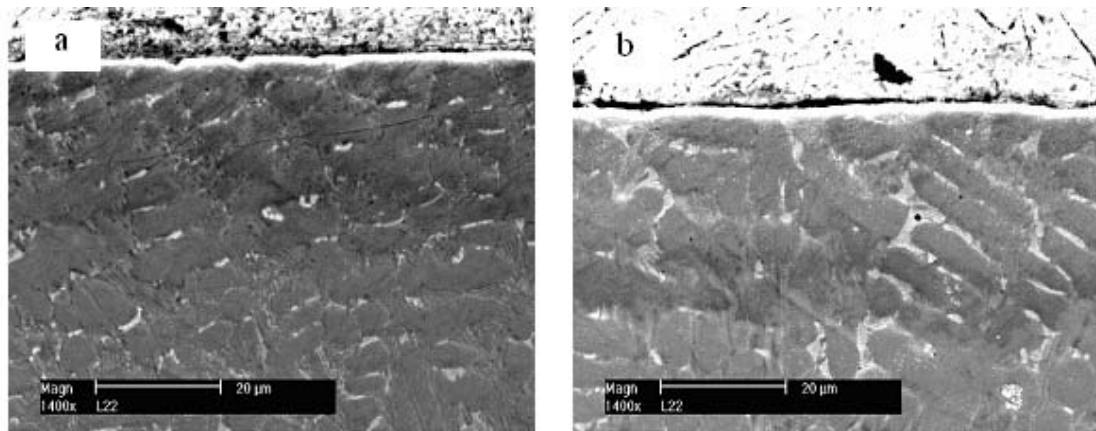
On the cross section of the clad layers general visible changes in microstructure were not found (Fig. 5). On the surface some small pits were observed (Fig. 5a) but in the great deal the surface was smooth (Fig. 5b).

**Fig. 5.** SEM of the cross-section of the clad; valve head from L22 engine; a- region where the small pits were observed; b- typical structure for the most of the faces

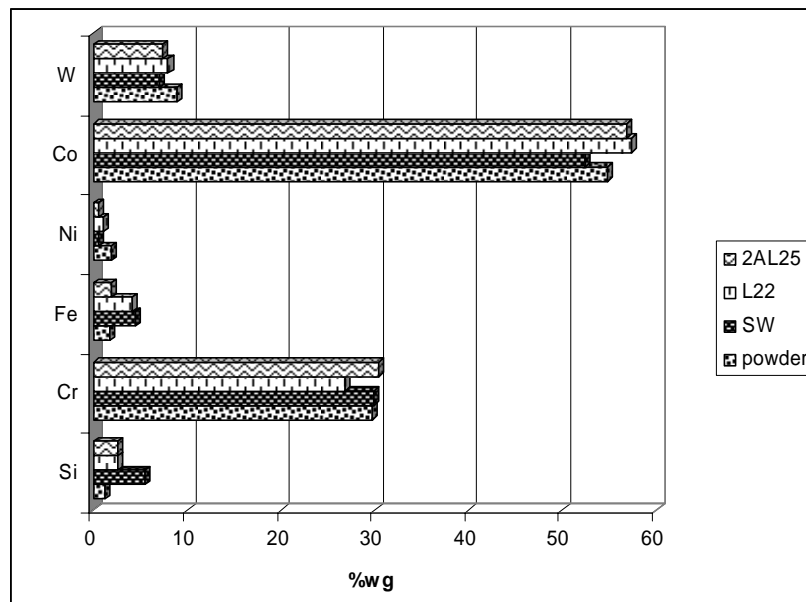
The chemical analysis EDS in the micro region on different part of the clad layer allowed establish the trends of chemical changes. Fig. 6 presented result of chemical analysis on the cross section of the clad layers, close to the surface for faces from the both engines after service in comparison to clad state and powder composition

**Fig. 6.** Chemical composition of the powder and composition of the surface region for: SW – as clad state, L22 – surface region of the face from L22 engine, 2AL25 - surface region of the face from 2AL25 engine

The small changes in the composition corroborated earlier metallographical results about not significant structural changes. Different service conditions resulted with differences in diffusion of some elements. Lower amount of chromium for L22 engine indicated more intensive oxidation and building a chromia scale. For less demand condition the “use” of chromium was less intensive.

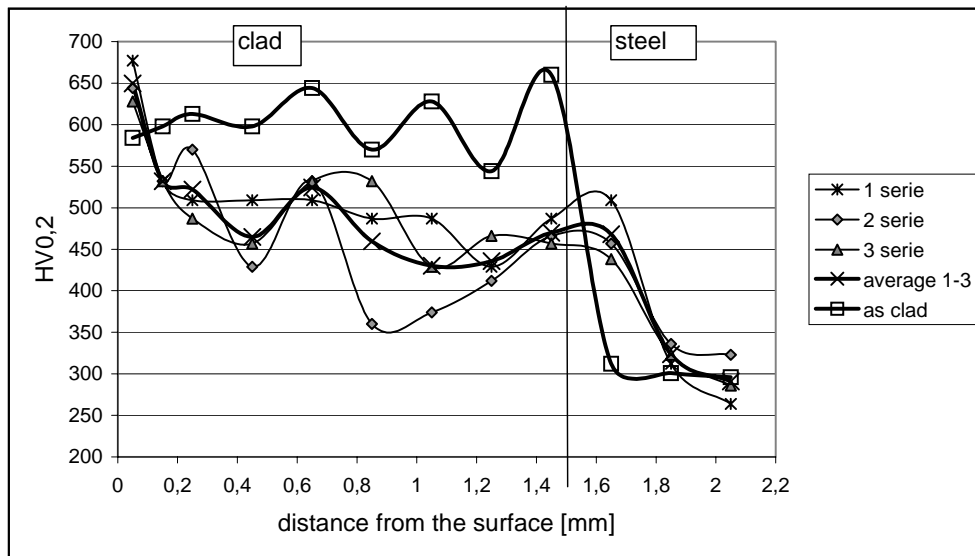
**Fig. 7.** Microhardness profile of cross-section specimen from the L22 valve head after two years of service

The microstructure observations were followed by hardness measurements which were carried on the same way for as clad layer and the samples from the valve heads after service. Because of the high measured differences on hardness numbers, three microhardness profiles were obtained in order to improve the statistical significance of the data. For the sample from the valve head from the L22 engine the results of measurements and average values which were calculated were showed on the Fig. 7. The decrease of the hardness numbers was observed but still clad layer presented higher hardness than steel base. Also variation of the hardness across the layer was limited which was a result of the diffusion processes during the long time of heat influence however this changes were not noticed in the microstructure.
