Water-lubricated bearings of ship propeller shafts - problems, experimental tests and theoretical investigations

Wojciech Litwin, Ph. D.
Gdansk University of Technology

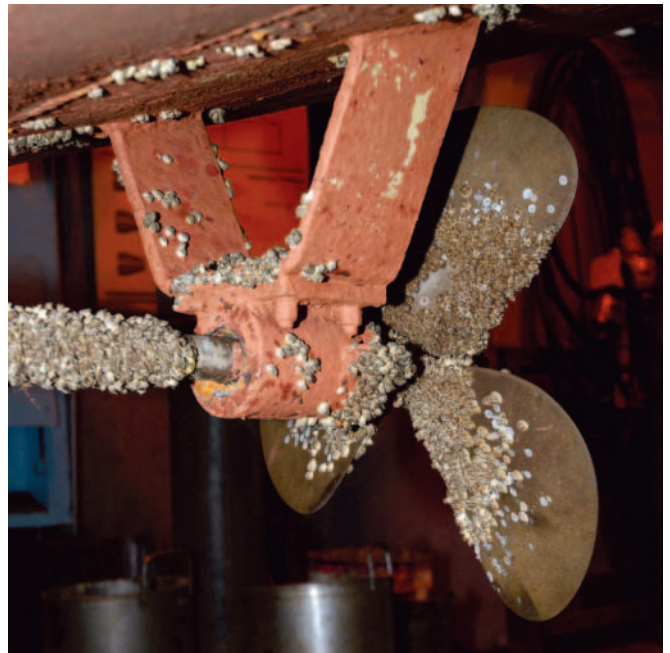
Fig. 2. Cantilever open bearing of yacht's propeller shaft

Each of them is characteristic of different properties and, resulting from them, advantages and disadvantages. Rubber effectively damps vibrations and is not sensitive to contamination, which is the reason for using it in e.g. cantilever open bearing systems (Fig. 2). It is important that contaminations which fell into rubber bearing accelerate its wear process only moderately. This concerns also hard contaminations, e.g. high-silica sand grains.

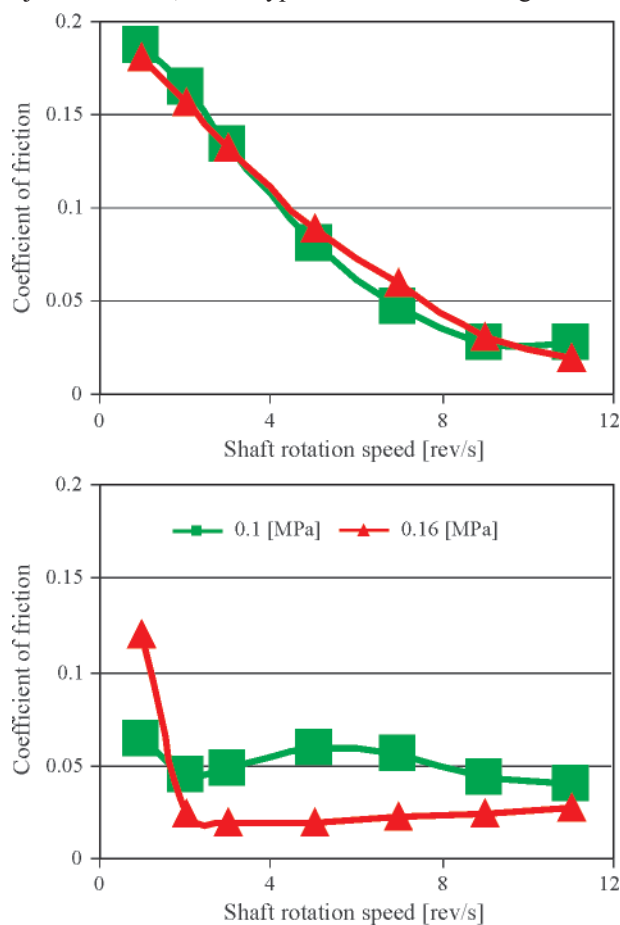
Fig. 5. Diagrams of friction coefficient values in function of shaft rotational speed; up side - the diagram recorded just after mounting the bearing, down side - the diagram obtained after several hours of running-in the bearing

Another technological problem is the achieving of possible high smoothness of co-operating slide surfaces. It is crucial because minimum thickness of lubricating film and hydrodynamic load-carrying capacity of bearing depends on surface roughness height. In the subject-matter literature publications dealing with influence of height and distribution of roughness on operation of hydrodynamic bearing, can be found. However as results from the author's experimental tests, this is bush roughness height which crucially influences hydrodynamical features of bearing [3,4]. The performed tests showed that running-in process of such bearing was very fast and a significant smoothness of slide surfaces was already reached after a few hours of operation. As a result, fluid friction state of operation was achieved faster (Fig. 5).

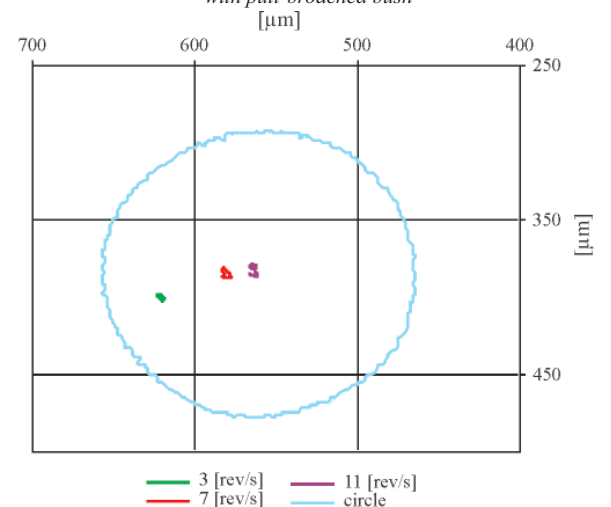
Fig. 18. Bearing fitted with composite bush of 0.0017 relative clearance value; up – the bearing with turned bush; down – the bearing with pull-broached bush

The performed tests showed that roughness topography, i. e. its arrangement has not any significant impact on bearing qualities [7]. Below, an example comparison of the experimentally recorded shaft axis trajectories, is shown. The observed very small differences in the journal's position demonstrate that the state of surface has negligible effect on hydrodynamic bearing qualities. Worth adding that the tests were performed just after mounting the bearing and before bush material running-in.
