# METAL IMPLANTS IN OSTHEOSYNTHESIS – CONSTRUCTION SOLUTIONS, MATERIALS AND APPLICATIONS

*The aim of the article is to present two case studies on intramedullary nails. The first one concerns a method of osteosynthesis for a patient, who was injured in an accident. The second one presents the failure of the implanted intramedullary nail. The research included evaluation of the type of fracture and the analysis of microstructure, chemical composition and hardness of the implant materials.*

[*Engineering of Biomaterials 115 (2012) 7-11*]

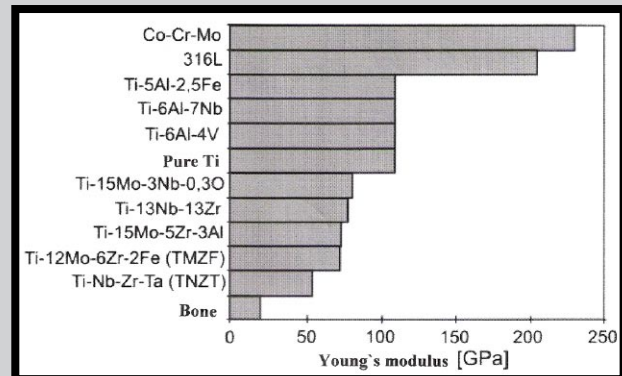
The elastic properties are the basic mechanical bone properties (Young's modulus, Poisson's factor, Kirchhoff's modulus, endurance to stretching, squeezing and cutting) [4]. Young's modulus has significant importance in implants. While producing implant materials it is desirable to lower the Young's modulus to the value typical of bone. The low Young's modulus is of great importance for eliminating stiff systems and obtaining elastic fixation of bone and implant. Of all known metallic biomaterials the lowest Young's modulus have titanium alloys, particularly the Ti-Nb-Zr-Ta alloy (FIG. 1) [5].

**FIG. 1. The Young's modulus for different kinds of metallic materials used in implantology as compared with bone [5].**

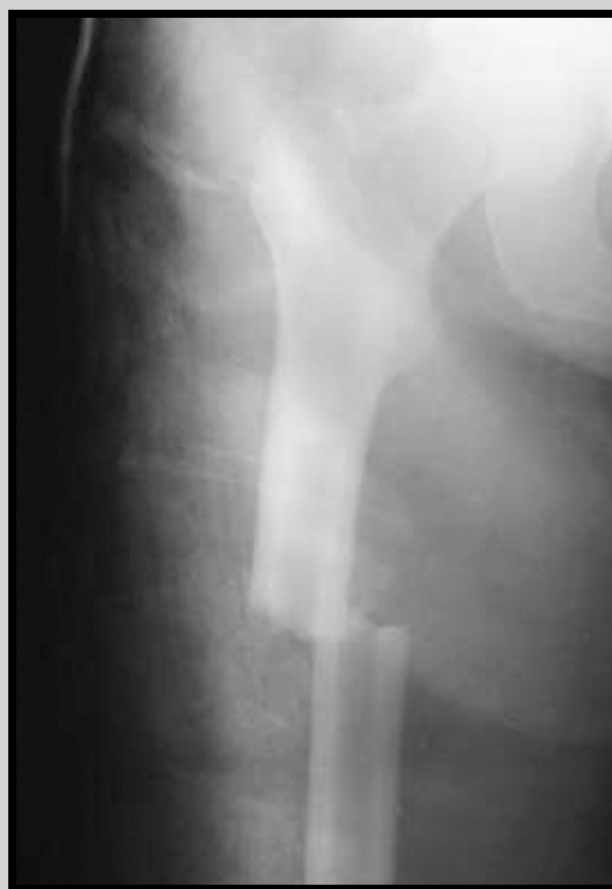
The first case study concerned a male patient aged 25 suffering from uncomplicated fracture of calve bone (FIG. 2). The patient underwent patch test on metals to select the proper material for the implant. After 48 h the allergic reaction was checked. It turned out the man was allergic to chromium. Two of all metallic alloys used in orthopaedics contain large amount of chromium, they are: stainless steel and cobalt alloy (TABLE 2) [15]. Therefore for this patient titanium alloy implant was chosen. It is an implant commonly used for allergic patients in the case of long bone fractures.

**FIG. 2. The fracture of femur stem.****TABLE 2. Chemical composition of metallic alloys used in orthopaedics [15].**
