# Experimental Study on Ultrasonic Monitoring of Splitting Failure in Reinforced Concrete

Magdalena Rucka · Krzysztof Wilde

**Abstract** This paper investigates inspection of reinforced concrete elements sensitive to the splitting failure. The behaviour of a reinforced concrete specimen subjected to a tensile stress is considered. The damage detection procedure is based on the ultrasonic wave propagation technique. The piezoelectric transducers are located on both ends of the specimen and the measurements are taken periodically during the incrementally increased loading. The features of measured signals in time and frequency domains as well as wavelet transforms before and after the splitting failure are studied. The experimental results show that proposed method can be used for monitoring of damage evolution in concrete elements. The method makes possible detection of the moment just before the splitting failure occurs.

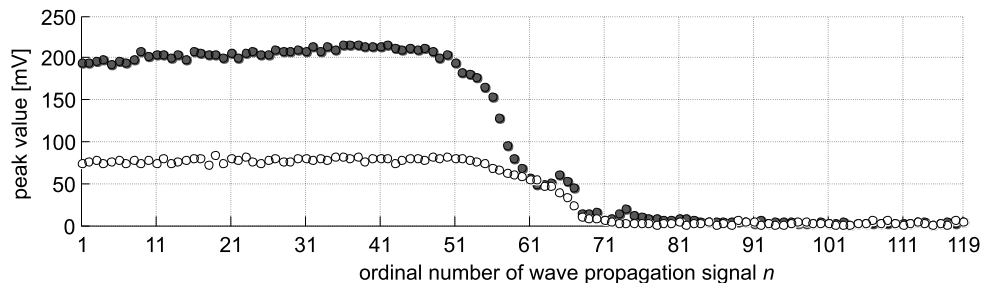
**Fig. 9** Peak values of wave propagation signals registered at point B in the specimen no. 1: the first wave packet corresponding to the first pressure wave traveling in the specimen (white dots) and the second wave

packet associated with interference of shearing and pressure waves reflected from the specimen cross-section boundaries (grey dots)

Figure 9 shows the peak values of the signals registered at point B for the specimen no. 1. Data in Fig. 9 are taken from the time signals (so called A-scans) for consecutive measurements of propagating ultrasonic waves. Peak values of the first incoming wave packet for the signals from  $n = 1$  to  $n = 119$  were plotted with white dots (Fig. 9). The first wave packet corresponds to the first pressure wave traveling in the specimen. The initial value of the peak was of about 80 mV. The first wave packet can be clearly seen for signal numbers from  $n = 1$  to  $n = 40$  (Fig. 9a). For the time records corresponding to higher signal numbers, the peak values of the first wave packet were determined for the time range  $t = 0.27$ – $0.28$  ms. The peak values of the second wave packet that can be seen at  $t = 0.37$ – $0.38$  ms were plotted in Fig. 9 with grey dots. The initial peak value of the second waveform was of about 200 mV. The second wave packet was associated with interference of shearing and pressure waves reflected from the specimen cross-section boundaries. The recognition which wave packet in the registered signal corresponds to pressure and shear waves was done based on wave velocities.

The amplitudes of the first wave packet were similar for the signal numbers from  $n = 1$  to  $n = 55$  (Fig. 9). From  $n = 56$  to  $n = 67$  the amplitudes started to decrease and from  $n = 68$  they became close to zero. Small micro-cracked

zones did not significantly affect the first pressure wave, and therefore, the significant drop of the maximum amplitudes was noticed when the first vertical crack appeared (at  $n = 65$ ). The amplitudes of the second wave packet were constant for signal numbers from  $n = 1$  to  $n = 51$  and the relatively rapid decrease of the amplitudes took place till  $n = 61$ . At signal number  $n = 75$  the maximum amplitudes of the second wave packet became very small. It seems that the change of the peak values of the second wave packet indicated the development of the micro-crack zone before splitting takes place. The vertical splitting cracks were observed for  $n = 65$  while the reduction of the amplitudes starts at  $n = 51$ . Formations of micro-crack zones had relatively large influence on the reflected shear and pressure waves resulting in large attenuation of the second wave packet.
