APPLICATION OF INFRARED THERMOGRAPHY TO NON-CONTACT TESTING OF VARISTORS

Stanisław Galla, Alicja Konczakowska

Gdansk University of Technology, Faculty of Electronics Telecommunications and Informatics, Gabriela Narutowicza 11/12, 80-233 Gdańsk, Poland (✉ galla@eti.pg.gda.pl, +48 58 347 2140, alkon@eti.pg.gda.pl)

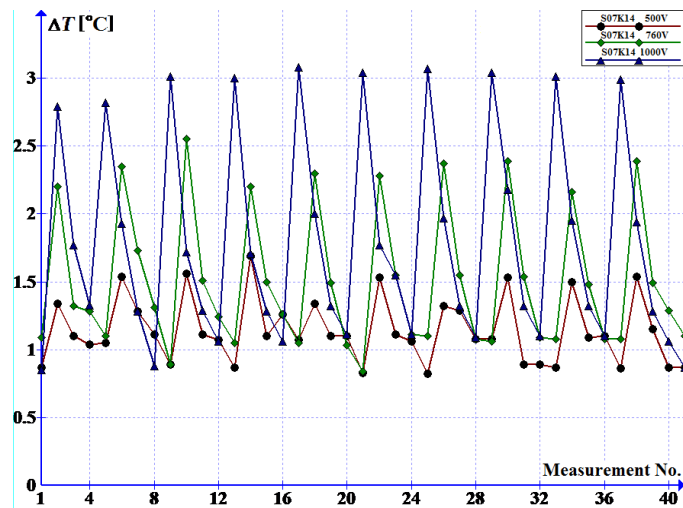
Fig. 3. Temperature increments ΔT recorded in successive measurements with infrared camera during application of surges at 3 voltage levels: 500 V, 760 V and 1000 V for varistor No. 5 of S07K14 type.

On the basis of recorded temperature increments, average values (for tested varistors) were assessed. The values were not exceeding 2°C, 3°C and 4°C for P22Z1 and S07K14 type varistors, for voltage surge levels of 500 V, 760 V and 1000 V (Fig. 2 and Fig. 3), respectively.

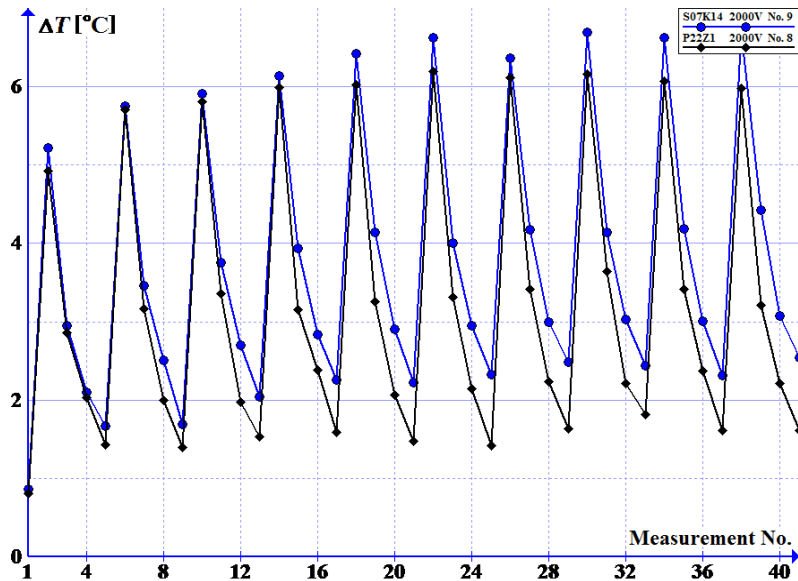
Fig. 4. Temperature increments ΔT recorded in successive measurements with infrared camera during application of surges of 2000 V voltage level for varistor No. 8 of P22Z1 type and varistor No. 9 of S07K14 type.

For P22Z1 type varistors average values of recorded temperature increments were calculated. They exceeded 6°C for varistors Nos. 6, 7 and 8, whereas for varistors No. 9 and No. 10 were smaller than 6°C . The capacitance values $C(t_N)$ for varistors Nos. 6, 7 and 8 exceeded 2612 pF, whereas for varistors No. 9 and No. 10 were smaller than the above value. Thus, the capacitance changes, as well as temperature increment values, indicate that varistors Nos. 6, 7 and 8 lose their protective properties.

For S07K14 type varistors average values of recorded temperature increments were calculated. For all varistors the values exceeded 6°C . The capacitance values $C(t_N)$ for all varistors exceeded 2530 pF. Thus, the capacitance changes, as well as temperature increment values, indicate that all S07K14 type varistors lost their protective properties.

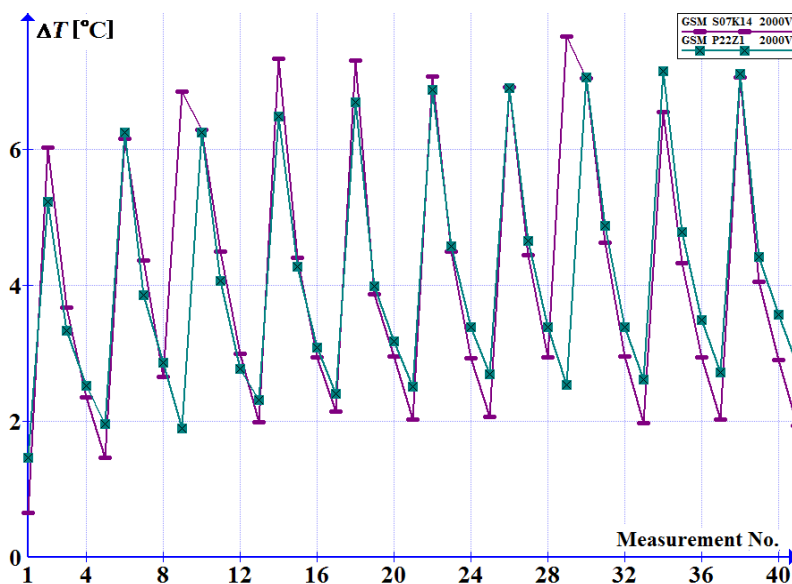
Fig. 5 illustrates that S07K14 type varistors showed a higher temperature increment (7.24°C) than the P22Z1 ones (6.3°C).

Fig. 5. Temperature increments ΔT recorded in successive measurements with infrared camera, during application of surges with 2000 V voltage level for P22Z1 and S07K14 type varistors operating in communication modules No. 3.

The recorded temperature increments for surges with 500 V, 1000 V and 2000 V levels were equal to 1.3°C, 3.15°C and 6.3°C for modules with P22Z1 type varistors, and 1.35°C, 3.52°C and 7.24°C for modules with S07K14 type varistors. The capacitance values of varistors submitted to surges with voltage levels of 500 V and 1000 V, measured 24 hours after completion of tests, have not changed significantly, i.e. to the point that corresponds with losing protective properties by varistors. Thus, it can be stated that the varistors have not changed their protective properties. The temperature increment values on the varistor surfaces have not also suggested loss of protective properties by varistors, i.e. they have not exceeded 6°C. However, the capacitance values of varistors operating in modules No. 3 submitted to surges with the 2000 V voltage level, measured 24 hours after completion of tests, have increased considerably. The temperature increment values on the varistor surfaces were higher – from the 20th measurement on – than the values suggesting loss of protective properties of varistors, i.e. exceeded 6°C (Fig. 5).

The level of changes in capacitance values and temperature increment values for varistors operating in modules No. 3 suggests recommending their replacement with other varistors before launching the GSM modules into the market.
