Types of wear and tear of biomaterials used in orthopaedic surgery

Purpose: Purpose of this paper is presentation of observations on different kinds of wear and tear of biomaterials used in contemporary orthopaedic surgery.

Design/methodology/approach: Types of prosthesis damage, encountered in medical practice, and their causes have been described. Results of many clinical studies were analysed to review prosthesis damage from the stage of implanting (such as intrusion of a foreign object between its components) to their natural wear and tear after many years of use (abrasive wear, biological corrosion).

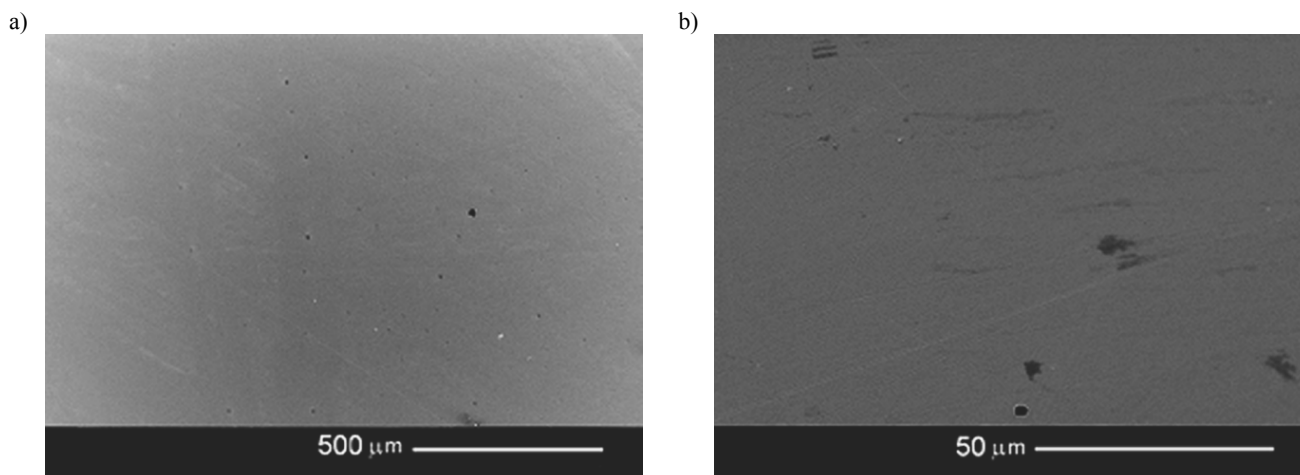
Fig. 1. The surface of a new socket - images at different magnifications

One of the tribological pairs in a hip joint prosthesis is the „prosthesis head - socket” moving contact. The process of wear in the contact depends mainly on the type of friction pair and the surface roughness. Of the two elements (socket and head) which are in contact in an implant, the socket is more susceptible to wear as it is made of a softer material (they are made of plastic - usually hard polyethylene (HDPE or UHDPE), while heads are made of metal or ceramic materials). Examples of images of sockets - both new and damaged as a result of different types of wear - are shown in Figs. 1-5, with Fig. 1 being the reference image for all the studies described in this paper.

As the photographs show, the nature of wear of an implant sockets is highly varied. Compared to new sockets, whose surface is very smooth (Figs. 1 a, b), the surface of used sockets is in much worse condition. The most common type of wear observed in the sockets under examination was damage caused by biological corrosion (Figs. 2 a, b). This indicates insufficient resistance to that type of corrosion of the materials used for the implants. Despite using hard PE to make prostheses sockets, sometimes the material is seen to flow (Figs. 3 a, b).

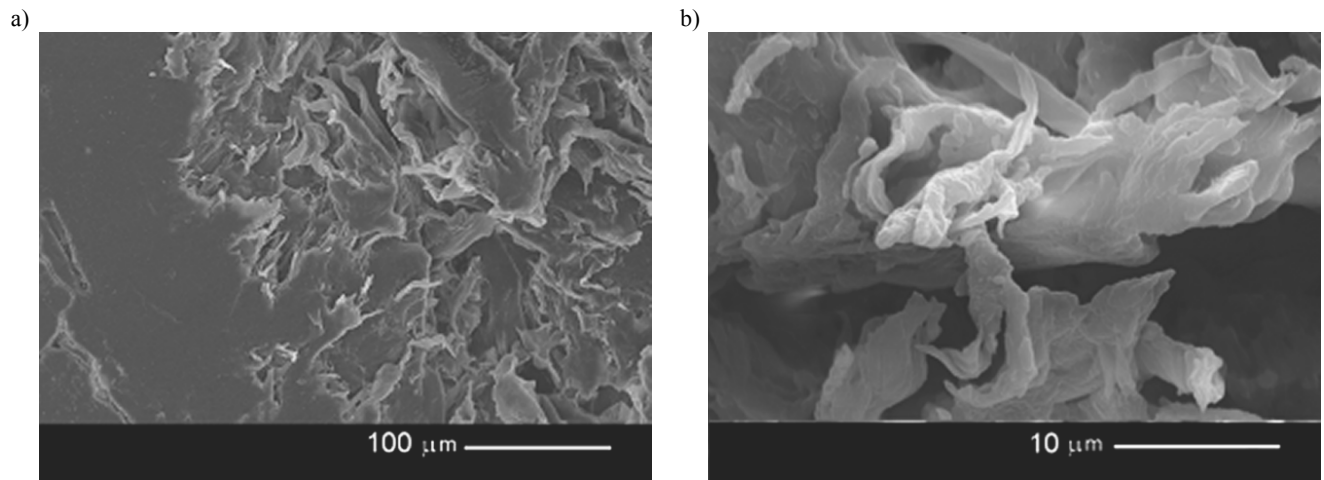
Fig. 2. The surface of a socket damaged as a result of biological corrosion

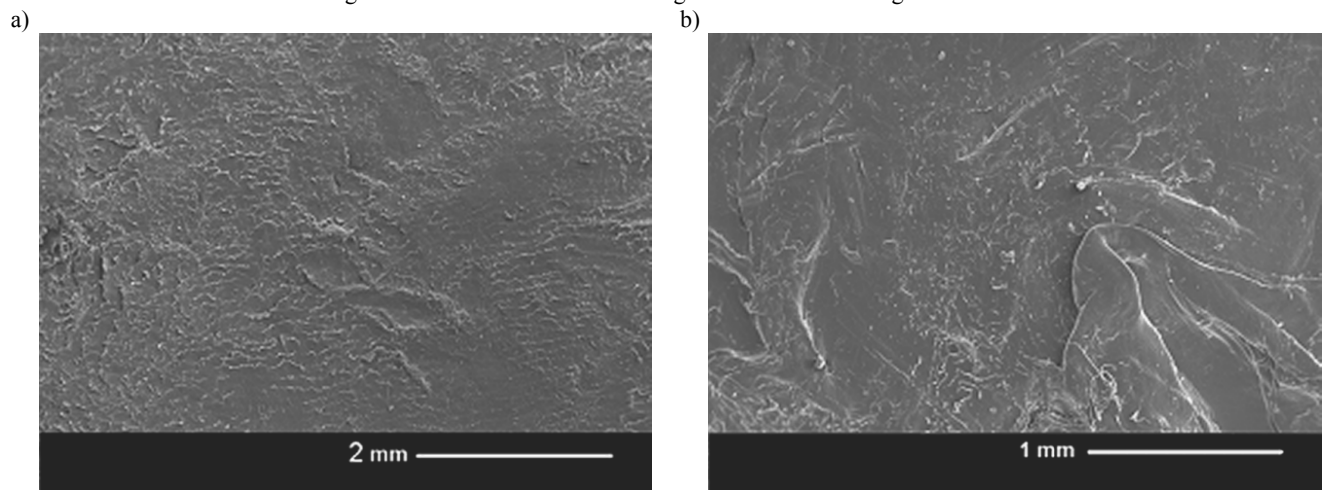
Fig. 3. Plastic flow of the socket material

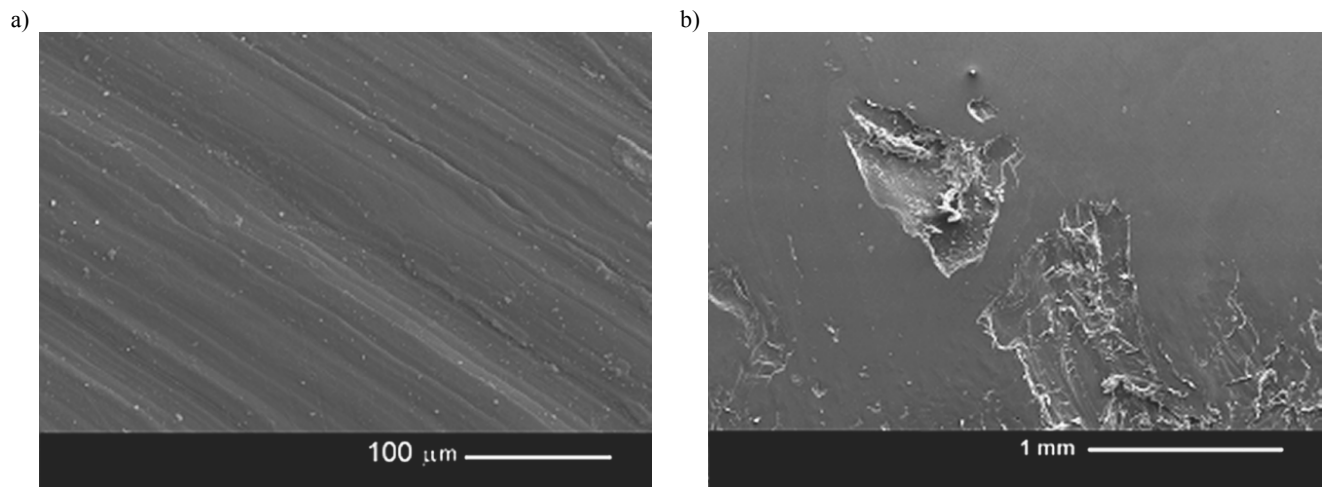
Fig. 4. Examples of different types of wear of hip joint prostheses sockets: a) abrasive wear, b) chipping the sockets material

Some socket surface has been seen to crack (Fig. 5a). However, abrasive wear has been the most common type of damage to their surface (Figs. 4 a, b). This may have been caused by elements of the socket material which have chipped off during the joint use (Fig. 4) or foreign bodies (Fig. 5 b) which entered the "prosthesis socket - head" contact zone. This has been confirmed by authors of other publications [2,35], whose studies have shown that parts of prostheses made of hard metals, which are in contact with polyethylene, do not show signs of significant wear even after more than ten years of use. Only hard products of wear, e.g. chips of bone cement, which enter the friction zone, can scratch the smooth surface of the metal element.
