Types of wear and tear of biomaterials used in orthopaedic surgery

ABSTRACT

Purpose: Purpose of this paper is presentation of observations on different kinds of wear and tear of biomaterials used in contemporary orthopaedic surgery.

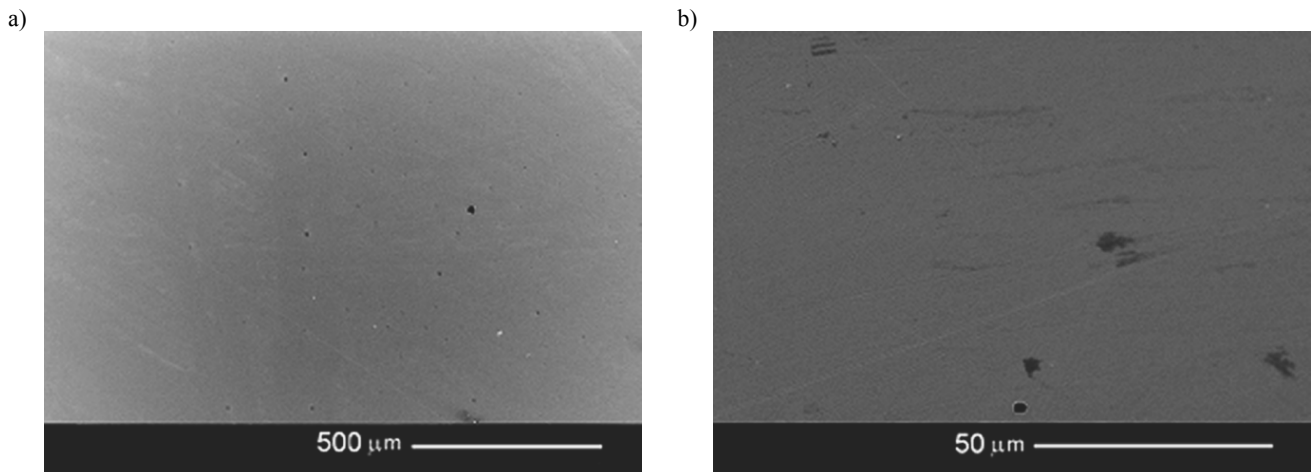
Fig. 1. The surface of a new socket - images at different magnifications

One of the tribological pairs in a hip joint prosthesis is the „prosthesis head - socket” moving contact. The process of wear in the contact depends mainly on the type of friction pair and the surface roughness. Of the two elements (socket and head) which are in contact in an implant, the socket is more susceptible to wear as it is made of a softer material (they are made of plastic - usually hard polyethylene (HDPE or UHDPE), while heads are made of metal or ceramic materials). Examples of images of sockets - both new and damaged as a result of different types of wear - are shown in Figs. 1-5, with Fig. 1 being the reference image for all the studies described in this paper.

As the photographs show, the nature of wear of an implant sockets is highly varied. Compared to new sockets, whose surface is very smooth (Figs. 1 a, b), the surface of used sockets is in much worse condition. The most common type of wear observed in the sockets under examination was damage caused by biological corrosion (Figs. 2 a, b). This indicates insufficient resistance to that type of corrosion of the materials used for the implants. Despite using hard PE to make prostheses sockets, sometimes the material is seen to flow (Figs. 3 a, b).

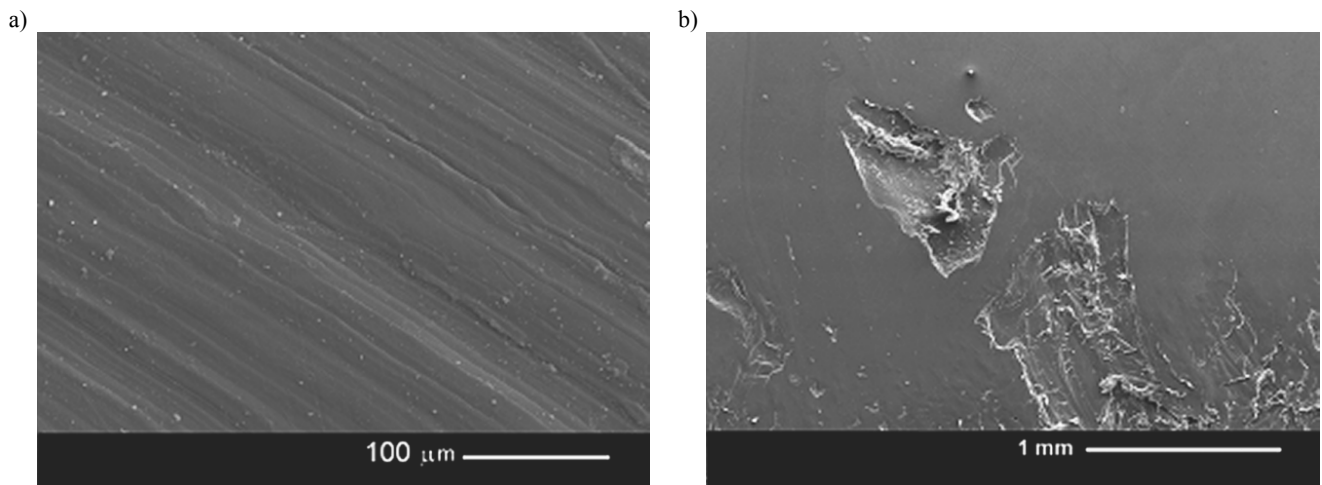
Fig. 4. Examples of different types of wear of hip joint prostheses sockets: a) abrasive wear, b) chipping the sockets material

Some socket surface has been seen to crack (Fig. 5a). However, abrasive wear has been the most common type of damage to their surface (Figs. 4 a, b). This may have been caused by elements of the socket material which have chipped off during the joint use (Fig. 4) or foreign bodies (Fig. 5 b) which entered the "prosthesis socket - head" contact zone. This has been confirmed by authors of other publications [2,35], whose studies have shown that parts of prostheses made of hard metals, which are in contact with polyethylene, do not show signs of significant wear even after more than ten years of use. Only hard products of wear, e.g. chips of bone cement, which enter the friction zone, can scratch the smooth surface of the metal element.

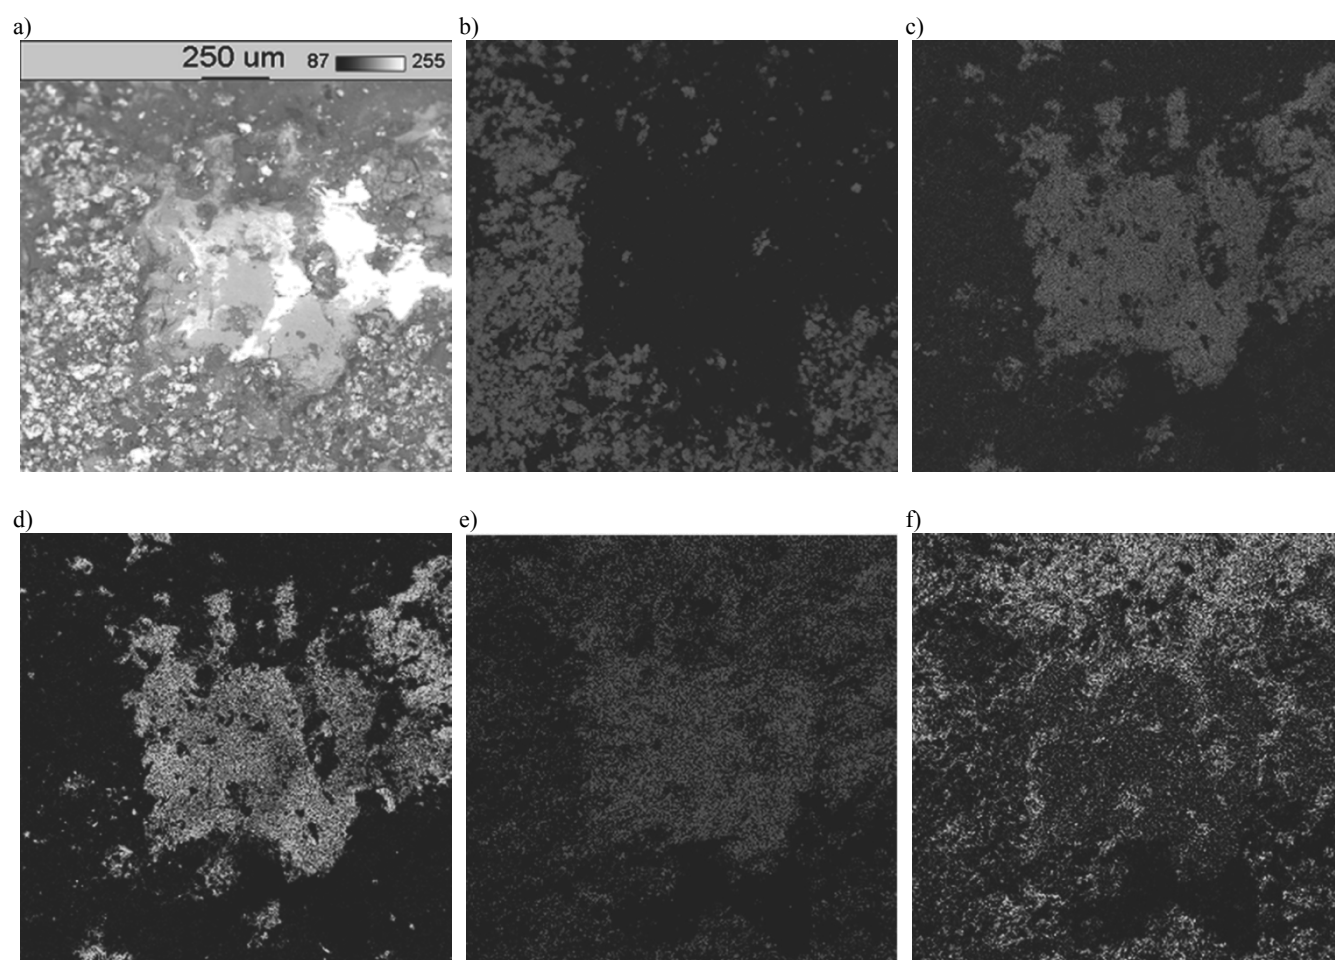
Fig. 6. Intrusions in titanium socket: a) image of the intrusion, b), c), d), e), f) distributions of titanium, phosphorus, calcium, oxygen and carbon

Some elements have been observed on the sockets surface which may have come from the patient's body. As is seen on the maps of surface element distribution, the intrusion shown in Fig. 6 contains mainly calcium, phosphorus and oxygen. Those elements are found in hydroxyapatites, which are the main components of bones. This allows one to conclude that the element entered between the head and the socket during the prosthesis implanting procedure.

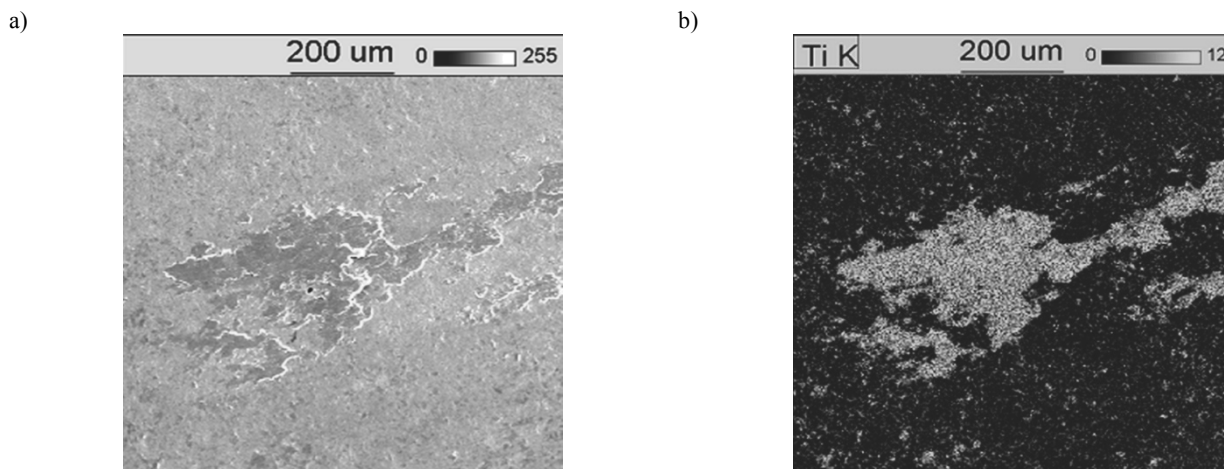
An analysis of the chemical composition has shown that certain titanium elements appeared on the prosthesis head, made of Co-Cr-Mo alloy (Vitalium). As the map of titanium distribution (Fig. 9) shows, its presence exactly coincides with the eruption. Titanium is not as hard as the Vitalium alloy, so those are not particles stuck into the surface; rather they are spread on the surface. Therefore, its presence here has different reasons. As the socket casing was made of titanium, the eruption on the surface may originate from it. This indicates that apart from typical wear processes by friction, a process of dissolving titanium by body fluids and transporting it to other places takes place.

Fig. 9. Foreign material on the surface of the head of a hip joint prosthesis: a) image of the intrusion, b) surface distribution of titanium.

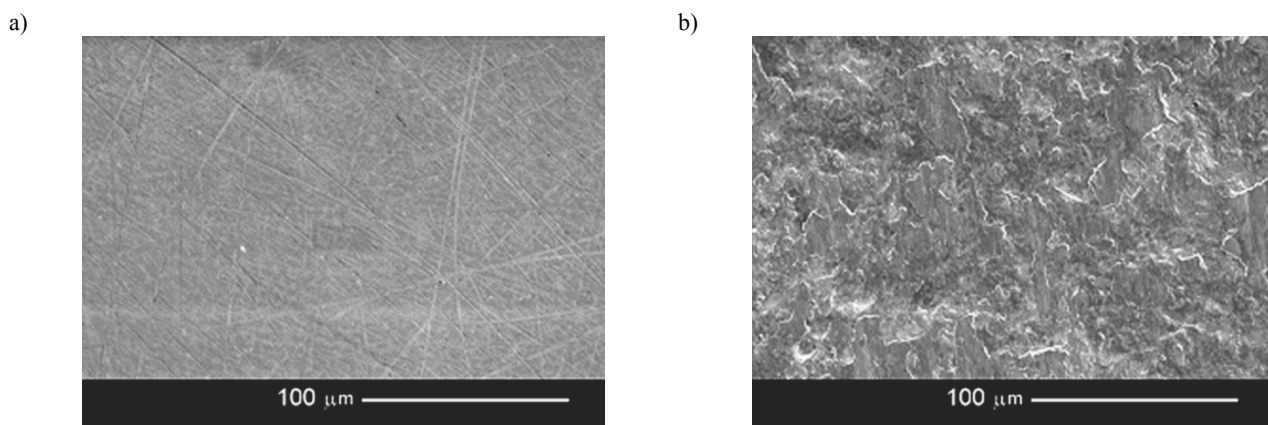
Apart from intrusions, there are also other types of wear observed on the surface of a prosthesis head. The surface of a non-worn head, shown in Fig. 10, is relatively smooth and there are only scratches on it caused by mechanical processing. A worn prosthesis head looks completely different (Fig. 10b). This is typical wear observed in cutting elements. Material defects and traces of its plastic flow are visible.

Fig. 10. Examples of different types of wear of heads of hip joint prostheses: a) non-worn surface, b) surface worn by friction
