Gdańsk University of Technology, Poland

EXPERIMENTAL INVESTIGATIONS ON CONCRETE BEAMS REINFORCED WITH CFRP LAMELLAS

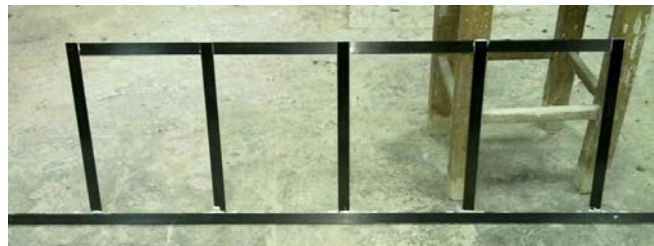
The reinforcement was prepared as a series of frames which were fixed together with the appropriate segments of the lamellas. The mounting material was a two-ingredient epoxy resin glue, also provided by S&P.

Fig. 3. Reinforcing cage before covering with sand

In order to improve the bond between the reinforcement and the concrete, the frames were covered with 1.0-2.0mm grain sand, following the application of the epoxy resin. The same epoxy resin was used for the mounting of the separate reinforcement parts. Gaps were left for strain gauges only.

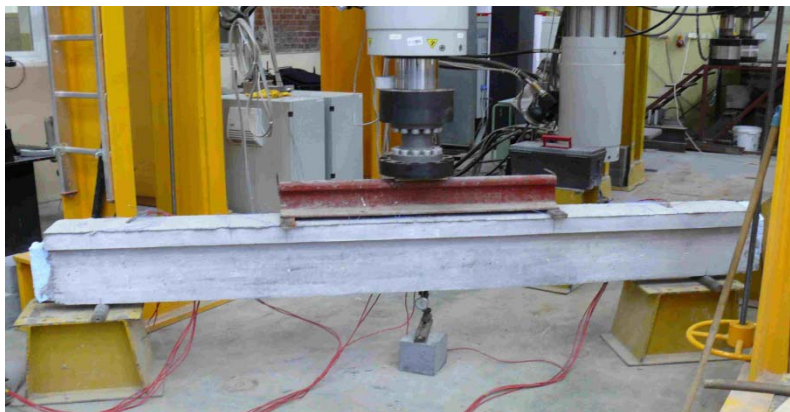
The force from the piston of the tester ($2P$) was transferred to the beam by the travers, which was decomposing it into two concentrated forces. (Fig. 4, Fig. 5). With such parameters of the setup, the slenderness of the shear was $a/d = 70/30 = 2,33$.

Fig. 5. The beam at the setup

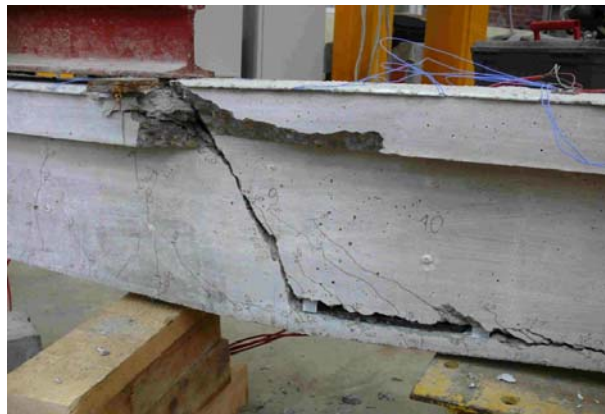
Distinct diagonal crack in beam 1 occurred on the right hand side support. The crack has cut through the base of the extensometer (No 9) The strain of base No 9 was approx. 6%, with the load of $2P = 100$ kN and it grew to 10,6% with the further increase of the load. This suggests a 1 mm width of the crack. Further increase of the load resulted in the loss of the load-bearing capacity at the force of $2P = 135$ kN. This was accompanied by a distinct sound of a short, single crack. The load was re-applied to the beam. This resulted in the complete damage of the beam with the crushing of the T- flange concrete. (Fig. 7)

Fig. 7. Cracks in beam 1 on right hand side support

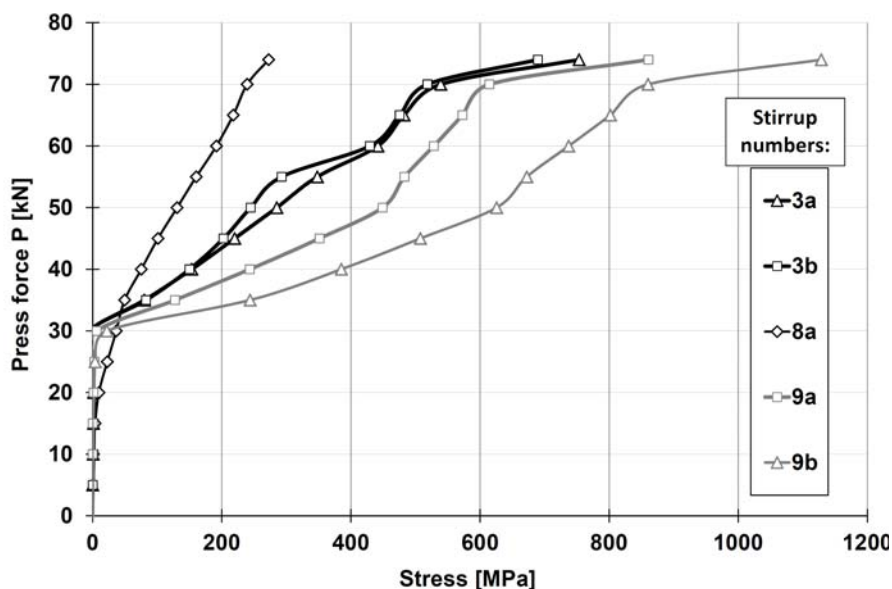
Fig. 8 shows stress diagrams in the most strenuous stirrups of beam 2. The stresses were calculated on the basis of the strains recorded during the tests. The maximum stresses in the stirrups as measured during the test were: $\sigma_{sbmax}=1052,1$ MPa for beam 1 and $\sigma_{sbmax}=1128,5$ MPa for beam 2. They were 42% and 45% of the lamella' strength of $\sigma_{max} = 2500$ MPa. Considering the fact that the tested beams were deeply cracked in the final phase of the loading, it seems that most of the shear forces were transferred by the lateral reinforcement only.

Fig. 8. Stress diagram in chosen stirrups of beam 2
