Gdańsk University of Technology, Poland

EXPERIMENTAL INVESTIGATIONS ON CONCRETE BEAMS REINFORCED WITH CFRP LAMELLAS

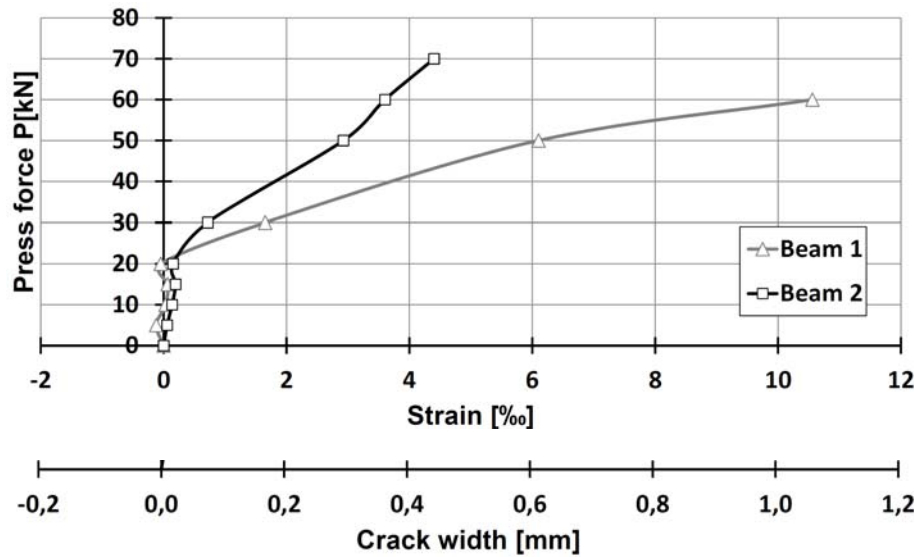
The width of the cracks was not investigated as part of the test. However it can be estimated based on the readings taken at the bases of the extensometer. The maximum strain readings were achieved at base 9 in both tested beams. A distinct increase of the strains in these bases was associated with the widest inclined crack from shear which passed through them. Therefore it seems that the strains at the bases closely reflect the width of the cracks which pass through them. Fig. 13 presents the strains as described above.

Fig 13. Strains at extensometer base No 9 and the corresponding width of the inclined cracks.

It should be noted that the durability of the FRP reinforcement is much different from the durability of the steel. As for that the expectations for the width of the cracks which are applied to the composites should differ from the ones for the reinforced concrete. Therefore (following the US design code [3]) there are two allowed crack levels agreed: $w_{lim}=0,7$ mm inside the buildings and $w_{lim}=0,5$ mm on the outside. Table 1 shows that beam 1 surpassed the above criteria with the loading force of

P=50 kN. Beam 2, which was cracking more evenly, satisfied both of the criteria within all spectrum of the loads until the total loss of the load-bearing capacity.
