Gdańsk University of Technology, Poland

EXPERIMENTAL INVESTIGATIONS ON CONCRETE BEAMS REINFORCED WITH CFRP LAMELLAS

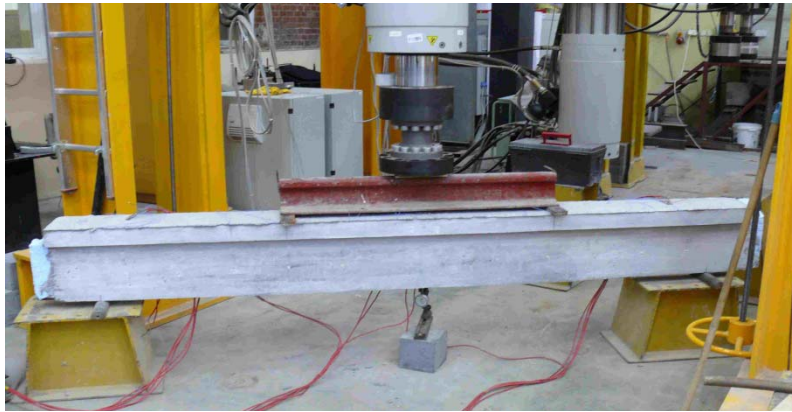
Fig. 5. The beam at the setup

The force from the piston of the tester ($2P$) was transferred to the beam by the travers, which was decomposing it into two concentrated forces. (Fig. 4, Fig. 5). With such parameters of the setup, the slenderness of the shear was $a/d = 70/30 = 2,33$.
