## CONSTRUCTION SOLUTIONS FOR HISTORICAL OBJECT FOUNDATIONS IN THE CONTEXT OF CHANGING THEIR FUNCTIONAL USE

Kazimierz GWIZDAŁA<sup>1</sup>, Sylwia FLORKOWSKA<sup>2</sup>  
Gdańsk University of Technology,  
Civil and Environmental Engineering, Gdańsk, Poland

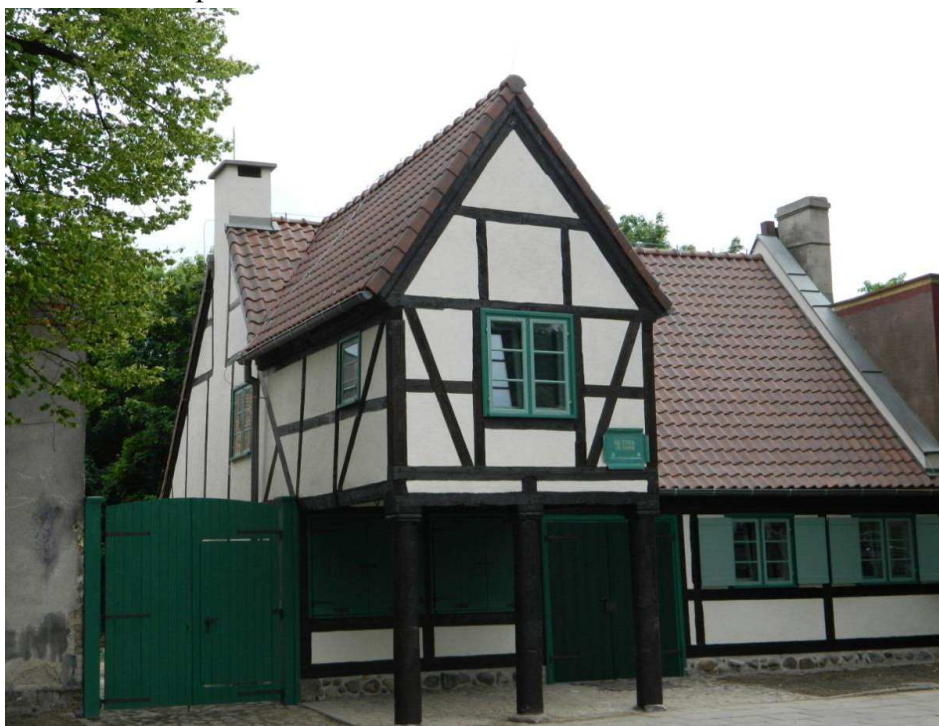
Fig. 1. Forge building after completion of construction-conservation work

An example of a project involving works connected with reinforcing the foundation is the renovation of an arcade house in Gdańsk Orunia. The building was constructed in 1800, and originally served as a workshop and forge; in the XX century, it was converted into a residential dwelling. In 2012, works which aimed to completely renovate the building as well as adapt it to serve a new function were assumed [1]. The existing brick-stone foundations of the building were found to be in a satisfactory technical condition, and required only moisture protection. However, due to the introduction of new construction elements and changes in static and service load, it was necessary to construct new foundations. Favorable subsurface and groundwater conditions made it possible to construct direct foundations in the form of reinforced concrete strips. The works were carried out using the method of reinforcing in segments, after first loading and supporting the construction of the building along the foundations.

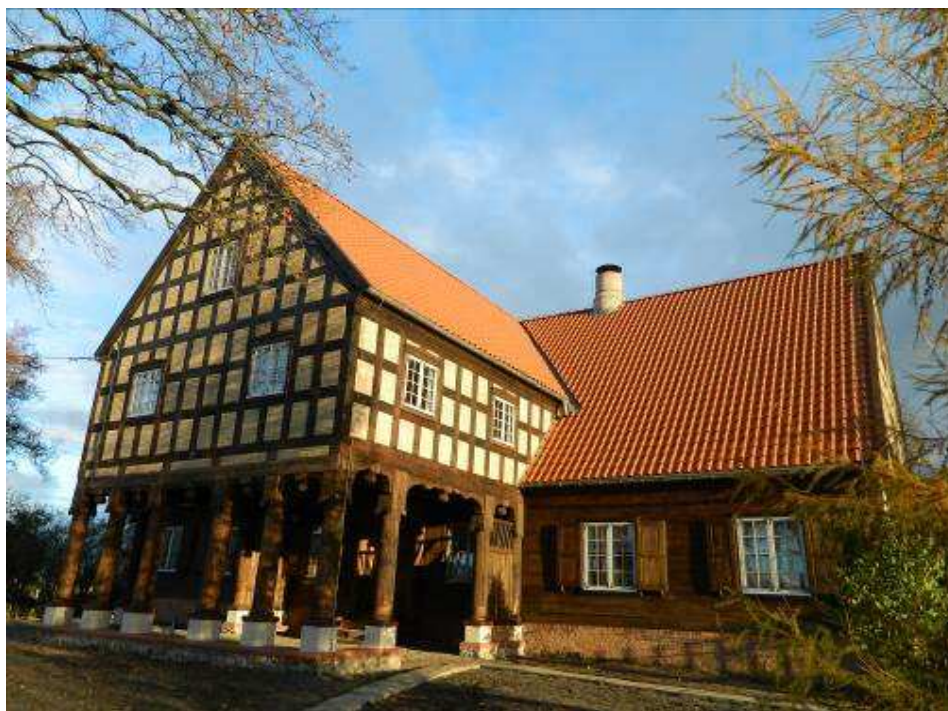
Fig. 2. Arcade house in Marynowy upon completion of building-conservation works

A similar solution (in the form of introducing a new direct foundation) was applied during the renovation of a XIX-century arcade house in Marynowy. One of the assumptions of the renovation project for the building was maintaining the original spatial layout of the rooms while allowing them to be used for residential and public utility purposes. Due to the anticipated higher values of service loads and bad technical condition of the arcade construction, it was necessary to reinforce it. Upon analyzing the soil conditions and carrying out static-strength calculations for the construction of the house, it was decided that a foundation in the form of reinforced concrete strips will be made beneath the construction of the destabilized arcade. A stone pedestal was placed on the

foundation structure, on which the repaired and reinforced load-bearing posts of the arcade were placed.

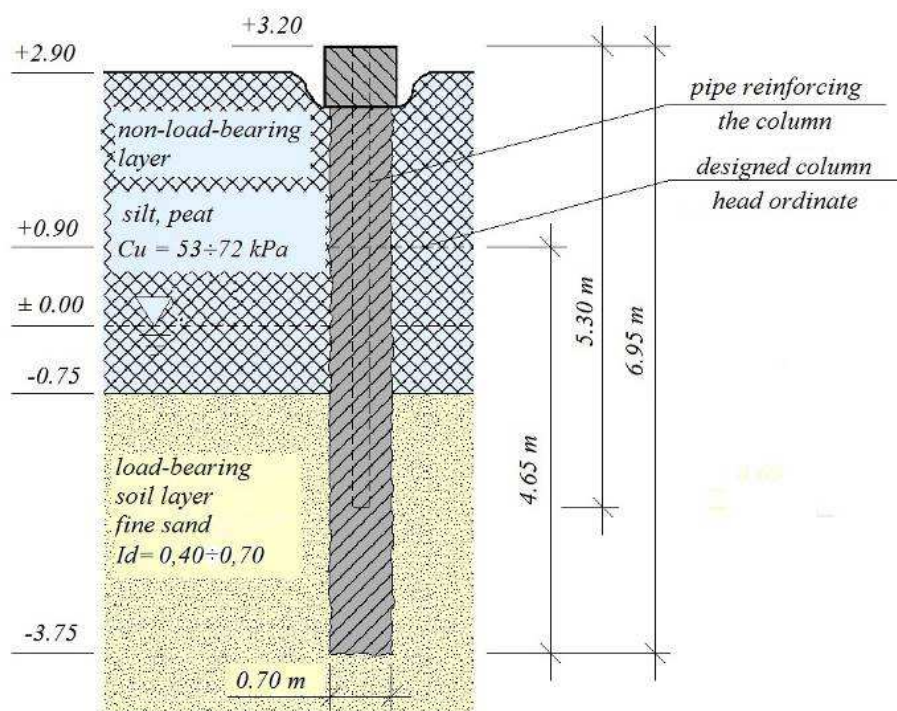
Fig. 3. Geotechnical cross-section of soil along with the jet column

Thanks to the applied technology, it was possible to restrict the settlement of the building, as well as stabilize the construction. Applying column foundations ensures high rigidity of the support and the reduction of section forces in existing buildings. The created jet grout columns made it possible to carry increased loads over to deeper, load-bearing layers of the soil (Fig. 3).

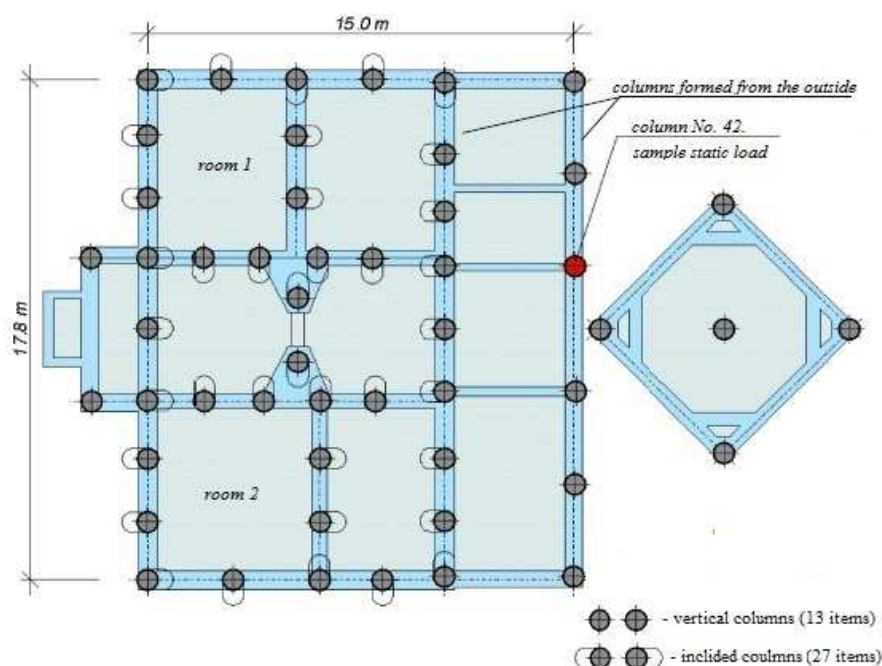
Over 40 vertical and inclined jet grout columns, crowned with reinforced caps, were formed beneath the discussed Młyniska Manor building. The diameter of a single column was 0.7 m, whereas their length ranged from 4 to 6 m depending on the applied load and depth of the load-bearing sand layer.

Fig. 4. Layout of columns beneath Młyniska Manor building [3]

The inclination of the outside columns was 8:1, whereas in the case of inside ones - 10:1; however, the directions in which they were inclined varied in order to ensure adequate stiffness and behavior of the entire column group. The proper inclination of columns ensured relatively easy execution, i.e. the machine was placed only in two inside rooms (1 and 2), as shown in Fig. 4. The jet grouting was carried out using mono-jet technology, at a pressure of approximately 50 MPa. A grout slurry was made of portland cement 35, the total of which amounted to 3250 dm<sup>3</sup>. The rotation speed of the jet rod was 20 rotations/min., whereas the withdrawal velocity was 4 cm/10 sec. [2]. An additional test column was made in the neighborhood of the strengthened building, which was used to verify the load-bearing capacity of columns accepted in the reinforcement project (Fig. 5). The settlement of a single column for the design load of  $Q_r=600$  kN was under 3mm.

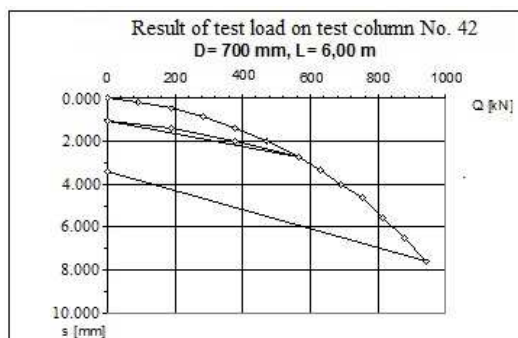
Fig. 5. “Młyniska Manor” - results of test load on test column [2]
