APPLICATION OF ACUSTIC EMISSION FOR DETECTION OF FATIGUE MICRODEAMAGE IN MAIN AND CRANK BEARINGS FOR DIESEL ENGINES

Jerzy Girtler

*Gdańsk University of Technology
Faculty of Ocean Engineering and Ship Technology
Department of Ship and Land Power Plants
tel. (+48 58) 347-24-30; fax (+48 58) 347-19-81
e-mail: jgirtl@pg.gda.pl*

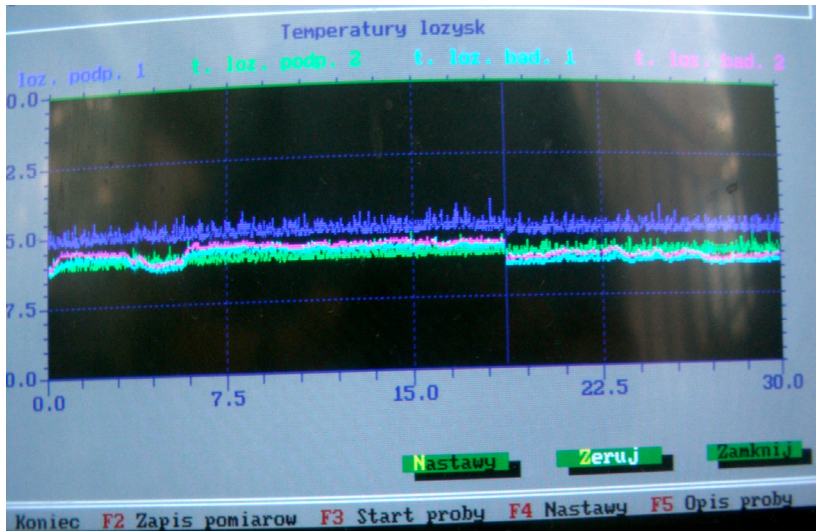
During the tests the recorded values included: loads (Fig. 1), temperature of the tested bearing and supporting bearings (Fig. 3), journal rotational speed, oil pressure, lubricating oil temperature and the ambient temperature.

Fig. 3 Temperature spectra for the tested bearing and the supporting bearings [9]

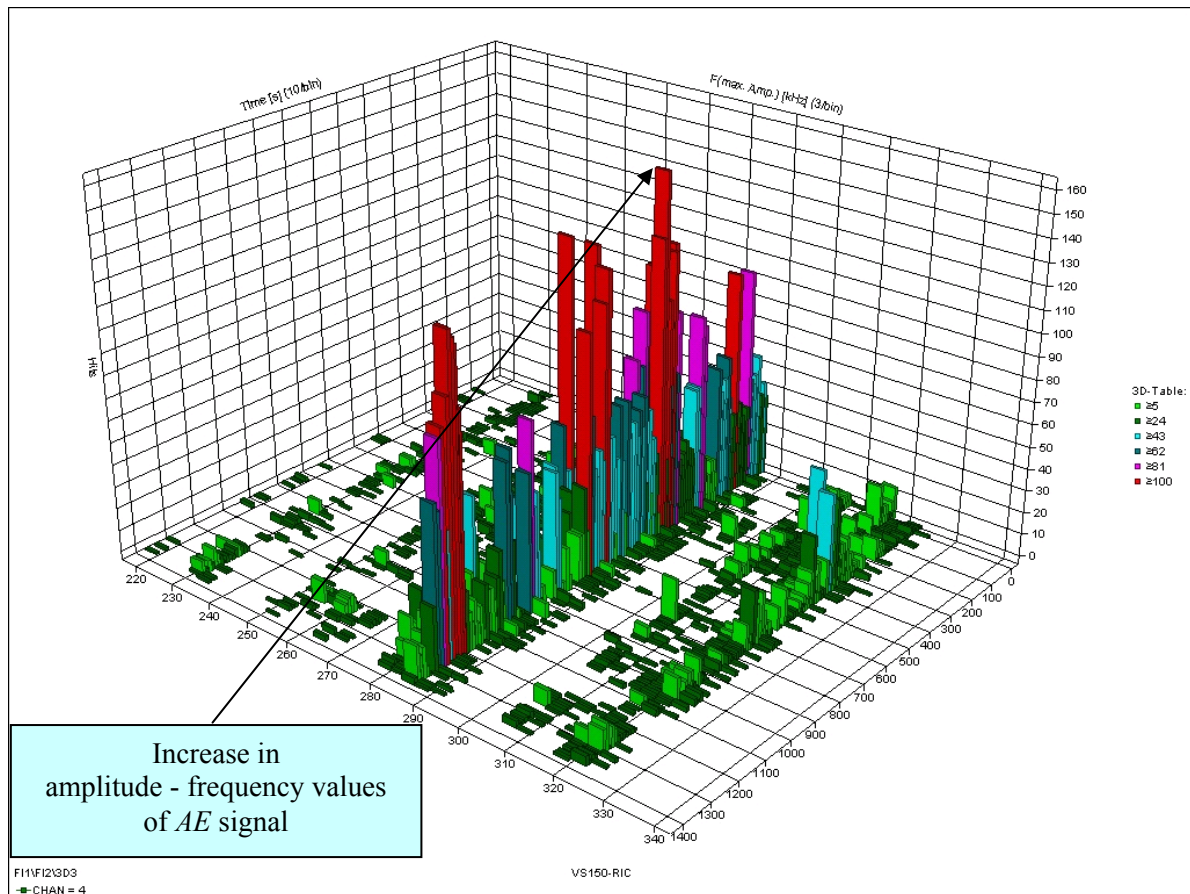
The test was stopped when recording a significant increase in the amplitude-frequency values of AE signals. This situation is shown in Fig. 4.

Fig. 4. Frequency bands of the signals recorded by the AMSY-6 equipment, indicating a fatigue damage in the sliding layer of the bearing bush [9]
