APPLICATION OF ACUSTIC EMISSION FOR DETECTION OF FATIGUE MICRODEAMAGE IN MAIN AND CRANK BEARINGS FOR DIESEL ENGINES

Abstract

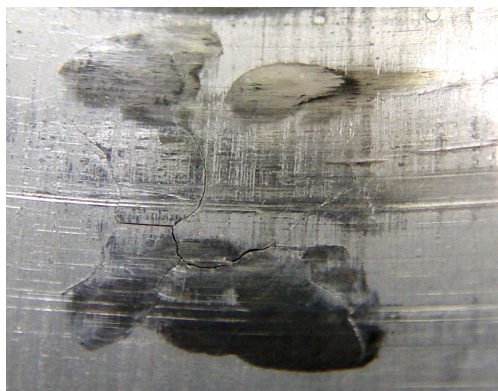
The existence of a standard net of fatigue cracks was recorded on the tested bush of MB58 alloy, as shown in Fig. 7a and b, and Fig. 8.

Fig. 8. Net of cracks on the sliding surface of the MB58 bush (zoom out of the part of the sliding surface shown in Fig. 7b) [9]
