OVERFLOWING TESTS AT THE POLISH DREDGDIKES RESEARCH DIKE – STABILITY OF THE DIKE SURFACE AGAINST EROSION

Abstract. In the project DredgDikes the different research dike embankments were tested with respect to overflowing water induced erosion. Therefore, flumes were installed on the land side embankments in which the effect of overflowing water on the vegetated surface was investigated. On the Polish DredgDikes research dike near Gdansk, Poland, two parallel flumes were installed and the surface of the dike made of different mixtures of ash, silt and sand as well as clay was tested both in vegetated and unvegetated state. The results showed that the grass sods placed on the dike embankment had a comparably low erosion stability, particularly if placed directly on the hardened ash/silt dike cover with better results if placed on a clay cover, while the ash/silt mixture showed a high erosion resistance without vegetation. This results in the recommendation to use a thicker vegetation layer on top of the ash composite dike if the vegetation shall account for the erosion resistance or else, that even if the grass cover is washed away, a very solid cover made of the ash composite can w

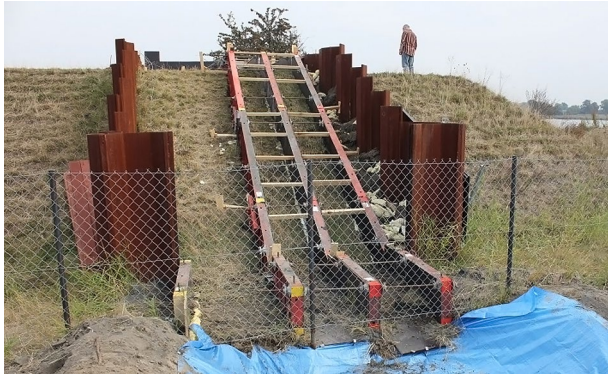
Fig. 5. Basic experimental set-up of the Gdansk flume system

Based on a modified NTPEP (2013) test set-up two parallel flume channels were installed on the downstream embankment of the research dike. Figure 5 shows the basic experimental set-up. Each flume had an inner width of 0.6 m and nine test sections. The flumes were made of construction form elements and each of these was fixed onto the slope and sealed with construction foam. Wooden slats served as markings for the individual test sections (Olschewski *et al.* 2014).

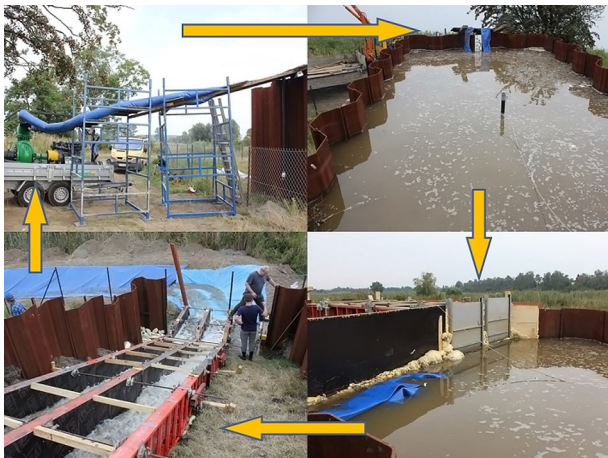
Fig. 6. Water cycle for the overflowing tests: pump, reservoir, shutters and flumes

On the dike crest the water inlets for discharge control were placed. The water delivery system included the Vistula River (as a reservoir), a pump and flexible tubes, the sheet pile basin, steel shutters at the flume inlets and a runoff channel (Fig. 6).
