## Case study

# Restoration and preservation of the reinforced concrete poles of fence at the former Auschwitz concentration and extermination camp

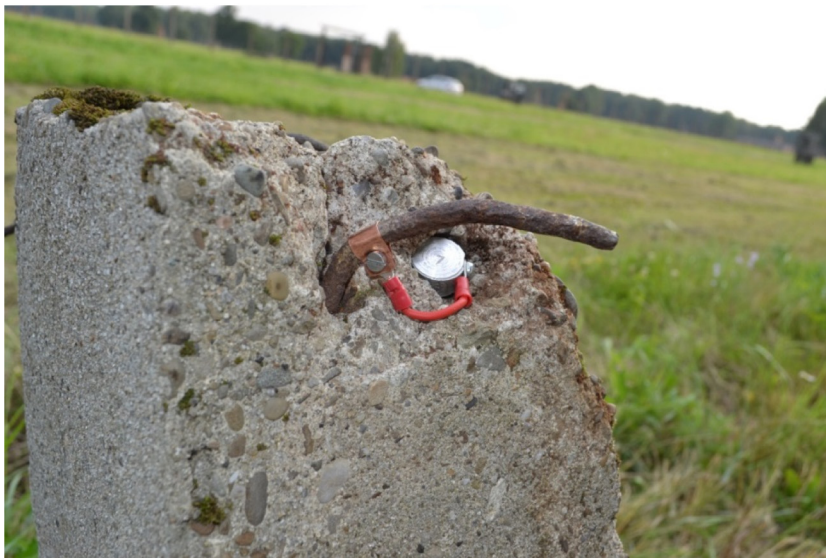
**Fig. 7.** Pillars located in the former Auschwitz camp protected with sacrificial anodes before applying a new repair mortar: variants with protector buried in soil (a), variant with protector placed directly on reinforcement (b).

In order to ensure effective protection of steel reinforced pillar two variants of protection are suggested. The first one consists in placing the protector in ground in vicinity of the reinforced concrete pillar as illustrated in Fig. 6a. Electrical connection between the protector and the steel reinforcement is accomplished in the underground section of the pillar, so the protection system is not visible for the potential visitors, which fulfills the requirements for conservation of historical heritage objects. The same requirement is fulfilled by the second variant of protection, which predicts positioning of the protector directly on the reinforcement (Fig. 6b). In this case the protector is typically in form of small-dimension zinc disc or wire fixed on and electrically connected with the reinforcement bar. Then missing layer of concrete is applied covering the rebar together with the protector. As long as the concrete layer is not penetrated by water, ions and the front of carbonation is away from the reinforcement, steel does not corrode and the protectors play a waiting role. The moment the aforementioned agents reach the rebar the sacrificial anodes start to provide electrochemical protection. The second variant of protection is ideally suited for the degraded pillars calling for restoration where the reinforcement is revealed and exposed to atmospheric conditions. In case of both approaches the effectiveness of applied protection as well as the time instant when the protector has to be replaced can be monitored and determined by measurements of electrochemical potential of the pillar's reinforcement. Both proposed variants of electrochemical protection have already been implemented at separate pillars present on the area of the former Auschwitz camp (Fig. 7a and b).
