Case study

Electrolytic corrosion of water pipeline system in the remote distance from stray currents—Case study

Case study of corrosion failure of urban water supply system caused by the harmful effects of stray currents was presented. The failure occurred at a site distant from the sources of these currents namely the tramway and railway traction systems. Diagnosis revealed the stray currents flow to pipeline over a remote distance of 800/1000 m from the point of failure. At the point of failure stray currents flowed from the pipeline to the ground through external insulation defects, causing the process of electrolytic corrosion of the metal. Long distance between the affected section of the pipeline and the sources of stray currents excludes the typical protection against stray currents in the form of electrical polarized drainage. Corrosion protection at this point can be achieved by using the earthing electrodes made of magnesium, which will also provide cathodic current protection as galvanic anode.

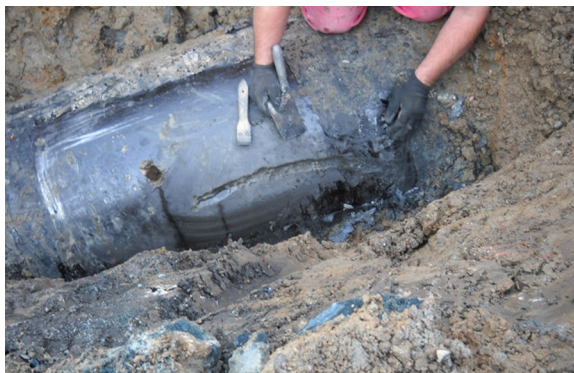
Fig. 1. View of pipeline corrosion failure.

Described corrosion damage occurred on the steel water pipe DN 300 in bitumen isolation. The age of this fragment of pipeline is estimated to be about 18 years and actual thickness of the pipe wall in the place of damage is slightly more than half of its normal thickness and it is in the range of 9–11 mm. Pipeline in the place of damage is buried in the sandy type of soil. Uncovered damage after digging out the pipeline, removing the bitumen coating and cleaning the surface is presented in Figs. 1 and 2. The failure occurred at the beginning of branching of the pipeline. The figures show the circular pipe wall perforation having a diameter of about 4 cm, containing the soil with corrosion products. On the right side of the defect, just below it, significant loss of metal within the distance of tens of centimeters and a width of approximately 3–4 cm is visible. This broad defect is probably caused by mechanical damage occurred during the mounting of water pipe system in the ground. In this wide scratch the losses of metal in the shape of circular cavities of different diameters are clearly visible. The shape of these cavities on the surface of a metal pipe wall reminiscent of the effect that would be obtained by destroying surface using drilling tool. Such losses of metal are typical for electrolytic corrosion caused by stray currents flowing from the pipe into the ground through the metal/electrolyte phase boundaries in the protective coating defects [13].

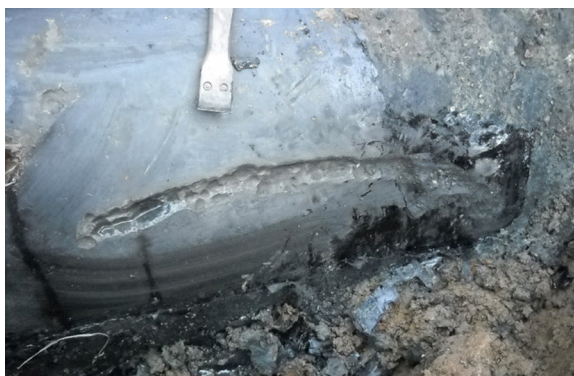
Fig. 2. Zoom on the defect site.

The initial diagnosis of the causes of the corrosion of water supply system based on the appearance and shape of corrosion cavities pointed to the effects of stray currents. Suspicion of such impact in this side of water supply network raised certain astonishment, due to the considerable distance from the sources of stray currents. The place of pipeline failure is 800 m away from passes under the tracks of the tram line and after next 200 m it passes under the railroad tracks.
