Case study

Electrolytic corrosion of water pipeline system in the remote distance from stray currents—Case study

The paper presents a case of corrosion of DN 300 underground water pipeline made of steel belonging to the water supply system of the city of Krakow and describes the methodology of undertaken corrosion diagnosis. Corrosion damage was caused by the effects of stray currents. The failure occurred despite a considerable distance (nearly a kilometer) from the crossing the tram and train with pipeline.

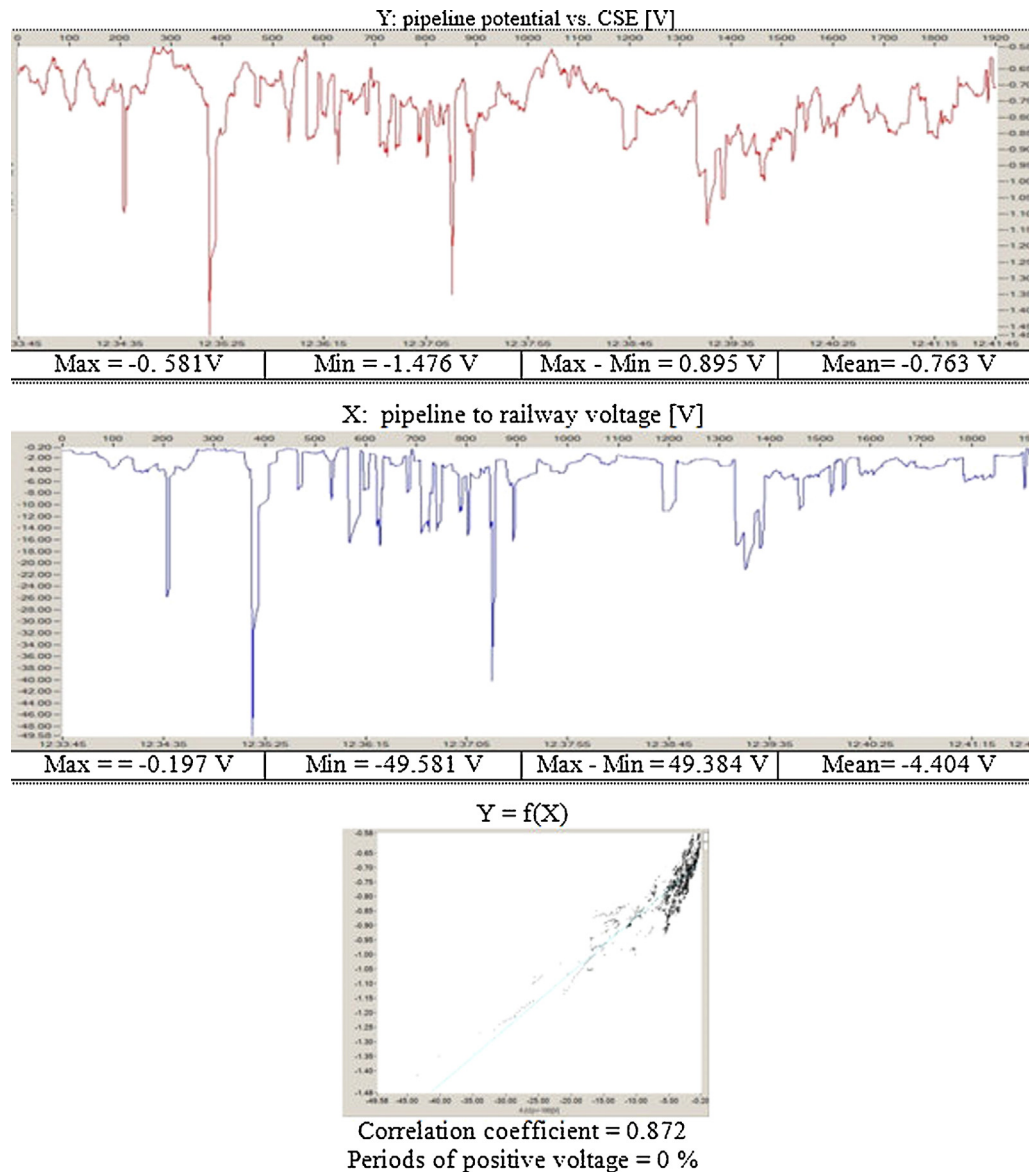
In order to confirm the above conclusions the correlations between potential of pipeline and pipeline to tram rails voltage (Fig. 5) and pipeline to train rails voltage (Fig. 6) were examined.

Very similar results of the measurements in the case of railroad were obtained. Pipeline to rail voltage during the measurements was exclusively negative and instantaneous values reached up to -50 V . In the place of measurement on the of pipeline there is also cathodic zone sourcing from the railroad influence. The result is a cathodic polarization effects on pipeline. The mean value of the potential of pipeline at the time of measurement was equal to -0.763 V . The coefficient of correlation of 0.87 and diffuse shape of the graph of correlation indicates that pipeline potential changes are caused not only by the railway traction, but also the tram.

Fig. 6. Analysis of the railway influence on pipeline.

The results of measurements indicate that in the section of pipeline passing under the railway line and a bit further under the tram tracks the stray currents flow into the pipeline. These currents flow further trough pipeline, but it must return to its source in order to close its electrical circuit. Therefore, currents must flow from the pipeline to the ground, and this is done in these areas, which are favored by the configuration of the water supply system and electric traction and the electric field
