**Ł. Bolewski, M. Szkodo, M. Kmieć**

*Gdańsk University of Technology, Faculty of Mechanical Engineering, Department of Materials and Welding Engineering, 11/12 Narutowicza, 80-233 Gdańsk, Poland*

## CAVITATION EROSION DEGRADATION OF BELZONA<sup>®</sup> COATINGS

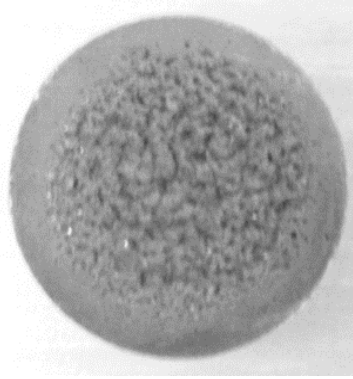
**Fig. 4.** Belzona 1321 applied on P110 probes after cavitation test; Belzona® 5831 - St-barrier

The 2-part ceramic filled epoxy coating designed to provide erosion and corrosion resistance of metal surfaces. This solvent free epoxy coating has high chemical resistance and bonds to any rigid surface. Due to its high compressive strength it can be also used to create a perfect shim. This material is applied without the need for specialist tools in room temperature. The material after cavitation erosion impact is shown in Fig. 4. Examples of applications for Belzona 1321 (Photo 3):

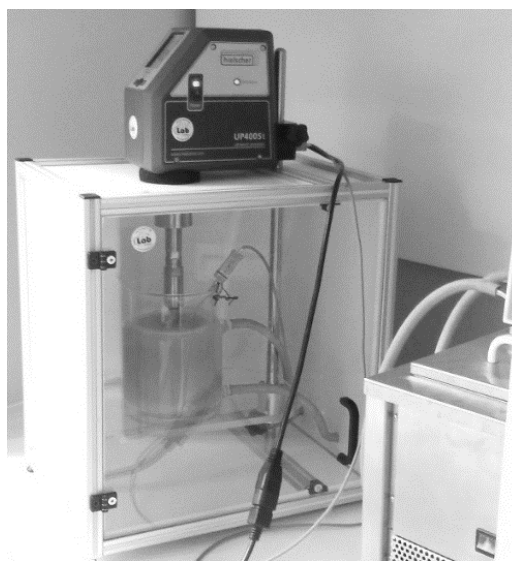
Cavitation erosion tests were performed on the ultrasonic cavitation test rig to explore the coatings' cavitation erosion resistance according to most of ASTM G32-10 tests method recommendations. The vibratory cavitation apparatus Hielscher UP400s is shown in Fig. 6. This equipment with ultrasonic processor generates longitudinal mechanical vibrations. The medium is subjected to compression and decompression subsequently, which causes it to tear in weakest

points, form cavitation bubbles, and then collapse. The power output of the processor can be steplessly adjusted between 20% and 100% of the maximum output. The vibrations are amplified by the sonotrode fitted to the horn and formed as a  $\lambda/2$  vibrator and transferred via its end face to the medium to be sonically irradiated. The UP400s device can be used to irradiate liquids and granulates. The sonotrode H14 has 14 mm diameter tip and provides maximum of 110  $\mu\text{m}$  peak to peak amplitude in water. The acoustic power density on its tip is about 106  $\text{W}/\text{cm}^2$ . An integrated PC interface with special control enables the PC aided monitoring and control of all the important parameters of the ultrasonic processor and the connection of additional sets (e.g. temperature probes) [6]. The vessel used for the tests has a cooling bath, through which an ultra-thermostat circulates cooling agent. The temperature can be set between  $-10$  to  $100^\circ\text{C}$  [18].

Fig. 6. Cavitation test stand

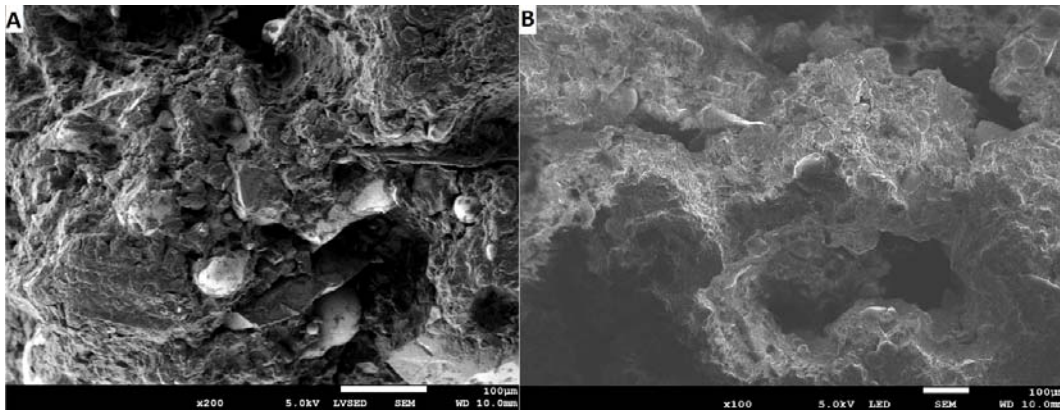
Fig. 11. SEM photos of coating 1321 sample after end of cavitation tests in distilled water

The microscopic observation from Scanning Electron Microscopy (SEM) shown results of effect of cavitation erosion on coatings 1321 (Fig. 11), and 2141 (Fig. 12). For the sample coated 5831 SEM images not been made, because the coatings was detached in 80% from steel probe in all two studied cases: water (30 min) and drilling mud (90 min) (Fig. 8-9, Table 3-4). The so high adhesion failure may be caused by the thermal mismatch between the coating and substrate or by local thermal softening of coating. Adhesion plays an important role in the incubation period and ensures the protection of the substrate material against mass lose. Coating 1321 revealed a significant degradation during the test, but not detached out from the surface of probe (Fig. 4). In the pictures (Fig. 11) see visible surfaces after cavitation treated, the material has been deformed and expose the internal structure of protective two-component epoxy structure with ceramic strengthening grains. The 1321 material is eroding by initiating cracks at interface of matrix/ceramic particles that following propagation in an epoxy matrix. The cracks combine and cause chip off epoxy matrix. This results in exposure of ceramic particles and pluck them out from matrix support. Authors conclude that cavitation phenomena of high pressure micro-jet impacts that act on surface when bubbles collapse. Under influence of this phenomenon coating 1321 may undergo local thermal softening, which has essential impact on the coatings deformation. The soft epoxy resin first to erode away, leaving behind the exposed ceramic particles Fig.11.

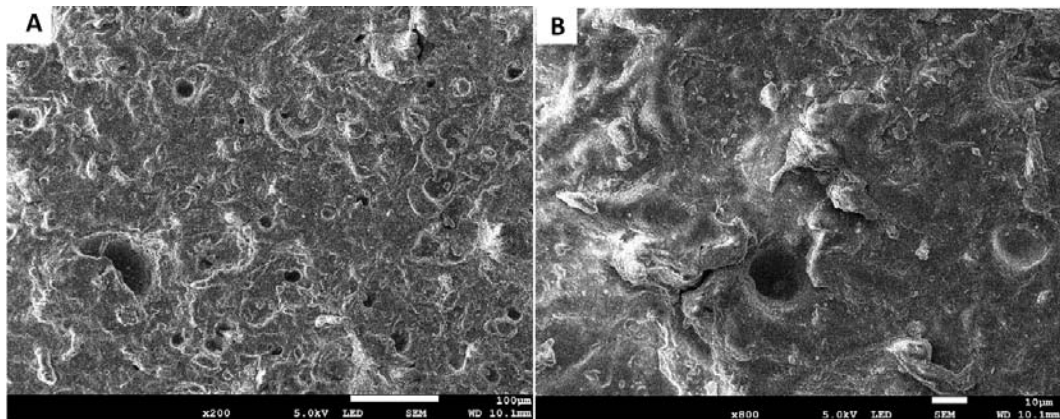
Fig. 12. SEM photos of coating 2141 samples after end of cavitation in distilled water

Material 2141 coating of two-component polyurethane is characterized by high plasticity behaviour reminiscent of elastomer. SEM results shown in Fig. 12 the essence of the impact of cavitation erosion on the material. Fig. 12 A) shown a cavities of spherical shapes, which have causes of micro-jet impact generated during implosion of cavitation bubbles. Fig. 12 B) shows one of such voids and cavitation impacts in the traces formed on the sample surface. Also visible cracks formed in the area near cavitation craters, cavitation load initiate fracture that develop on surface of the eroded material and leading to loose of thin flakes of material (delamination). However, the weight loss was unnoticeable, the accuracy of scales not captured changes in the mass of the coated sample. The outstanding observed results can be attribute of the strong adhesive connection of coating.

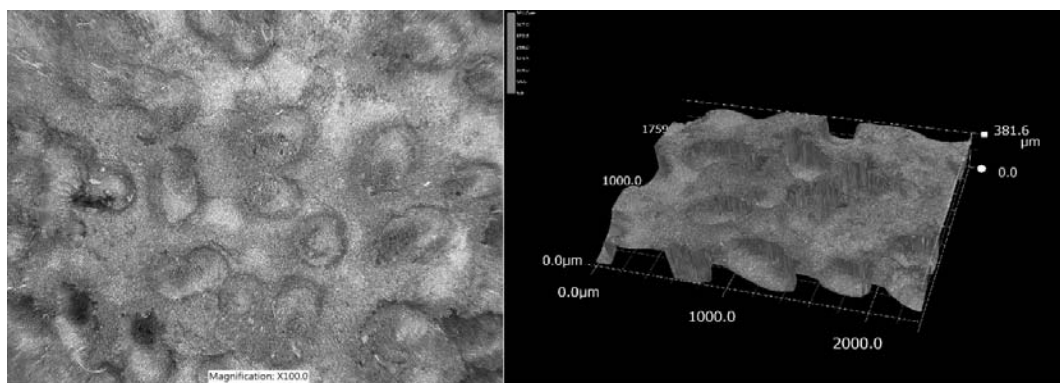
Fig. 13 shows micrographs of tested surface steel P110 sample. Two mechanisms of mass removal were observed. Formation of deep micro-cavities due to micro-jet action and cracking of the material from slip line or grain boundaries.

Fig. 13. Optical microscope photos of eroded surface of P110 sample tests in distilled water
