Ł. Bolewski, M. Szkodo, M. Kmieć

Gdańsk University of Technology, Faculty of Mechanical Engineering, Department of Materials and Welding Engineering, 11/12 Narutowicza, 80-233 Gdańsk, Poland

CAVITATION EROSION DEGRADATION OF BELZONA[®] COATINGS

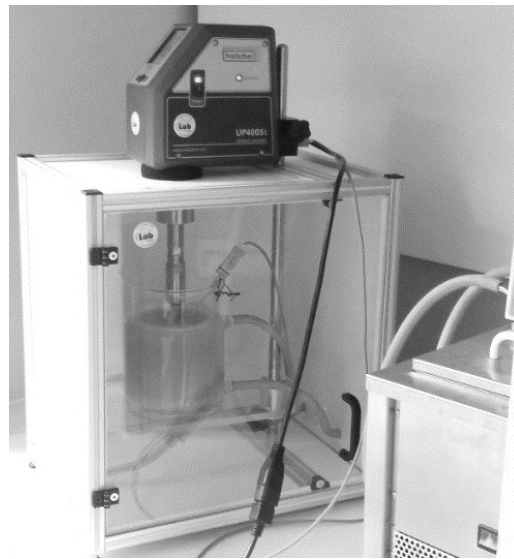
Fig. 6. Cavitation test stand

Cavitation erosion tests were performed on the ultrasonic cavitation test rig to explore the coatings' cavitation erosion resistance according to most of ASTM G32-10 tests method recommendations. The vibratory cavitation apparatus Hielscher UP400s is shown in Fig. 6. This equipment with ultrasonic processor generates longitudinal mechanical vibrations. The medium is subjected to compression and decompression subsequently, which causes it to tear in weakest

points, form cavitation bubbles, and then collapse. The power output of the processor can be steplessly adjusted between 20% and 100% of the maximum output. The vibrations are amplified by the sonotrode fitted to the horn and formed as a $\lambda/2$ vibrator and transferred via its end face to the medium to be sonically irradiated. The UP400s device can be used to irradiate liquids and granulates. The sonotrode H14 has 14 mm diameter tip and provides maximum of 110 μm peak to peak amplitude in water. The acoustic power density on its tip is about 106 W/cm^2 . An integrated PC interface with special control enables the PC aided monitoring and control of all the important parameters of the ultrasonic processor and the connection of additional sets (e.g. temperature probes) [6]. The vessel used for the tests has a cooling bath, through which an ultra-thermostat circulates cooling agent. The temperature can be set between -10 to 100°C [18].
