THE EFFECT OF FISHING BASIN CONSTRUCTION ON THE BEHAVIOUR OF A FOOTBRIDGE OVER THE PORT CHANNEL

Łukasz Pyrzowski
Mikołaj Miśkiewicz
Jacek Chróścielewski

Gdansk University of Technology, Faculty of Civil and Environmental Engineering

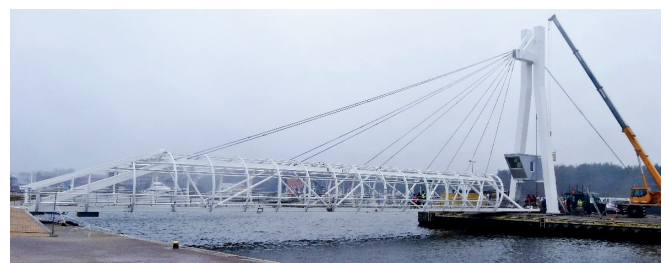
Fig. 1. Rotating footbridge for pedestrians over the Ustka port channel (configuration W1a)

The analysed footbridge (Fig. 1.) is situated in the area of Port Morski w Ustce Sp. z o.o., Pomorskie voivodeship. Its function is to pass the pedestrian and cycle traffic over the port channel being the mouth of the Słupia river. The rotating structure of the bridge makes it possible to close the passage temporarily to allow the watercraft to enter or leave the port [19-22].
