Monitoring System of the Road Embankment

Abstract. The paper presents the monitoring system of the embankment supported on concrete columns and overlaid by a load transfer platform (LTP) with the embedded steel grid. This field investigation was to study the complex interaction between the columns, the LTP layer, and steel reinforcement via full-scale in situ measurements during erection of the embankment. The study was focused on the behaviour of steel reinforcement and the behaviour of the outer rows of columns since there are limited reference data available for this problem. The system was designed to provide information to engineers about the condition of the embankment at every stage of construction and during standard exploitation of road. The measurements provided information about the changes of strains of steel grid and concrete columns and settlement of the structure.

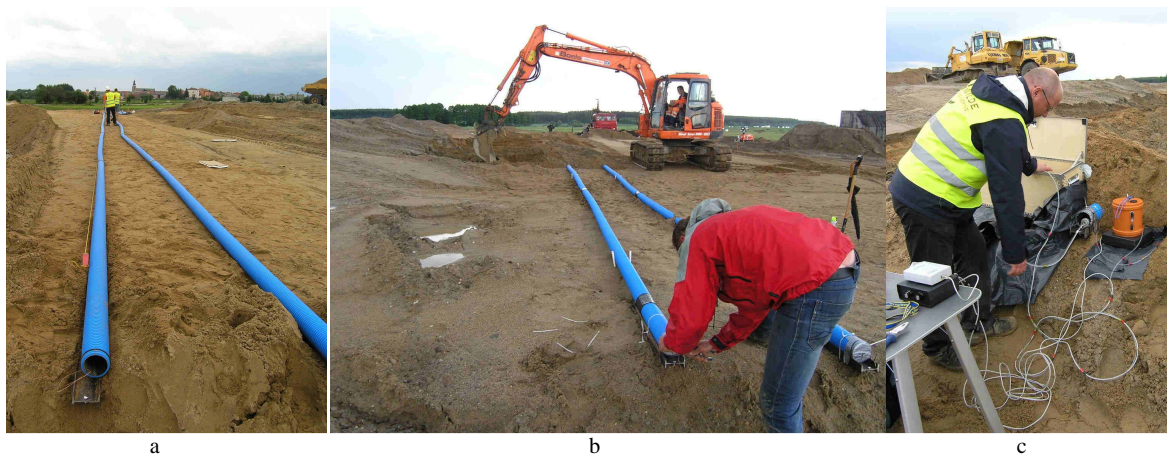
Fig. 8. a, b. Installation of tubes; c. First measurement after tubes backfilling

Two horizontal tubes were installed (Fig. 8a, 8b). Initially, it was planned to install one tube beneath the transmission layer and the second one above this layer. However, because the monitoring system was a prototype, it was decided to double the measurements conducted at the top of the transmission layer. Both tubes of 10 cm diameter were made of PVC, corrugated outside and smooth inside. At both ends of each tube steel H-beams of 1 m length were attached (Fig. 8a). The steel beams allowed to stabilize the tubes and were also used for installation of the reference pins needed for geodetic measurements.

The settlement at the LPT level was measured using a very precise differential pressure transducer (Fig. 8c). The device consists of a probe, inserted into the tube and pulled the tube using a rope. Inside the probe, there is a sensor with a membrane recording small pressure changes for determining the relative height of the probe. The relative height readings were converted to absolute level data based on geodetic measurements taken at the reference pins located on both sides of each tube.
