# Bus bays inventory using a terrestrial laser scanning system

**Abstract.** This article presents the use of laser scanning technology for the assessment of bus bay geo-location. Ground laser scanning is an effective tool for collecting three-dimensional data. Moreover, the analysis of a point cloud dataset can be a source of a lot of information. The authors have outlined an innovative use of data collection and analysis using the TLS regarding information on the flatness of bus bays. The results were finalized in the form of colour three-dimensional maps of deviations and pavement type.

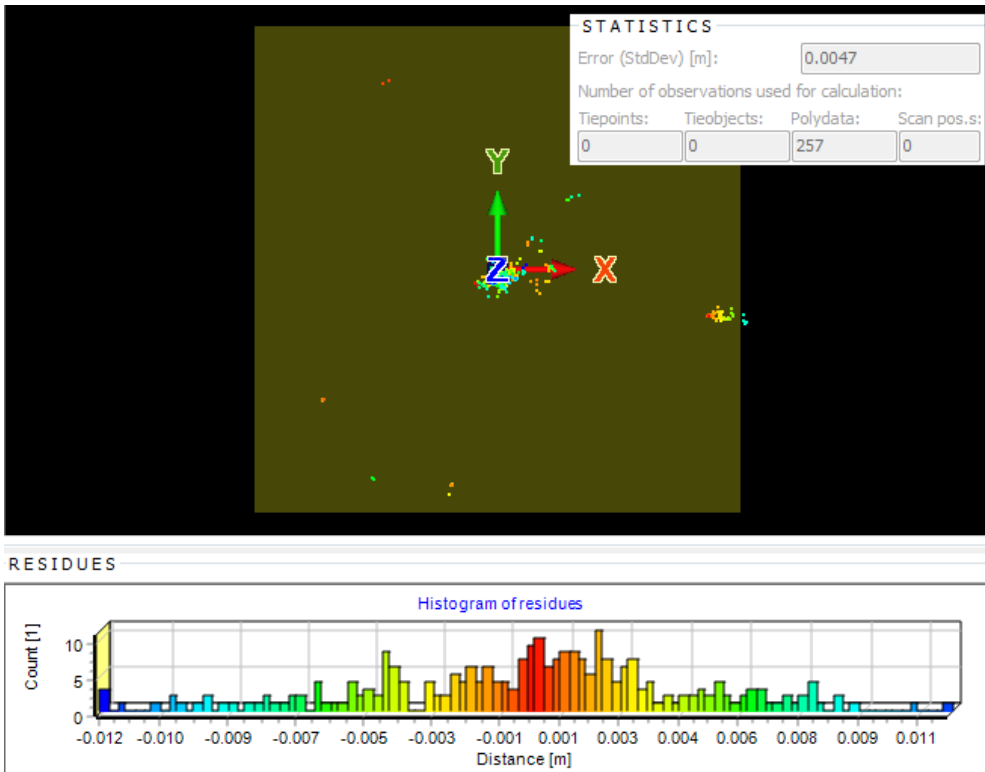
The experiment was conducted by scanning positions at the beginning and end of the bus bay. To be remembered is the traffic. While noise from the cars is easy to remove, it can leave a shadow which could cause unexpected errors in analysing (for example errors when meshing the data) the scanned object. The results of the alignment of the scanned bays are presented in Fig. 2.

**Fig. 2.** Alignment of the scans results.

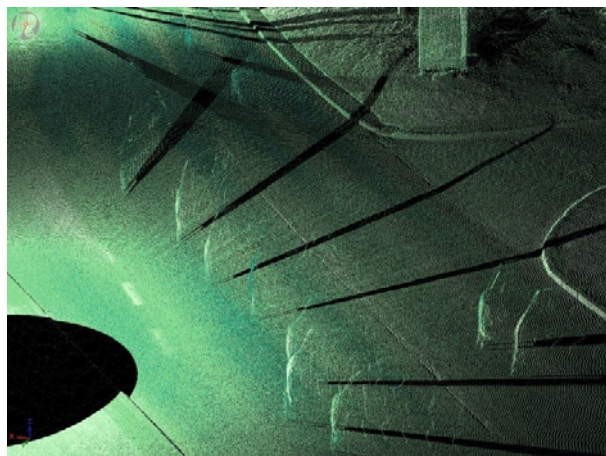
For the purposes of this paper, two different types of bus bays were scanned. The first one was built from asphalt and the second one from sett. The results of the two scans are presented below (Fig. 3, Fig. 4).

**Fig. 3.** Result of asphalt bus creek scanning.

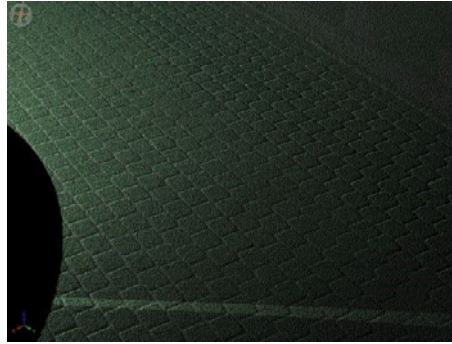
**Fig. 4.** Result of sett bus creek scanning.

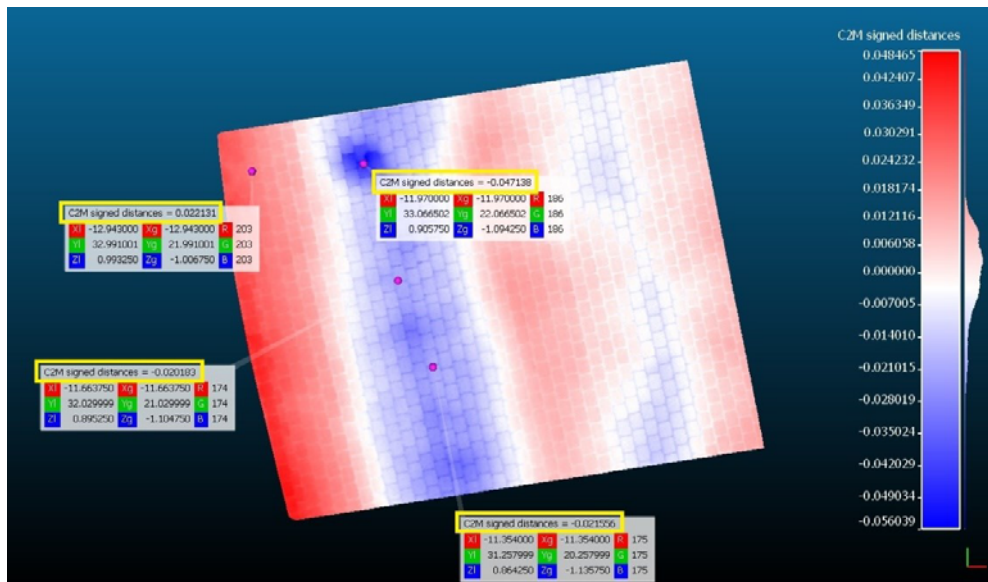
Information on the selected points is displayed. In the yellow frame, the value of the deviation from the plane is indicated.

**Fig. 5.** Result of analysis of the segment (3.5 x 4 meters) creek with concrete blocks (units - meters).

In order to assess the condition of the bus creeks, geometry analysis was conducted in addition to the individual segments of transport infrastructure objects. During the study, the CloudCompare software was used. The analytical process was as follows:

- a) Separation of the cloud of points representing the portion of the bus creek, which will be subjected to analysis [9],
- b) Fitting a plane on a point cloud (RMS fitting method),
- c) Development of three-dimensional maps of deviations,
- d) Visualization of maps in mesh form [10].

The drawings can be the basis for many conclusions about the state of the bus bays. The rating based on graphics is intuitive and makes it easy to identify ruts in an analysed area of road. The presented procedure can be widely used to analyse the geometry of flat objects when inventorying those objects.

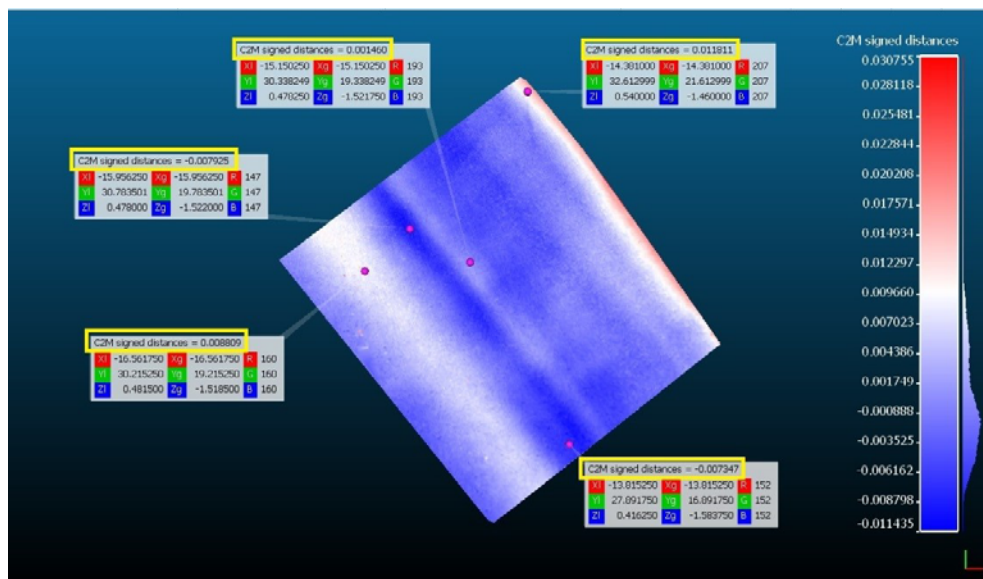
**Fig. 6.** Result of analysis of the segment (3.8 x 4.2 meters) asphalt creek (units - meters).
