# Analysis of the cyclic load-unload-reload tests of VALMEX aged fabric.

**ABSTRACT:** The paper presents mechanical response of the VALMEX fabric during the cyclic loading-unloading and reloading experiments. Two types of the aged material used for nearly 20 years as the roofing of the Forest Opera in Sopot (Poland) have been tested. The results have been separately obtained for the warp and fill directions. The comparative analysis has revealed that the material aged in service is more durable in the fill direction, but less durable in the warp direction. It has been also shown, that the material aged in service has kept its high strength properties and could be longer used in the real structure.

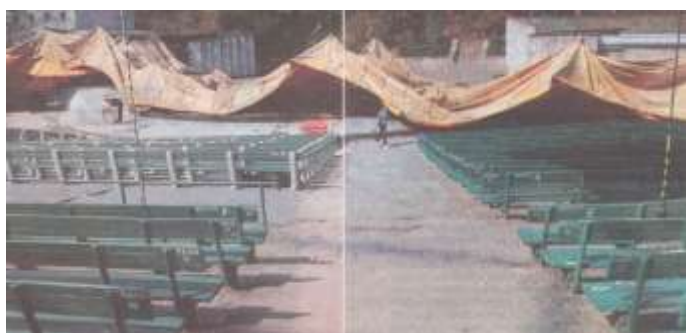
Figure 1. Putting down the roofing structure of the Forest Opera in Sopot (Poland) before winter season (Dziennik Bałtycki 2007).

The VALMEX fabric FR 1000 Hallen type III Universal analyzed in this study has been produced by a German company Mehler Technologies in the early nineties of the 20th century (POLNAM 1989). Two different sorts of the same fabric have been examined. The first one has been used for 20 years as the canopy of the Forest Opera in Sopot (throughout the paper called the USED material). During operation the USED VALMEX material underwent at least 20 cycles of stretching and unstretching, as used only in summer periods, to be put down for winter (Fig. 1).

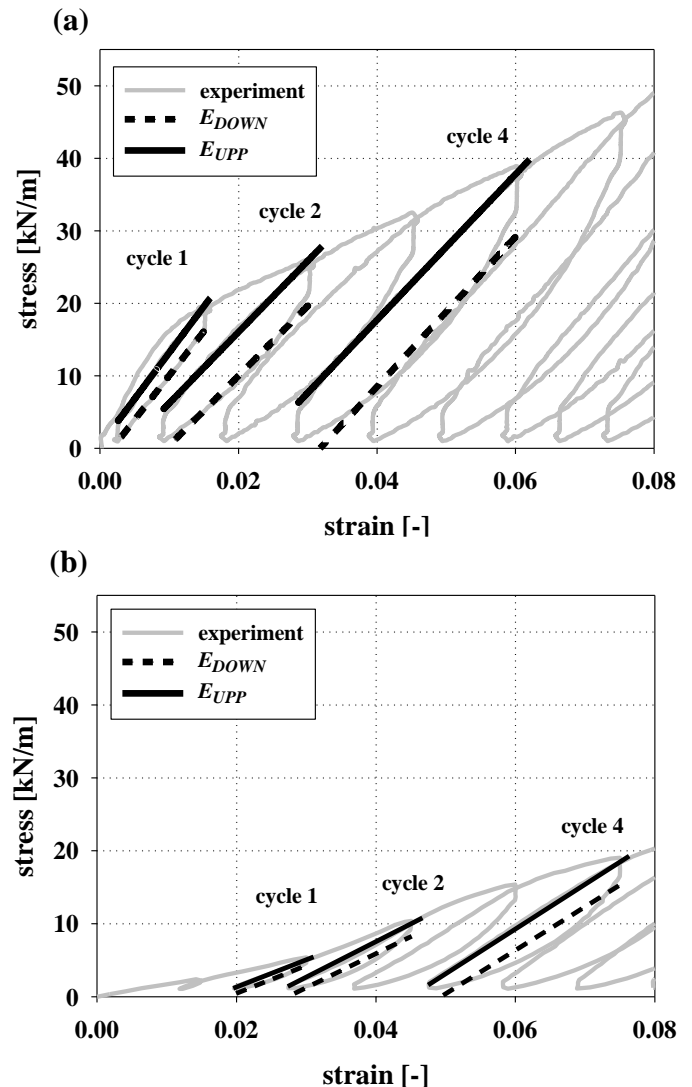
Figure 3. Methodology of elastic modulus identification in each load-unload cycle for the warp (a) and fill (b) direction

In the procedure proposed here, each unloading and then successive reloading cycle has been separately approximated by a linear function

$f(x) = a \cdot x + b$ . Inclination  $a$  representing the longitudinal stiffness modulus of the achieved lines are denoted, then, as  $E_{DOWN}$  and  $E_{UPP}$  for the unloading and reloading phase, respectively. Short relaxation periods between each loading phase have been omitted in the identification process. This methodology is presented for several cycles in Figures 3a, 3b for the warp and fill direction, respectively. The results from both unloading and reloading stages are very similar, thus the value of longitudinal stiffness modulus for every cycle has been calculated as the mean value  $E_{MEAN}$  of the  $E_{DOWN}$  and  $E_{UPP}$ . Figures 4a, 4b show the mean values  $E_{MEAN}$  for each cycle for the warp and fill directions, respectively.
