Corrosivity of environment and the current state of the steel elements at the former Auschwitz concentration camp

The objective of this study was to assess corrosivity of the atmospheric environment in the former Auschwitz I and Auschwitz II-Birkenau concentration and extermination camp, and to identify the protective properties of existing corrosion products in order to estimate the actual corrosion rate of original steel elements located there. The current atmospheric corrosivity of the former Auschwitz camp, specified during one year of exposure of steel samples according to the EN ISO 12944-2 (1998) standard, was determined and it can be described as a boundary between the low C2 and medium C3. The steel corrosion rate in these conditions was in the range of 14–34 $\mu\text{m}/\text{year}$ with the average rate of 27 $\mu\text{m}/\text{year}$. A layer of corrosion products formed on uncovered original reinforcement steel rods during ca. 70 years of atmospheric exposure was examined in terms of their protective properties with respect to steel. The microstructure, chemical composition, and elemental chemical state were analyzed by means of scanning electron microscopy equipped

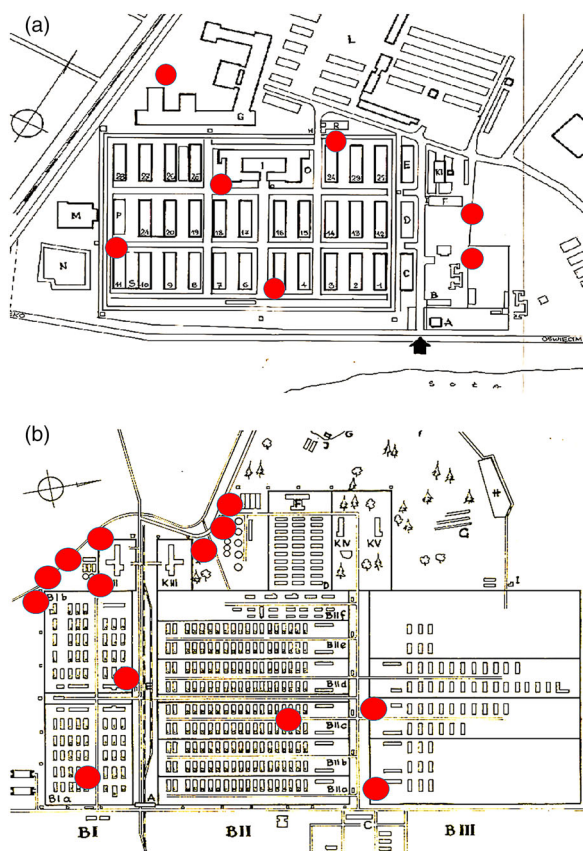
Figure 1 Places of exposure of steel samples for corrosivity tests in Auschwitz I (A) and Auschwitz II-Birkenau (B).

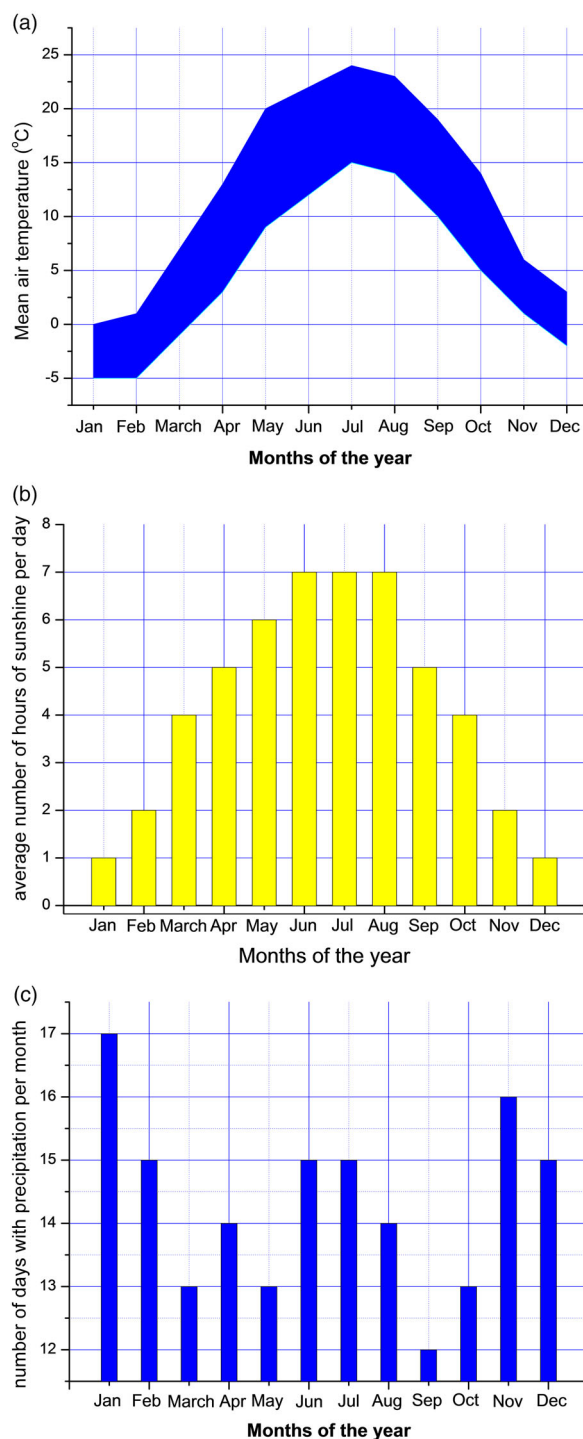
Figure 3 Characteristics of the climate of the town Oswiecim, where the former Auschwitz concentration and extermination camp is situated. Graphs based on data obtained from local meteorological station for the last 10 years.

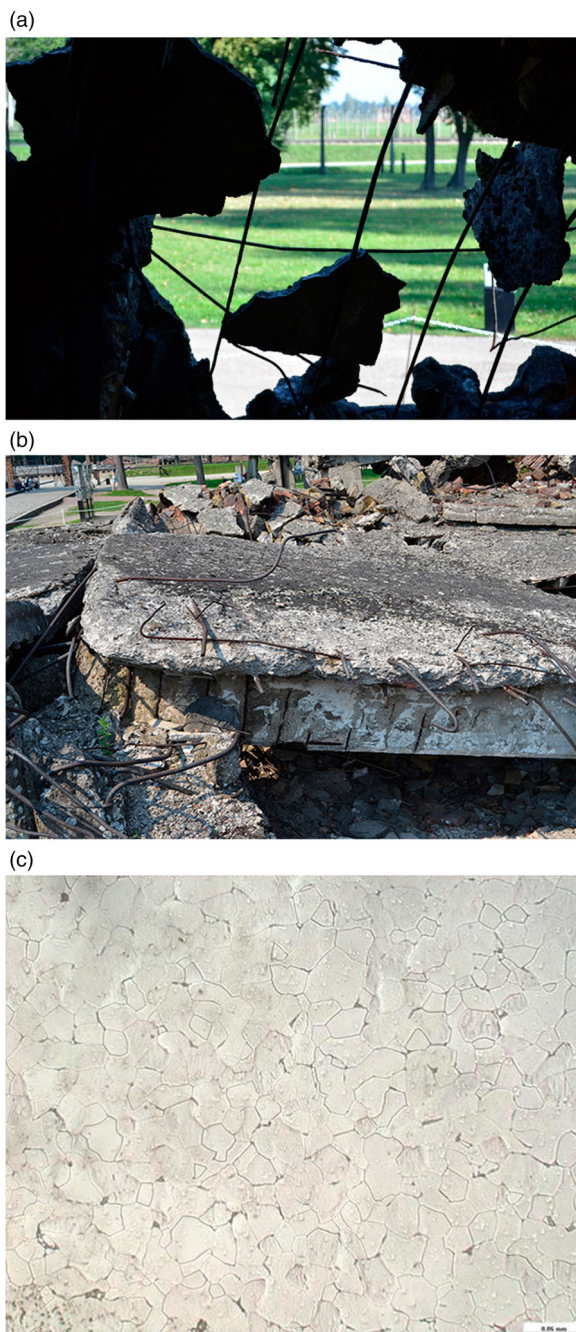
Germans blew up the crematoria. As a result some of the reinforcing bars were uncovered in the ruins (Fig. 5) and have been exposed to the ambient environment until now. Metallographic analysis (Gotkowski & Jachym, 2014) of 42 different original steel samples showed that the steel used is ferrite-perlite type, similar to the composition of the present steel S235JR (Europe) or A283 Gr. C (USA). Full representative exemplary analysis is shown in Table 4.

Figure 5 Uncovered reinforcing steel bars of the ruins of the crematorium II in Auschwitz II-Birkenau (A), a ceiling of the gas chamber of this crematorium (B), and the metallographic structure (grainy ferrite and very small amounts of perlite, several non-metallic inclusions, magnification 200 \times) of the reinforcing bar adopted from Gotkowski & Jachym, 2014 (C).
