## MONITORING SYSTEM OF THE ROAD EMBANKMENT

**Abstract.** The paper presents the analysis of the monitoring system of the embankment supported on concrete columns and overlaid by a load transfer platform with the embedded steel grid. This field investigation was to study the complex interaction between the columns, the load transfer platform layer, and steel grid via in situ measurements during erection and live loading of the embankment. The study was focused on the behaviour of steel grid and the behaviour of the outer rows of columns since there are limited reference data available for this problem. The system was designed to inform the engineers about the condition of the embankment at every stage of construction and during standard operation of the road. The measurements brought the information on strain variations of steel grid, concrete columns, and structural settlement and provided necessary evidence for the embankment numerical model validation.

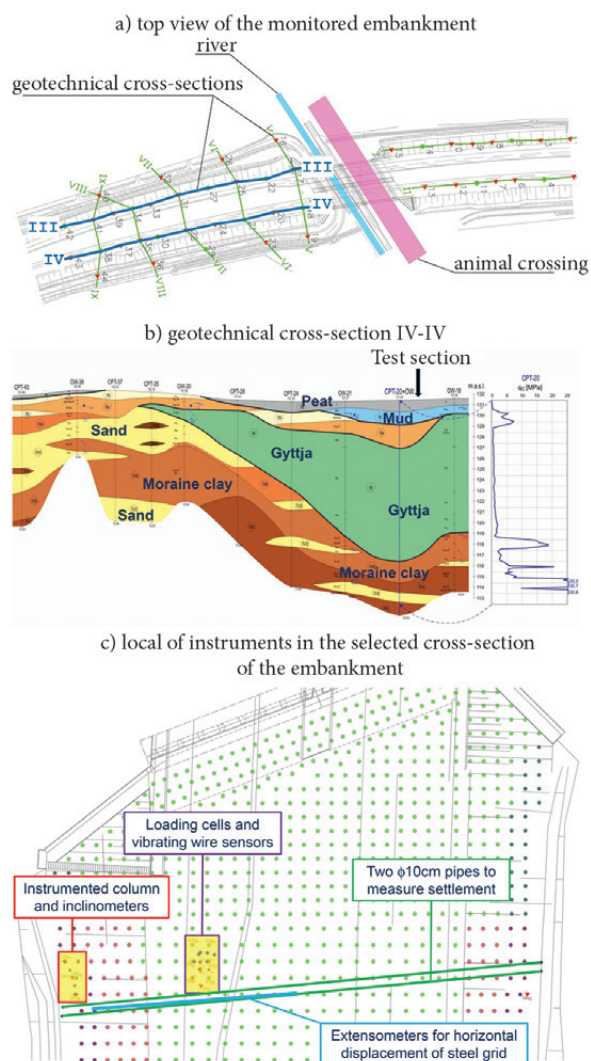
Fig. 1. Location of the monitored embankment

The monitored embankment is located next to the bridge (Fig. 1a). It is supported on CSC columns constructed by Keller Polska Sp. z o.o. moreover, overlaid by an LTP layer with an embedded steel grid (Fig. 2). The subsoil condition near the bridge is unfavourable: over 15 meters of mud, peat and gytja over moraine clay and fine sand. The structure of the embankment is the foundation on CSC columns diameter 360 mm with spacing changing from 1.4×1.9 m to 1.6×2.2 m. At the place of the most unfavourable soil conditions, the thickness of organic soil is about 13 m (according to Cone Penetration Test (CPT) 20, Fig. 1b). At that location, the spacing of columns changes from 1.9×1.9 m in the centre to 1.9×1.5 m near the fill slopes. The columns are built of concrete C16/20. Two rows of outer columns are reinforced of UBs 160 (S355/JR steel), the LTP layer is 0.5 m thick, the steel grid is made of S355 steel with the rigidity of 157 MN in the across road direction and 121 MN in the long road direction. The design was based on ASIRI National Project (Simon 2013).

The monitoring program includes the following measurement components (Fig. 1b, Figs 2–3):

The location of various components of the monitoring system is shown in Fig. 1c.

Numerical analysis was conducted with the use of Finite Element Method. The FEM model of the cross-section with organic soil thickness of 13 m (according to CPT 20) (Fig. 1b) was created. The soil was modelled by elasto-plastic material (CM); the linearly elastic material was adopted for reinforced columns. The equivalent live load equal 25kPa was assumed for the problem. Selected simulation results are shown in Fig. 9. The maximum total settlement achieved 9.9 cm, its part; equal to 3.9 cm came from deadweight, the rest 6.0 cm was produced by the live load.

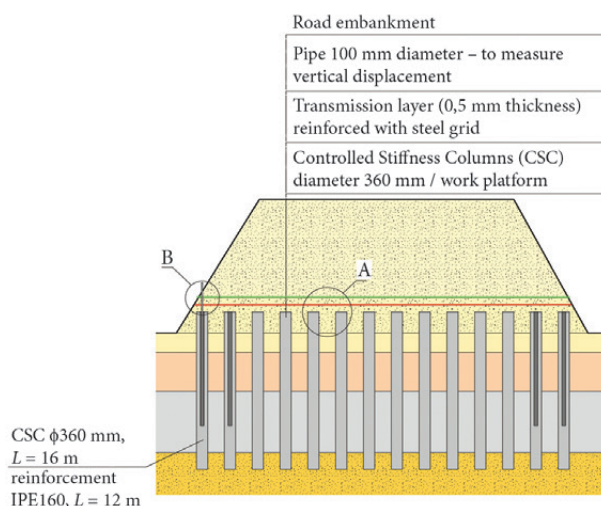
Fig. 2. Measurement scheme on cross-section of the embankment (detail A – Fig. 3a, detail B – Fig. 3b)

- forces in outer CSC column – 12 strain gages welded to steel beam IPE160 (4 sensors at three levels);
- distribution of vertical stresses on the columns and subsoil – load cell sensors mounted on the columns heads (2 sensors) and the subsoil (4 sensors);

- forces in the steel grid and horizontal displacements of steel grid – 14 strain gauges and four long base extensometers mounted to the steel grid;
- settlement of the embankment – measurements in one cross-section of the embankment, in two PVC pipes using “hydrostatic leveller”;
