## MONITORING SYSTEM OF THE ROAD EMBANKMENT

**Abstract.** The paper presents the analysis of the monitoring system of the embankment supported on concrete columns and overlaid by a load transfer platform with the embedded steel grid. This field investigation was to study the complex interaction between the columns, the load transfer platform layer, and steel grid via in situ measurements during erection and live loading of the embankment. The study was focused on the behaviour of steel grid and the behaviour of the outer rows of columns since there are limited reference data available for this problem. The system was designed to inform the engineers about the condition of the embankment at every stage of construction and during standard operation of the road. The measurements brought the information on strain variations of steel grid, concrete columns, and structural settlement and provided necessary evidence for the embankment numerical model validation.

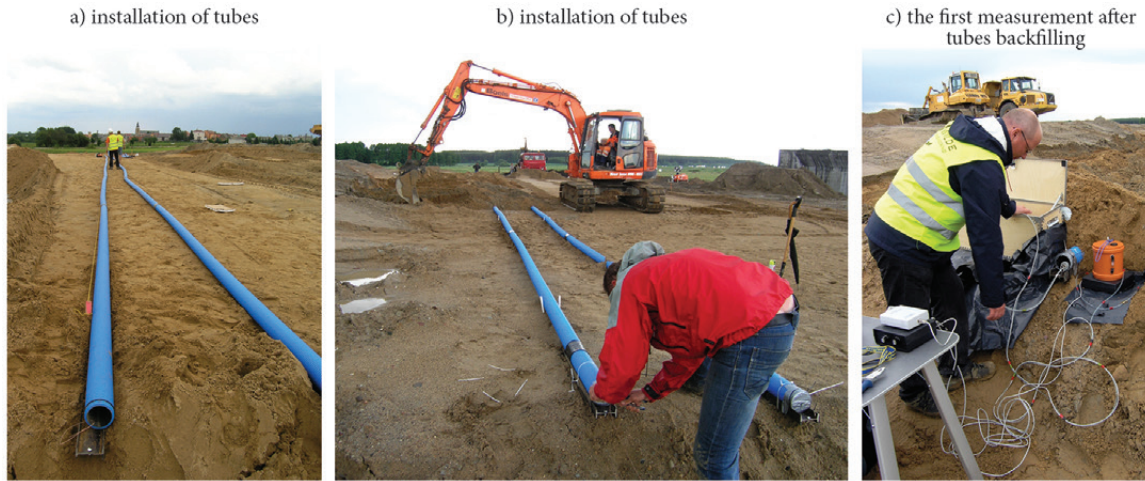
Two horizontal tubes were initially installed (Fig. 8a–b). First, it was planned to install one tube beneath the transmission layer and the second one above this layer. However, because the monitoring system was a prototype, it was decided to double the measurements conducted at the top of the transmission layer. Both tubes of 10 cm diameter were made of PVC, corrugated outside and smooth

Fig. 8. Embankment settlement measurement by hydrostatic levelling

inside. At both ends of each tube, steel H-beams of 1 m length were attached (Fig. 8a). The steel beams allowed to stabilize the tubes and were used for installation of the reference pins required to make geodetic measurements.

The settlement at the LPT level was measured using a high-precision differential pressure transducer (Fig. 8c). The device consists of a probe, inserted into the tube and pulling the tube using a rope. Inside the probe, there is a sensor with a membrane recording small pressure changes

to determine relative height of the probe. The relative height readings were converted to absolute level data based on geodetic measurements taken at the reference pins located on both sides of each tube.

The initial tests confirmed that the accuracy of settlement measurements with the applied system was less than 1 mm. It is noted that this device shows a measurement precision on other geodetic systems, e.g., terrestrial laser scanners (Bernat *et al.* (2014); Janowski *et al.* (2015); Laskowski, Szulwic (2014); Szulwic *et al.* (2016)). The hydrostatic levelling device, designed and produced by this monitoring system, was intended to control possible vertical displacements of the entire cross-section of the embankment. The measurements could be conducted within the transmission layer providing reliable information about its response.
