## MONITORING SYSTEM OF THE ROAD EMBANKMENT

**Abstract.** The paper presents the analysis of the monitoring system of the embankment supported on concrete columns and overlaid by a load transfer platform with the embedded steel grid. This field investigation was to study the complex interaction between the columns, the load transfer platform layer, and steel grid via in situ measurements during erection and live loading of the embankment. The study was focused on the behaviour of steel grid and the behaviour of the outer rows of columns since there are limited reference data available for this problem. The system was designed to inform the engineers about the condition of the embankment at every stage of construction and during standard operation of the road. The measurements brought the information on strain variations of steel grid, concrete columns, and structural settlement and provided necessary evidence for the embankment numerical model validation.

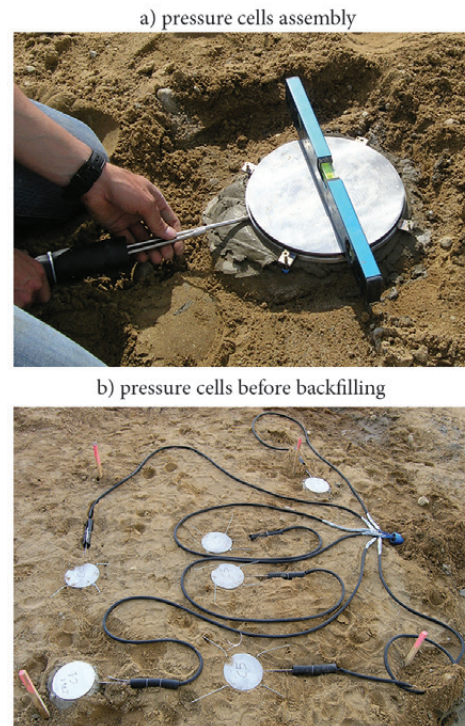
Fig. 5. Vibrating wire load cells measurement points

Vertical stresses acting on the column heads and the subsoil were measured using vibrating wire earth pressure cells with diameter 230 mm (Fig. 5b). These cells with ranges 5MPa (on columns heads) and 70 kPa (on subsoil)

showed resolution of 0.025% F.S., and accuracy  $\pm 0.1\%$  F.S. They work in the temperature range from  $-20\text{ }^{\circ}\text{C}$  to  $+80\text{ }^{\circ}\text{C}$ . The applied cells (Fig. 5a) were made of two circular stainless steel plates welded together around their periphery and spaced apart by a narrow cavity filled with de-aired oil. The change of earth pressure squeezed the two plates together causing a corresponding increase in fluid pressure inside the cell. A vibrating wire pressure transducer converted this pressure into an electrical signal, next transmitted to the readout location. The site of the applied cells is presented in Fig. 5b. The stresses acting on the ground were measured at the centre between four adjacent CSC columns and among “side” CSC columns. The cells placed on the columns were levelled and screwed (Fig. 5a). Pressure cells on the ground were placed directly on a compacted soil among the columns, fixed in positions with pins and backfilled.

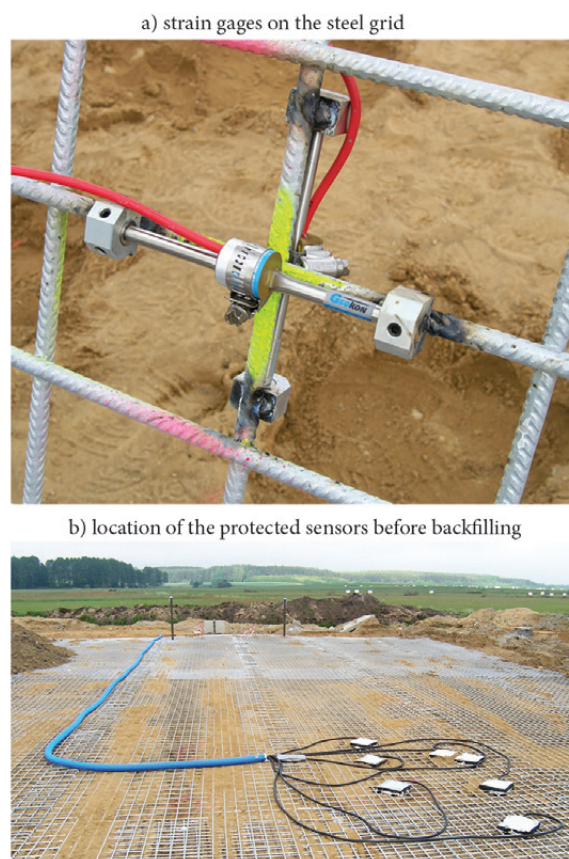
Fig. 6. Measured points on steel grid

Short base vibrating wire sensors were welded to the steel grid (Fig. 6a). The works were conducted after backfilling the first part of the LTP layer (Fig. 6b). The instrumented steel grid was laid down on the compacted fill. Afterward, the vibrating wire sensors were covered with waterproof boxes to protect them from external influences. The sensor shields were constructed using plastic boxes, sealed with micro-rubber and silicone seal. While all the sensors were installed, the control measurements showed each of them operationally; the readings were within the desired range.

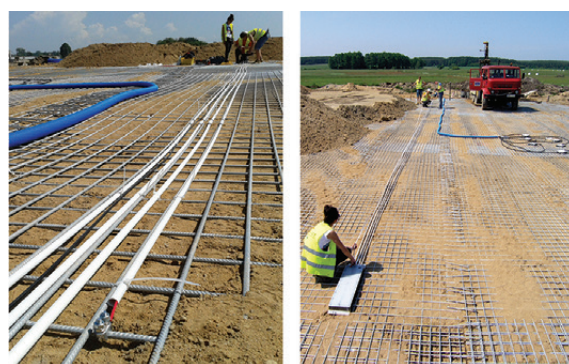
Fig. 7. Long base extensometers for measuring elongation of the steel grid

Long base extensometers measured “elongation” of steel grid sheets laid down on the ground with an overlapping. The device was made of four steel wires of different lengths (from 14.465 m to 23.743 m) connected to steel grid sheets in selected locations, and the measuring “box” with four extensometers screwed to the steel grid at the centre of the embankment (Fig. 7). All wires were covered with PVC protection tubes. Extensometers were installed across two or three separate steel grid sheets.

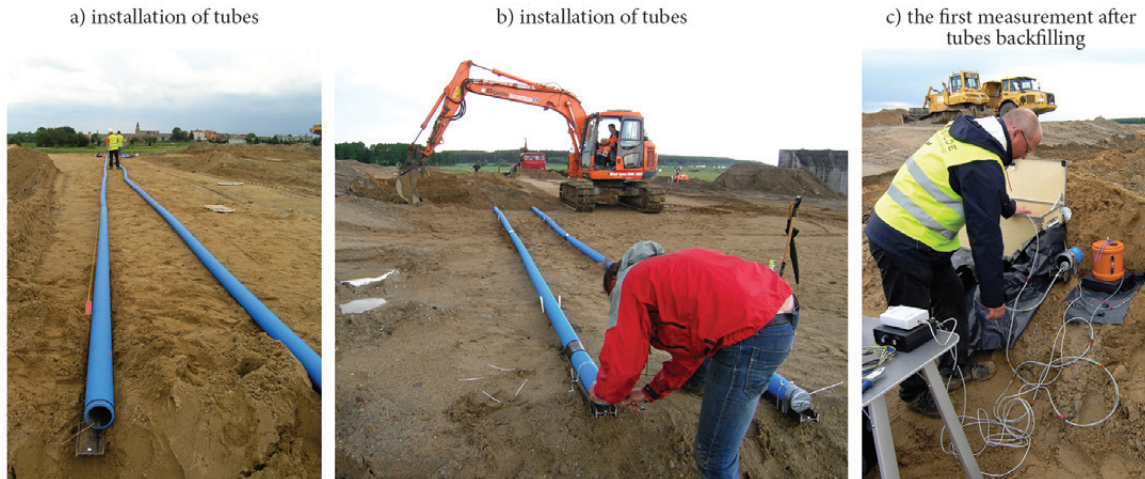
Fig. 8. Embankment settlement measurement by hydrostatic levelling

Two horizontal tubes were initially installed (Fig. 8a–b). First, it was planned to install one tube beneath the transmission layer and the second one above this layer. However, because the monitoring system was a prototype, it was decided to double the measurements conducted at the top of the transmission layer. Both tubes of 10 cm diameter were made of PVC, corrugated outside and smooth

inside. At both ends of each tube, steel H-beams of 1 m length were attached (Fig. 8a). The steel beams allowed to stabilize the tubes and were used for installation of the reference pins required to make geodetic measurements.

The settlement at the LPT level was measured using a high-precision differential pressure transducer (Fig. 8c). The device consists of a probe, inserted into the tube and pulling the tube using a rope. Inside the probe, there is a sensor with a membrane recording small pressure changes

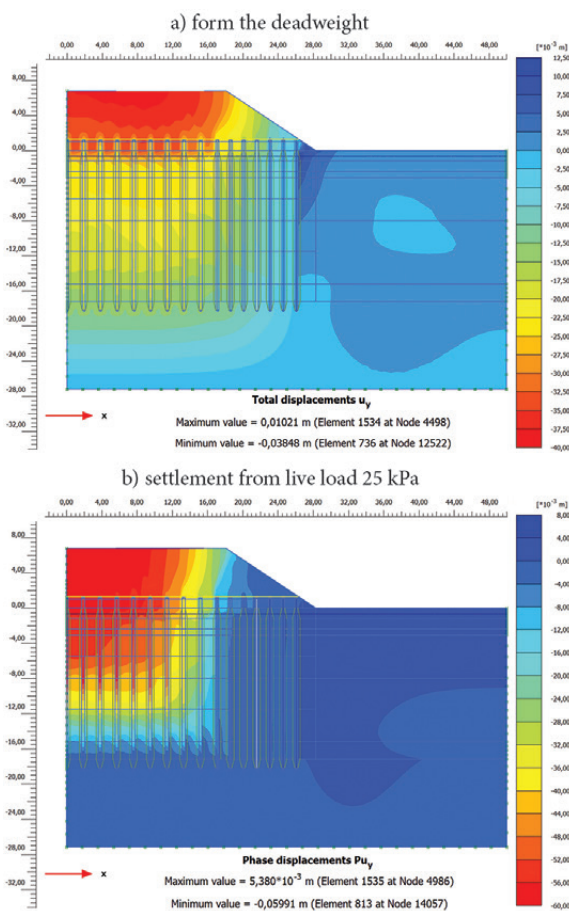
Fig. 9. Simulations of embankment settlement

Numerical analysis was conducted with the use of Finite Element Method. The FEM model of the cross-section with organic soil thickness of 13 m (according to CPT 20) (Fig. 1b) was created. The soil was modelled by elasto-plastic material (CM); the linearly elastic material was adopted for reinforced columns. The equivalent live load equal 25kPa was assumed for the problem. Selected simulation results are shown in Fig. 9. The maximum total settlement achieved 9.9 cm, its part; equal to 3.9 cm came from deadweight, the rest 6.0 cm was produced by the live load.

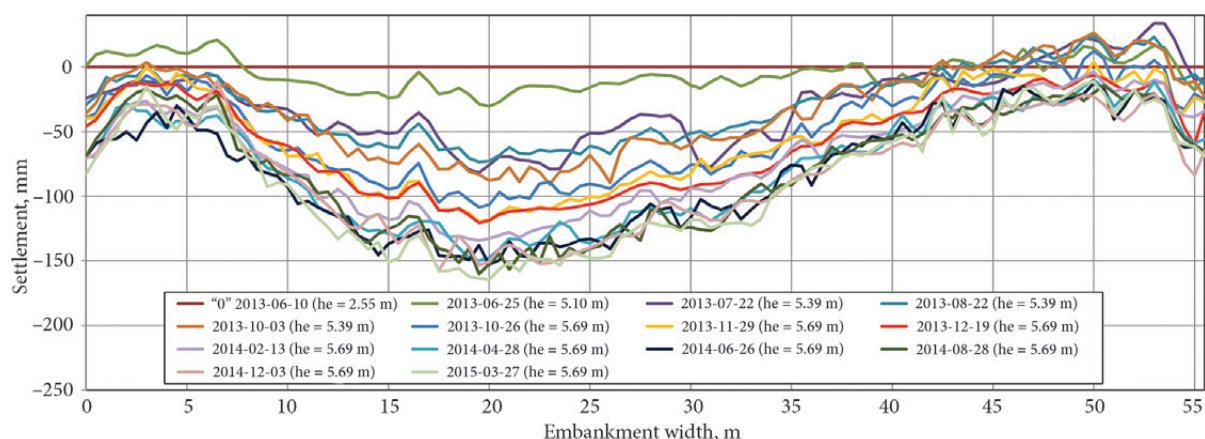
Fig. 10. Embankment settlement during construction (he – height of embankment)

Structural displacements obtained by the observational method are shown in Fig. 10. The measurements corresponding to the above numerical results are plotted by the red line, corresponding to the day of launching the road S-61 to public transport (December 19, 2013). At that time, the maximum displacement reached 12 cm, more than the displacement obtained by numerical analysis. The measured displacement profile (Fig. 10) is unsymmetrical along the road cross-section indicating that the soil parameters are irregular. The settlement process finally stabilized around one year after completion of the embankment construction. The maximum value of settlement during the observation period is about 150 mm.
