The effectiveness of fault detection in common rail injectors examination methods

The article presents the effectiveness tests of fault detection in common rail injectors. 40 injectors with different wear levels were tested. Testing was made on two test benches of a completely different design. Research includes comparison of accuracy, reproducibility and testability to detect specific defects. A device was created for visualization of the fuel injector spraying steam.

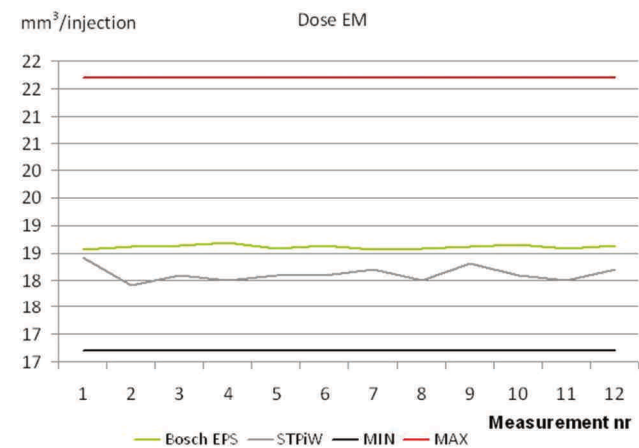
Fig. 7. EM test (actuation time 500 μs, pressure 80 MPa)

In order to compare the accuracy and reproducibility of the measurements, a series of 12 measurements was carried out on both devices. The solenoid injector with a catalogue number 0 445 110 021 was used to carry out the tests. The following graphs (Figs 6–9) presents the results of the tests. Green lines indicate results obtained on the Bosch EPS and grey lines stand for the STPiW device. The minimum

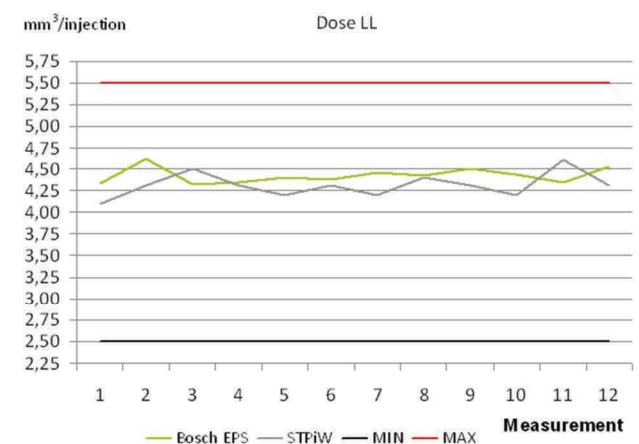
Fig. 8. LL test (actuation time 600 μs, pressure 25 MPa)
