The effectiveness of fault detection in common rail injectors examination methods

The article presents the effectiveness tests of fault detection in common rail injectors. 40 injectors with different wear levels were tested. Testing was made on two test benches of a completely different design. Research includes comparison of accuracy, reproducibility and testability to detect specific defects. A device was created for visualization of the fuel injector spraying steam.

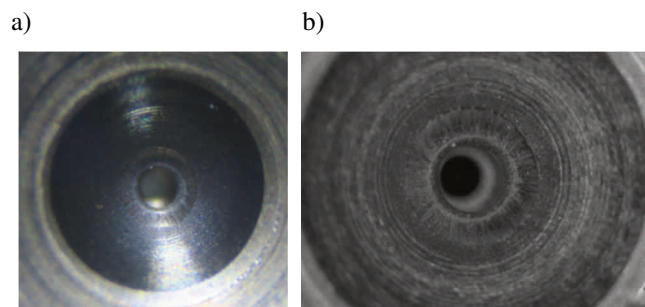
Fig. 14. Damage of the valve seat a) injector no 1, b) injector no 2

Figure 14 presents the control valve seat. The ring around the hole is the sealing surface. The quality of this surface is crucial to maintain valve tightness. The pictures show radial grooves caused by cavitation erosion. In addition, Figure 15 shows the ball of the first injector. The irregularity of the ball's surface is also causes leaks. These are the main causes of the injectors' malfunction the large return quantity.
