As- built inventory of the office building with the use of terrestrial laser scanning

Marek Przyborski¹, Paweł Tysiąc^{1,*}

¹Gdansk University of Technology, Faculty of Civil and Environmental Engineering, Department of Geodesy, Narutowicza St. 11/12, 80-233 Gdansk, Poland

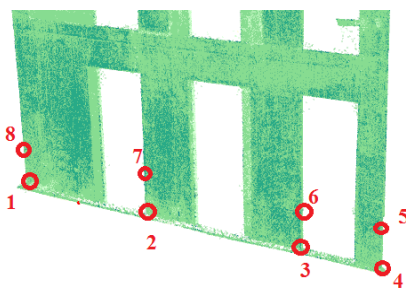
Fig. 8. Chosen points for plane matching which indicate the wall according to its perfect position.

The plane was estimated with the use of the least square- method by indicate 8 points, belonging to the walls at the bottom of walls. The representation of chosen points is presenting in Fig. 8. The same workflow was performed for each wall. The reason for placing points was that from the level 0 to the height of 1 meter it could be observed the hypothetical, non – angular deviated walls of the building. From that wall (It could be named- reference), the angular, real deviation was estimated.

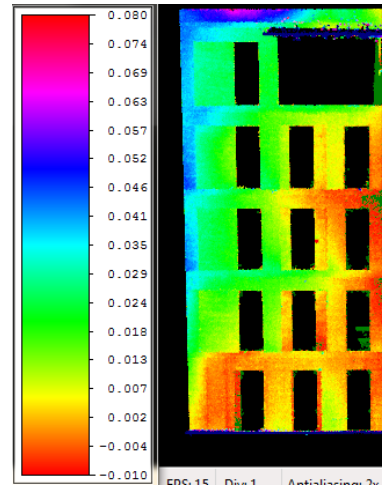
Fig. 10. Angular deviations for North wall in meters.

measurement accuracy was up to 1 cm, the plane matching error has to be estimated. It was computed as standard deviation values for points distances which was taken into consideration and belonging to that plane. With that process, the standard deviation value equals approximately 5 mm. Angular deviations for each wall are presented in Fig. 10 for North, Fig. 11 for South, Fig. 12 for West and Fig. 13 for East. Values are presented in meters.
