# Risk assessment methodologies for pedestrian crossings without traffic lights – Warsaw case study – pedestrian safety assessment

**Abstract.** Based on data from 2015 [1], it was found that 31% of all fatalities in road accidents in Poland were pedestrians. In places accessible to pedestrian traffic 74.2% of total accidents involving pedestrians were recorded. Approximately 53.9% of accidents involving pedestrians take place in the proximity of pedestrian crossings. In the context of improving the safety of vulnerable road users, an assessment of the condition of infrastructure in this sensitive area is very important. Warsaw took up the challenge of a comprehensive assessment of pedestrian crossings in determining the level of road safety and lighting conditions. Research covered pedestrian crossings without traffic lights in three central districts of the city. The work included field research by teams of experts analysing the geometry of pedestrian crossings, their environment and user behaviour. To complete the task, methodologies for assessing risks to pedestrian safety were developed. In this article the authors have attempted to systematise a description of the method of

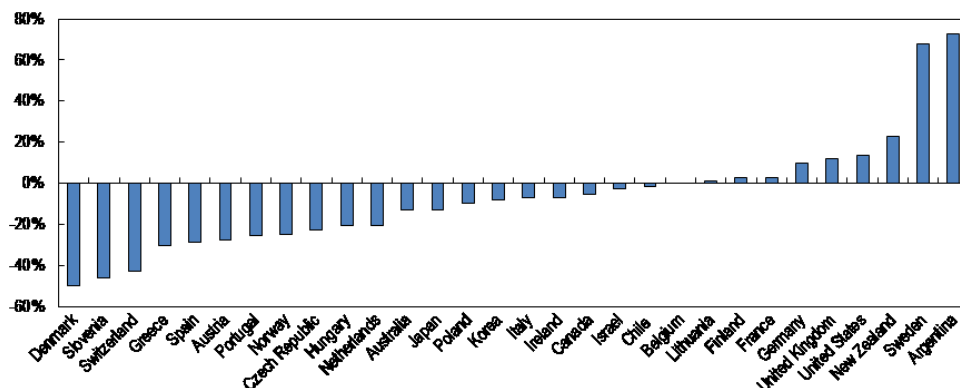
Fig. 1. Percentage change in the number of deaths among pedestrians, 2010-2014 [2].

According to the data [2], the number of pedestrian fatalities dropped by 9.7% (Fig.1) in the years 2010-2014 in Poland. The decrease in fatalities including pedestrians can be caused

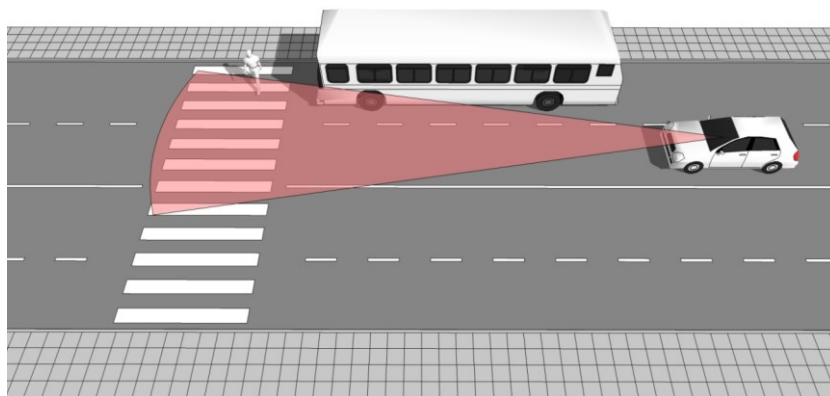
**Fig. 2.** Risk identification due to limited field of view [8].

In the third step of the procedure fields of view are defined that are required based on the speed limit and average speed values of the V85 of a particular cross-section. In order to determine the V85, data from the speed measurements were used and additional measurements were conducted.

In addition, the method of required visibility was developed by the authors taking into account the position of a pedestrian at a distance of 1m from the edge of the road at drivers' speed of V85.

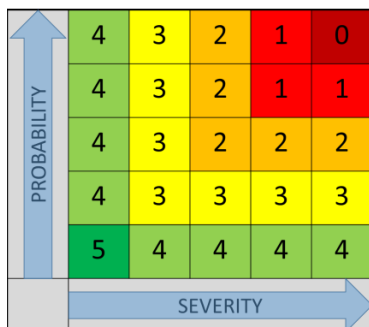
**Fig. 3.** Method of overall assessment of pedestrian risk in the area of pedestrian crossings.

In the sixth step, the Auditor gives an overall assessment on a scale of 0 to 5, where the rating of 0 means the greatest risk for pedestrians and 5 lowest risk for pedestrians (Fig. 3).
