# Failure Monitoring and Condition Assessment of Steel-Concrete Adhesive Connection Using Ultrasonic Waves

Magdalena Rucka

Department of Mechanics of Materials and Structures, Faculty of Civil and Environmental Engineering, Gdansk University of Technology, Narutowicza 11/12, 80-233 Gdansk, Poland; magdalena.rucka@pg.edu.pl or mrucka@pg.edu.pl; Tel.: +48-58-347-2497

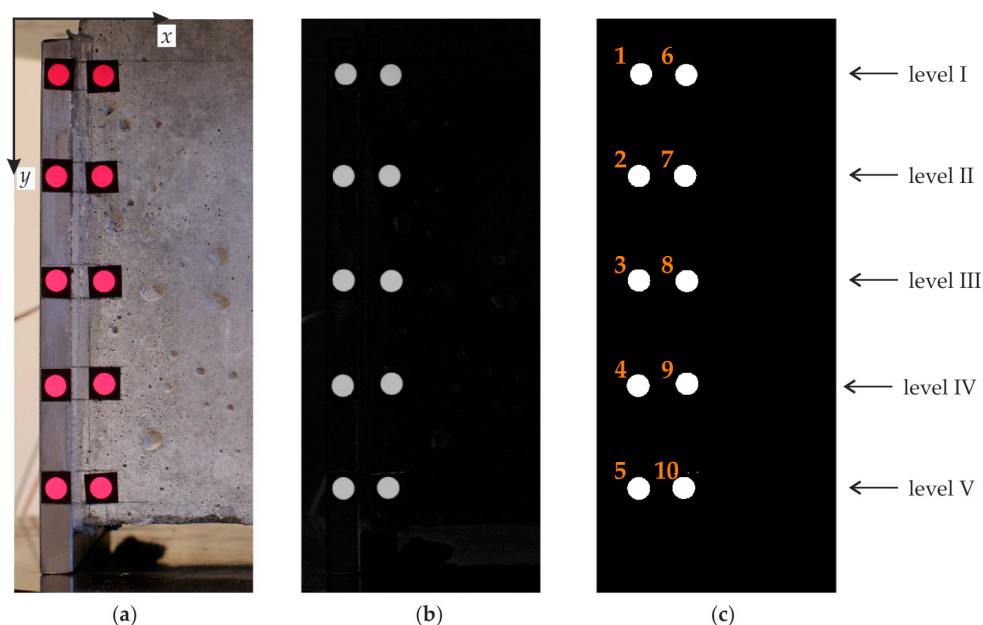
Figure 5. Digital photograph of the left adhesive joint: (a) RGB photograph; (b) magenta component; (c) binary image.

The interface slip between the steel plate and concrete cube was determined using a photogrammetric technique (c.f. [34]). The digital RGB photograph (Figure 5a) was transformed into the CMYK space according to the formula

where colors are marked as follows: *c*—cyan, *m*—magenta, *y*—yellow, *k*—black, *r*—red, *g*—green, *b*—blue. From the CMYK space, a component connected with magenta color was chosen for further processing (Figure 5b) in which the photograph was converted into a binary image with a threshold of 0.25 (Figure 5c). Then, for given points, the centers of gravity were calculated and the interface slips in *x* and *y* directions were determined at five levels (levels I to V).

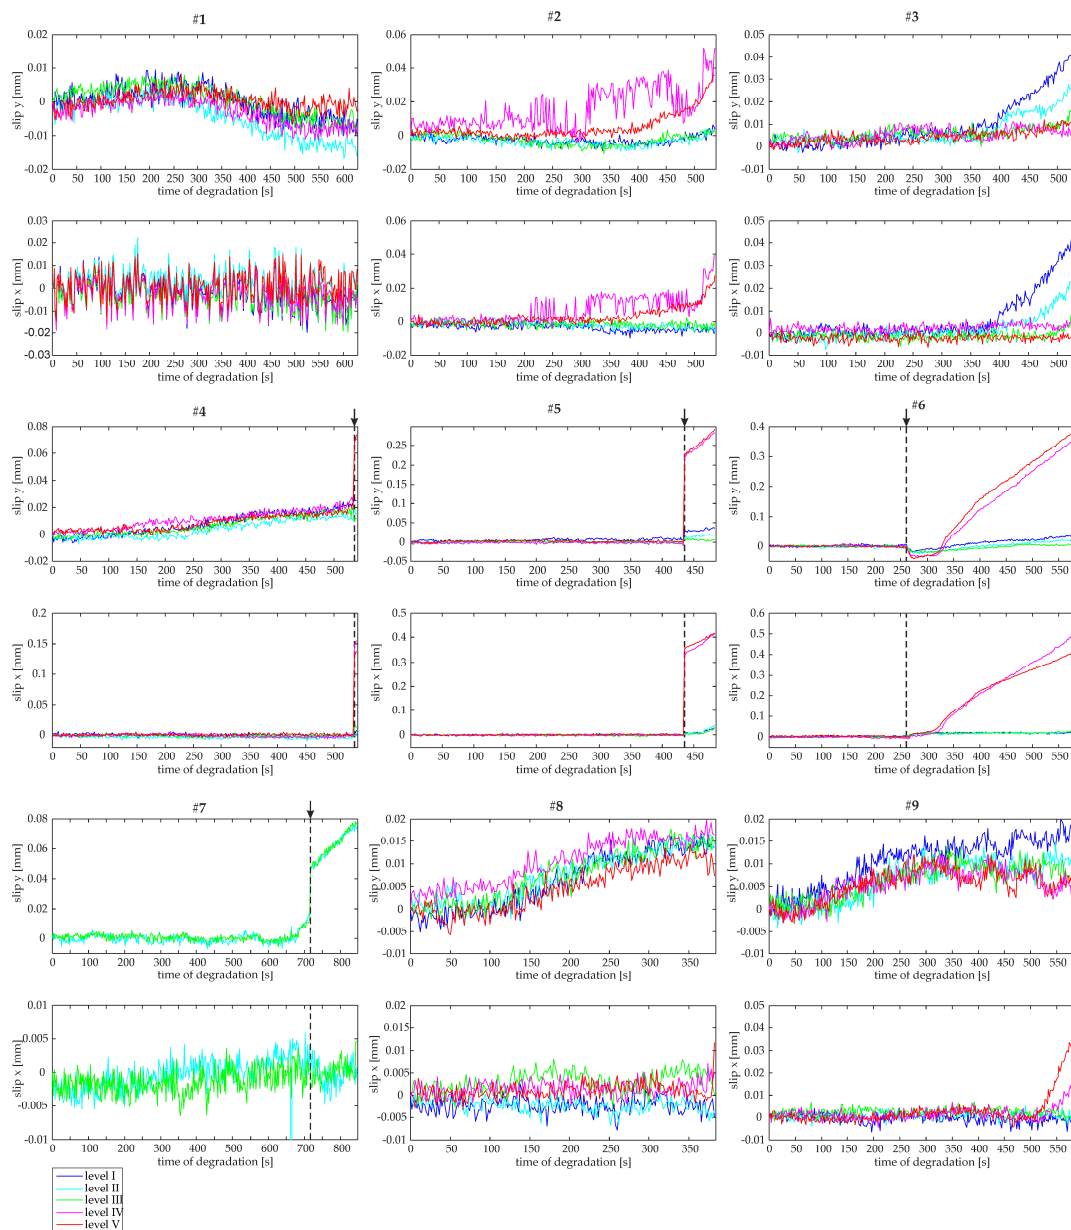
Figure 9. Interface slip between steel and concrete for tested push-out specimens (#1–#9).

Results of the interface slip between the steel and concrete in both vertical and horizontal directions are presented in Figure 9. For each specimen, the slip values are given for this interface at which the failure occurred (i.e., the right interface for specimens #1, #2, #6 and the left interface for specimens #3, #4, #5, #7, #8, #9). The moment of initiation of the crack in the concrete cube was indicated by the dashed lines (specimens #4–#7). In the case of the adhesive or mixed adhesive-cohesive failure, the measured slip varied around zero almost to the end of the degradation process. For specimens #2, #3 and #9, the monotonic increase of the slip was observed at the end of the test. The maximum values of the slip for the specimens representing mode I and mode IIc was about 0.05 mm. In the case of specimens with the cohesive failure in the bulk of the concrete cube, a sudden increase of the slip was observed in specimens #4, #5 and #7. A different behavior can be seen for specimen #6 for which the monotonic increase occurred after the cracking of concrete cube. The maximum values of the slip for specimens representing modes IIa and IIc were about 0.4 mm.
