Article

Failure Monitoring and Condition Assessment of Steel-Concrete Adhesive Connection Using Ultrasonic Waves

Magdalena Rucka

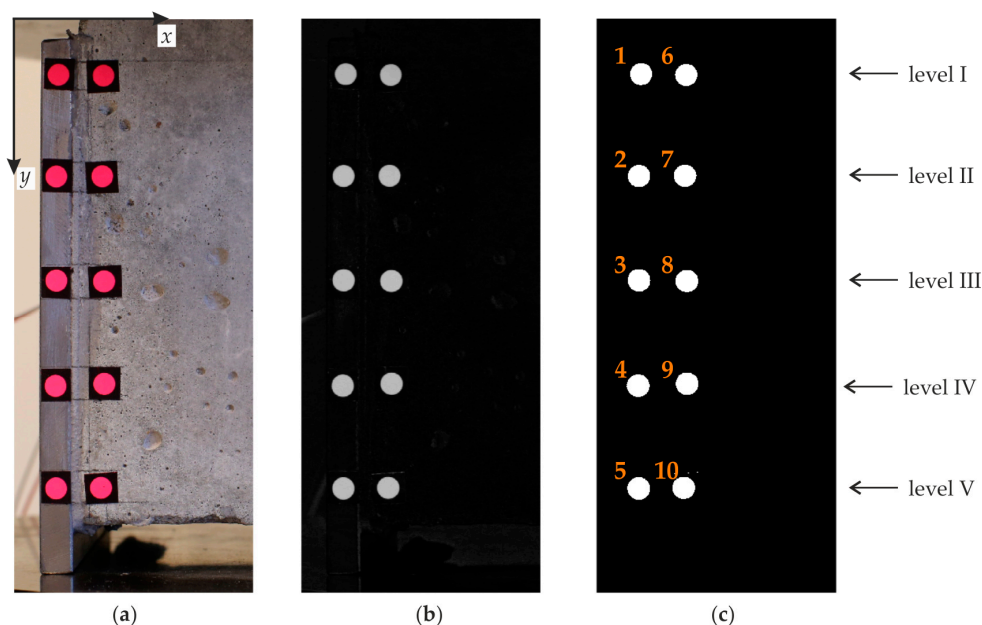
The interface slip between the steel plate and concrete cube was determined using a photogrammetric technique (c.f. [34]). The digital RGB photograph (Figure 5a) was transformed into the CMYK space according to the formula

where colors are marked as follows: *c*—cyan, *m*—magenta, *y*—yellow, *k*—black, *r*—red, *g*—green, *b*—blue. From the CMYK space, a component connected with magenta color was chosen for further processing (Figure 5b) in which the photograph was converted into a binary image with a threshold of 0.25 (Figure 5c). Then, for given points, the centers of gravity were calculated and the interface slips in *x* and *y* directions were determined at five levels (levels I to V).

Figure 5. Digital photograph of the left adhesive joint: (a) RGB photograph; (b) magenta component; (c) binary image.
