Article

Failure Monitoring and Condition Assessment of Steel-Concrete Adhesive Connection Using Ultrasonic Waves

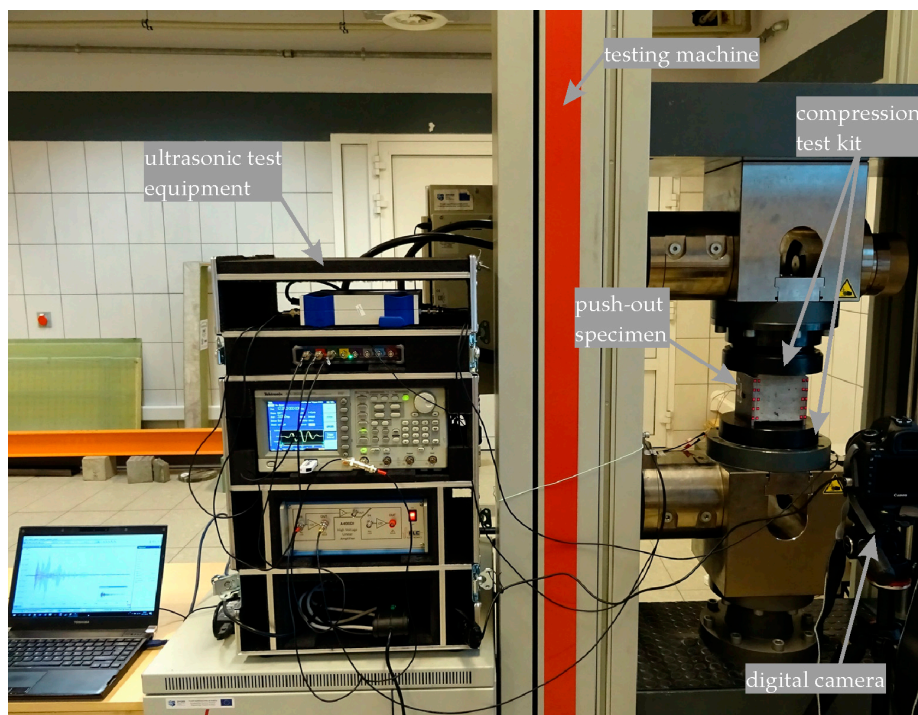
During the mechanical degradation in the testing machine, ultrasonic waves were induced and acquired every 2 s, until the specimen failure. Figure 3 shows the experimental setup. Three multilayer

Figure 3. Experimental setup for push-out and ultrasonic tests.

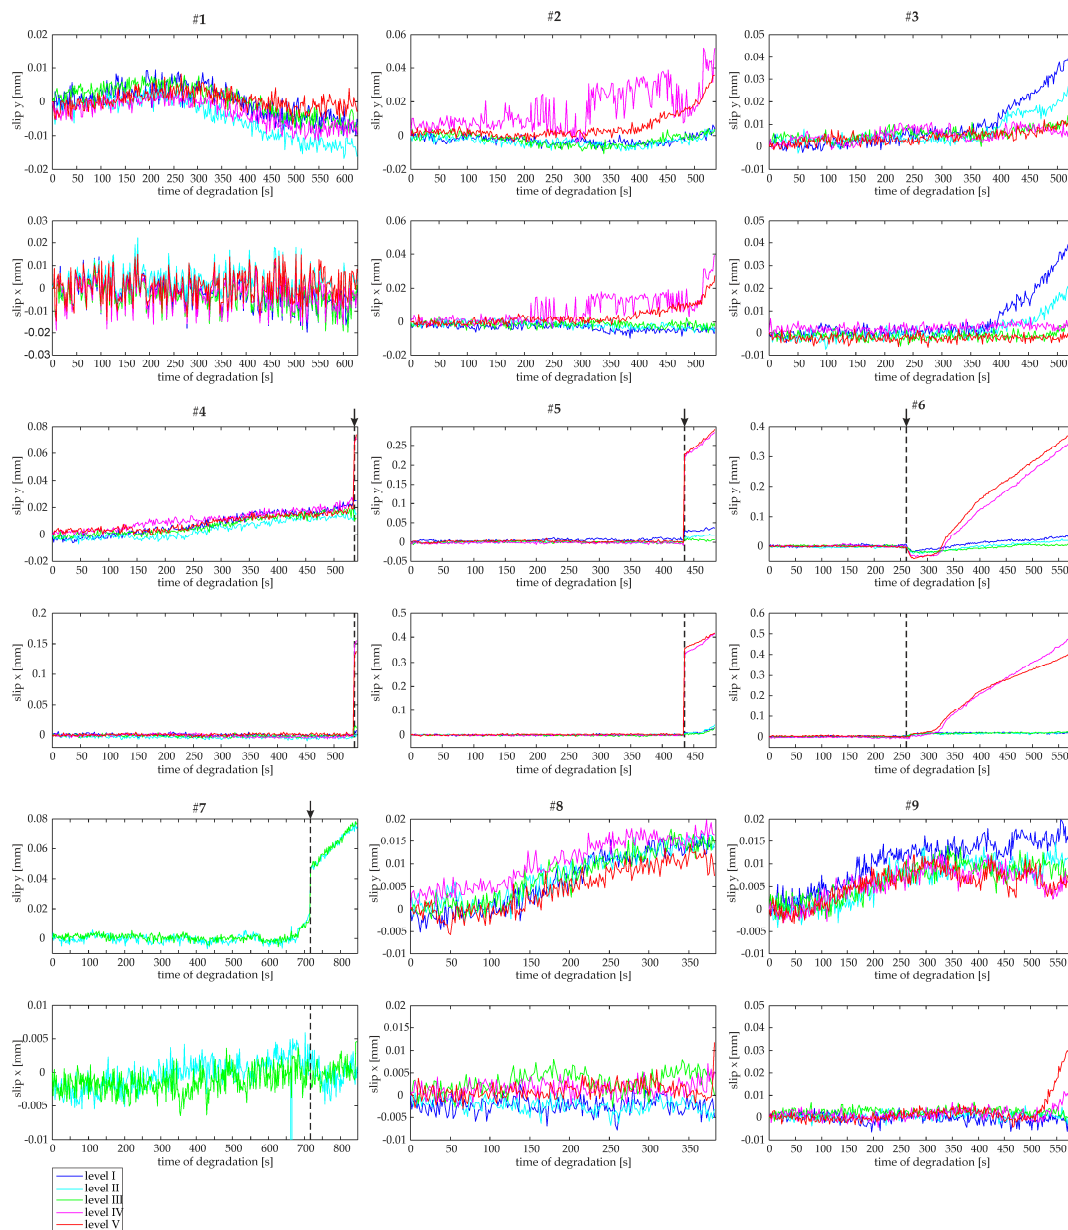
Results of the interface slip between the steel and concrete in both vertical and horizontal directions are presented in Figure 9. For each specimen, the slip values are given for this interface at which the failure occurred (i.e., the right interface for specimens #1, #2, #6 and the left interface for specimens #3, #4, #5, #7, #8, #9). The moment of initiation of the crack in the concrete cube was indicated by the dashed lines (specimens #4–#7). In the case of the adhesive or mixed adhesive-cohesive failure, the measured slip varied around zero almost to the end of the degradation process. For specimens #2, #3 and #9, the monotonic increase of the slip was observed at the end of the test. The maximum values of the slip for the specimens representing mode I and mode IIc was about 0.05 mm. In the case of specimens with the cohesive failure in the bulk of the concrete cube, a sudden increase of the slip was observed in specimens #4, #5 and #7. A different behavior can be seen for specimen #6 for which the monotonic increase occurred after the cracking of concrete cube. The maximum values of the slip for specimens representing modes IIa and IIc were about 0.4 mm.

Figure 9. Interface slip between steel and concrete for tested push-out specimens (#1–#9).

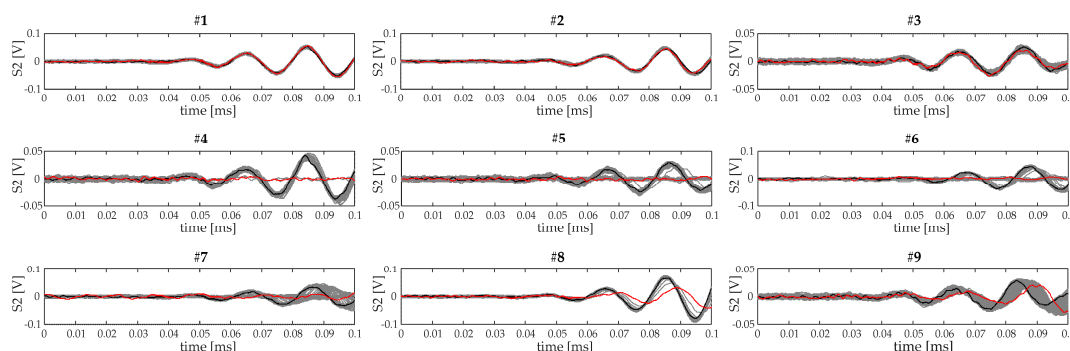
The ultrasonic waves were registered automatically every 2 seconds during push-out testing. All signals acquired by sensor S2 for specimens #1 to #9 are illustrated in Figure 10. Only an initial part of the signal with a length of 0.1 ms was analyzed to reduce the influence of interactions of waves with the compression test kit of the testing machine. The reference signal, i.e., the signal registered at the beginning of the push-out test is marked in black and the last acquired signal is marked in red. For specimens #1–#3, representing the adhesive-type failure (mode I), signals relating to successive states of mechanical degradation are similar and no significant changes in the magnitude or phase can be observed. In the case of push-out specimens #4–#10, for which the cohesive or mixed adhesive-cohesive failure occurred (mode II), experimental waveforms changed considerably during mechanical degradation.

Figure 10. Wave propagation signals registered during monitoring of steel-concrete push-out specimens (#1–#9); the first signal (reference) is given in black, the last registered signal in given in red, all other signals are given in grey.

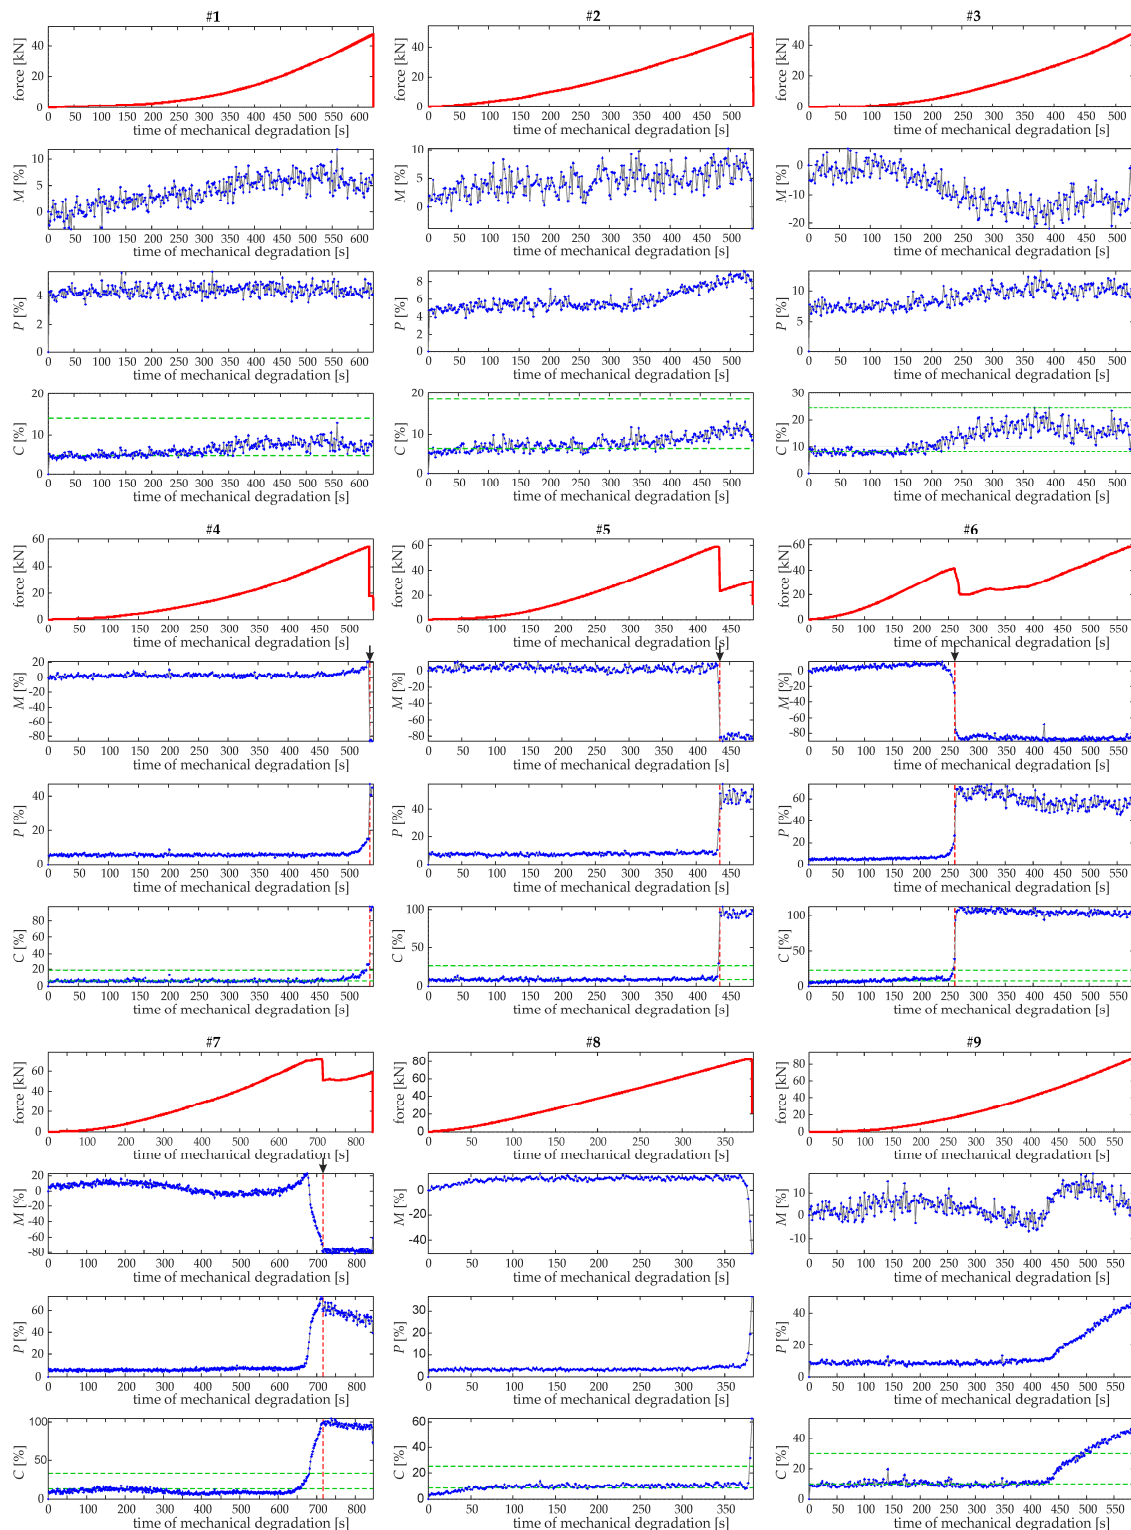
The results of applying the Sprague and Geers metric to all signals registered during the monitoring of the push-out test are presented in Figure 11. For clarity of observation, the load-time curves were provided for each specimen. Additionally, for specimens #4–#7, red dashed lines were drawn at the moment of initiation of the crack in the concrete cube. The S&G metric expresses the difference between the reference signal and the other signals registered during the push-out test. The error measures can range from 0 to 1 or more. The perfect agreement of time histories results in a zero value of the error measures, while the value of unity indicates a difference of 100%. The value of the P -error is always positive while the value of the M -error can be positive or negative, depending on whether the monitored signal has higher or lower amplitude than the reference signal. At the beginning of the process, the P -error fluctuated around the value of about 5% and the M -error around the value of about 0%. These values resulted from the presence of measuring noise in the subsequently triggered measuring signals.

Considering the specimens with the adhesive-type damage (the first row in Figure 11), all error measures are rather constant during the entire push-out test. A slight increase in the P -error value was observed for specimen #6; however, based on these errors it was not possible to detect incoming damage before the failure.

The second group are specimens belonging to failure modes IIa and IIb, for which the separation between the steel plate and concrete was preceded by the cracking of concrete. For specimens #4, #5 and #6, the increase in the P -error can be observed before the initiation of the diagonal cracks. This increase was quite sudden for specimen #5, but for specimens #4 and #6 it was gradual signaling incoming damage. Moreover, for specimen #6, the M -error gradually decreased before the initiation of the diagonal cracks. In the case of specimen #7, for which the crack appeared in the middle of the concrete cube, the gradual increase of the P -error and the decrease in the M -error can be seen, enabling detection of the micro-crack zones in the concrete long before the appearance of the macro-crack.

The last two specimens represented the failure of mode IIc. For the specimen #8, the detection of the cohesive failure was possible based on both the M and P -errors. In the case of specimen #9, the gradual increase of the P -error was observed (similarly as for specimen #2) indicating the increase in the load but not the appearance of the failure. This was because, the failure of specimen #9 was mainly adhesive, with a small area at which the cohesive failure occurred.

As a damage indicator, the C -error is proposed because it contains both the magnitude and phase errors. For each specimen, two horizontal lines were drawn in the plots of the comprehensive error (Figure 11). The first line is a mean of the 100 first values of the C -error and it determines a baseline. The second line is the baseline multiplied by a coefficient and it represents the state of possible damage. In this study, the value of the coefficient was set a priori as 3, however, in potential applications of structural monitoring, it should be verified based on comprehensive experimental data. Based on the indicator, it was not possible to recognize the upcoming separation between steel and concrete in any specimen with the adhesive failure (specimens #1–#3). In the case of specimens exhibiting the cohesive

Figure 11. S&G metric errors (magnitude error M , phase error P , comprehensive error C) during subsequent phases of degradation of push-out specimens (#1–#9).

or mixed adhesive-cohesive failure, the gradual increase of the C-error enabled earlier detection of potential damage.
