# A NEW APPROACH OF COASTAL CLIFF MONITORING USING MOBILE LASER SCANNING

Rafał Ossowski  
 Paweł Tysiąg  
 Gdańsk University of Technology, Poland

*The article proposes a new approach of coastal cliff monitoring which bases on a new comprehensive monitoring system, being a combination of mobile scanning from the sea with the geotechnical stability analysis. Mobile laser scanning is an innovative solution for 3D data collection which allows the monitored object geometry to be precisely measured, thus providing opportunities for series of analyses contributing to the development of an improved monitoring system. The authors present selected cliff profiles obtained from mobile scanning in the area of Jastrzebia Gora, complemented by relevant geotechnical analyses. The analysis of current cliff geometry is accompanied by calculations of hypothetical cliff profile changes resulting from possible action of nature forces. Finally, a comprehensive strategy for coastal cliff monitoring is proposed.*

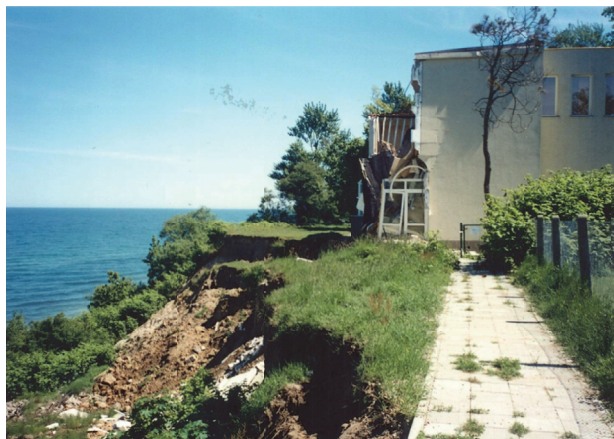
Fig. 2. The leisure centre "Horyzont" situated on the edge of an active cliff and damaged in 2002.  
(photo courtesy of W. Subotowicz)

The landslide hazard of the Jastrzebia Gora cliff has been known for several decades. The interest of the society and local self-government in this part of the coast increased in 1988 when the created landslide endangered the leisure centre "Horyzont" (Fig. 2). The average multiannual cliff abrasion rate in this region is approximately equal to 1m/year [1].

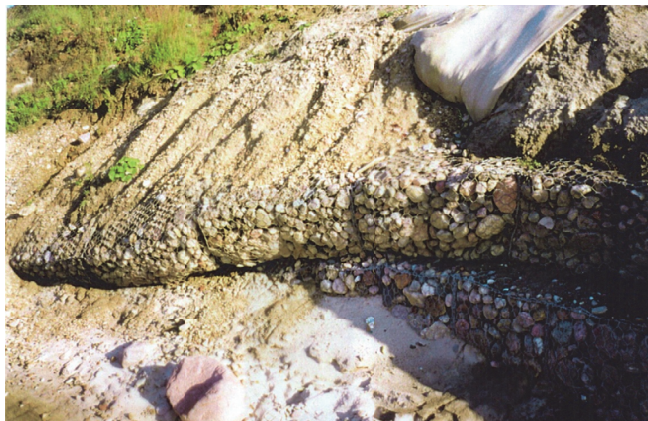
Fig. 3. Gabions composing the seawall in the region of "Bałtyk", damaged in 1998  
(photo courtesy of W. Subotowicz)

abovementioned cliff segment at Jastrzebia Gora. It had the form of a seawall consisting of gabions. At first, it was built along the eastern cliff part, of 200 m in length, where the partially damaged leisure centre "Horyzont" was situated. Unfortunately, first damages of this seawall were already observed as early as in 1998 (Fig. 3).

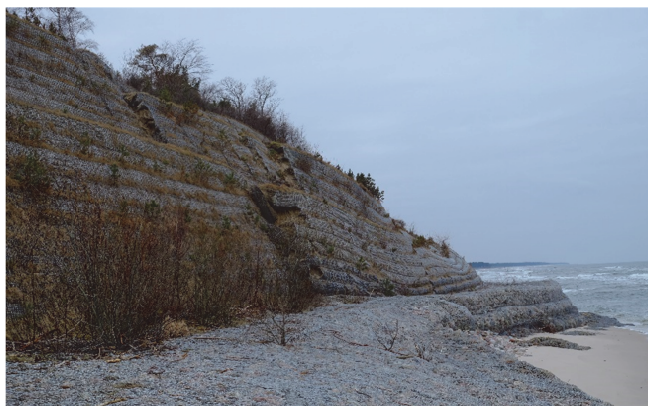
Fig.4. Degradation of reinforced cliff part at Jastrzebia Gora – situation of January 2017.

A general conclusion from the above situation is that all past protection measures revealed low durability (see Fig. 4). Consequently, permanent monitoring of the cliff is indispensable for the safety of tourists and residents.
