ECONOMICAL METHODS FOR MEASURING ROAD SURFACE ROUGHNESS

Dariusz Grabowski, Maciej Szczodrak, Andrzej Czyżewski

Gdańsk University of Technology, Faculty of Electronics, Telecommunications and Informatics,
G. Narutowicza 11/12, 80-233 Gdańsk, Poland (✉ ksm@sound.eti.pg.edu.pl, 48 58 347 1114)

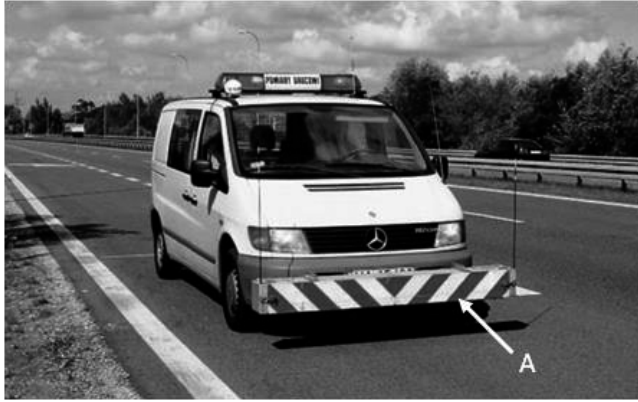
Fig. 1. A professional laser profilograph (A) mounted on a vehicle [11].

Another solution used, among others, by the General Directorate for National Roads and Motorways in Poland, is a laser profilograph [11]. One such device is a Dynatest's product, model 5051 Mk-II Test System. The device is installed on a beam mounted at the front of the vehicle, as shown in Fig. 1, equipped with densely distributed laser sensors. They scan the road surface area approximately every 5 mm and then the obtained data are stored in the fixed memory. The test is based on recording the maximum value of ground clearance between the damaged surface and the horizontal beam [12]. Usually the measurements are taken at 50 km/h, but it is also possible

In addition to laser sensors, the device is equipped with accelerometers, gyros, a GPS receiver and a distance meter. This enables to study the longitudinal and transverse roadway profiles, the curvature of curves, *etc.* [14].

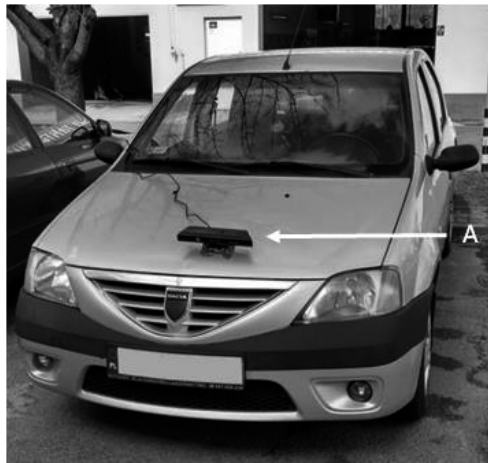
Fig. 5. A car equipped with a Kinect sensor (A).

sensor was mounted on the car engine flap using a mounting tape. The sensor's framerate enabled to drive at a speed of about 30 km/h. A photo of the vehicle setup for the test drive is shown in Fig. 5.
