Chinese Journal of Aeronautics

# Effect of selective laser treatment on initiation of fatigue crack in the main part of an undercarriage drag strut

Anna BIEN<sup>a</sup>, Marek SZKODO<sup>b,\*</sup>, Jerzy DOBERSKI<sup>c</sup>,  
Bartłomiej KARPIŃSKI<sup>b</sup>

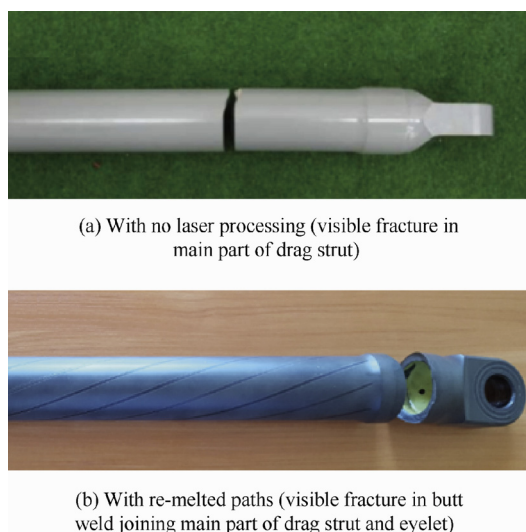
Fig. 7 Two drag struts of landing gear after testing fatigue.

Fig. 7 presents a view of the drag strut after the fatigue test. The fracture in the drag strut occurred in its main part, about 15 cm from the butt weld, joining the main part of the drag strut with the eyelet of the drag strut. The laser re-melted drag strut was able to withstand 1700 simulated cycles of landing. In contrast to the drag strut with no laser re-melting, the fracture in this drag strut occurred in the butt weld. It follows that the laser treatment can increase, for the same loading, the number of cycles to failure of the drag strut by about 70%. Subsequently, metallographic research was performed in order to verify the microstructural changes caused by the laser treatment. For this purpose, a sample was cut from the laser re-melted drag strut. The location of the cut corresponded to the spot of fracture in the drag strut with no laser re-melting. Then, a metallographic cross section was made. Structural examination of the cross section revealed that the laser treatment led to re-melting the surface layer to a depth of about 70  $\mu\text{m}$ .
