Article

Non-Destructive Assessment of Masonry Pillars using Ultrasonic Tomography

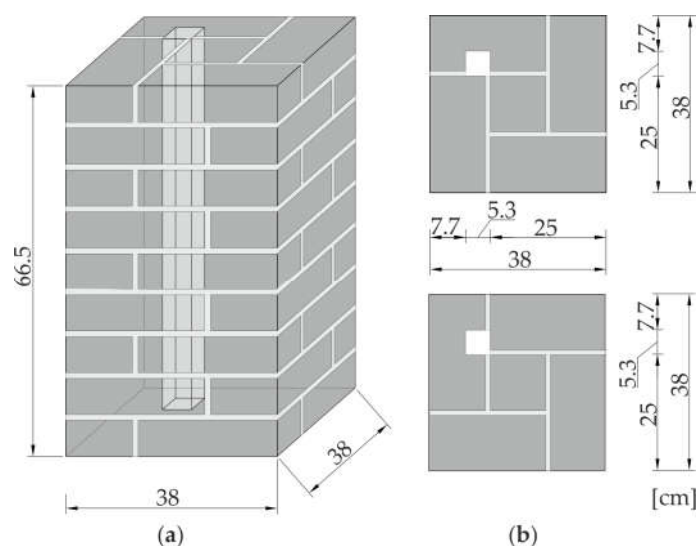
Figure 2. Geometry of the tested pillars: (a) 3D view; (b) plane view of even and odd layers.

A masonry pillar was used as a testing object. The pillar was manufactured using solid bricks, with dimensions of 25 cm × 12 cm × 6.5 cm. Joints between bricks were 1 cm thick and were filled with gauged (cement-lime) mortar. Nine brick layers were used to build the specimen. The model had a length of 66.5 cm and cross-section dimensions of 38 cm × 38 cm. The geometry of the pillar and a view of the even and odd layers are shown in Figure 2.

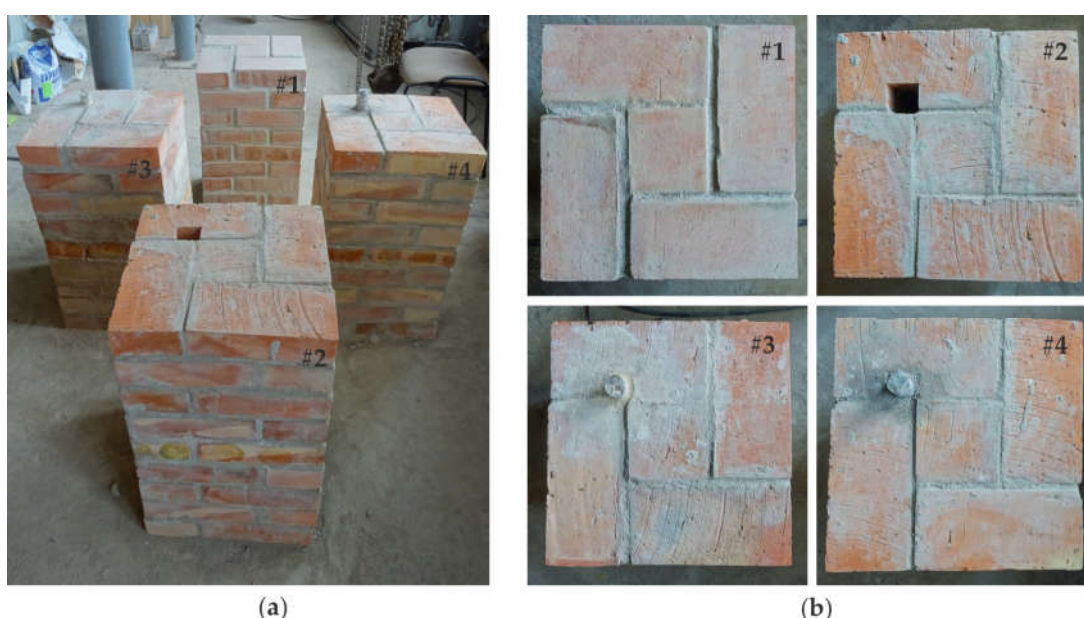
Figure 3. Photographs of laboratory models of the brick pillars: (a) overall view; (b) plane views of specimens #1 to #4.

The test specimens included one pristine pillar and three pillars with inclusions (Figure 3). The first pillar (#1) was prepared as a reference model. Pillars #2, #3 and #4 had a square hole through the entire height of the specimen. The hole, with dimensions of 5.3 cm × 5.3 cm, was situated at a distance of 7.7 cm from the pillar edges (Figure 2b). The hole in pillar #2 remained empty, while in the case of pillars #3 and #4, an anchor was mounted in it. The threaded steel bar had a diameter of 32 cm, and was grouted using two types of mortar. In pillar #3, the anchor was mounted using gypsum mortar to represent a weak bond, while in the case of pillar #4, cement mortar was used to represent a strong bond.

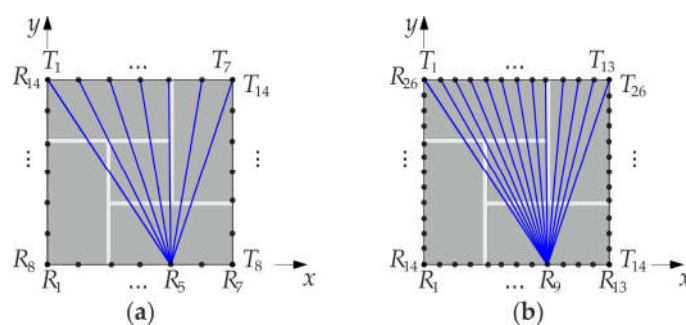
Figure 5. Configuration of the measurement points: (a) configuration #A (transmission of waves at points T_1 - T_{14} and sensing of waves at points R_1 - R_{14}), (b) configuration #B (transmission of waves at points T_1 - T_{26} and sensing of waves at points R_1 - R_{26}).

Measurements were carried out on the middle (i.e. 5th) layer of bricks. Two experiments were conducted. In the first test (configuration #A), 7 measurement points were distributed at each pillar edge, while in the second test (configuration #B), measurements were taken at 13 points. The configurations of the measurement points are given in Figure 5. Transmitting points are denoted by T, and receiving points by R. The receiving transducer was set at a given point, and then the transmitting transducer was moved from the first to the last point on the opposite wall. There were 14 transmitting/receiving points for configuration #A and 23 transmitting/receiving points for configuration #B.

Numerical analyses of the stress wave propagation were carried out using the finite element method (FEM) in the Abaqus/Explicit. A two-dimensional model of the fifth layer of the pillar was developed using four-node plane strain elements, with reduced integration (CPE4R). The size of all elements in the model was $1 \text{ mm} \times 1 \text{ mm}$. The material of the pillar was assumed to have linear elastic behavior. The material properties of the bricks and mortar were determined experimentally (Table 1), and for the steel, the following parameters were adopted: $E = 200 \text{ GPa}$, $\rho = 7850 \text{ kg/m}^3$, $\nu = 0.3$. The connections between the bricks and mortar as well as between the mortar and steel were modelled as a tie constraint. The boundary conditions were assumed to be free on all edges. The excitation signal was a one-cycle sine wave of 54 kHz frequency, modulated by the Hann window. The size of the integration step was 10^{-7} s . The output acceleration signals were recorded at the same points as in the experimental investigations (Figure 5).
