Article

Advantages of the Application of the Temper Bead Welding Technique During Wet Welding

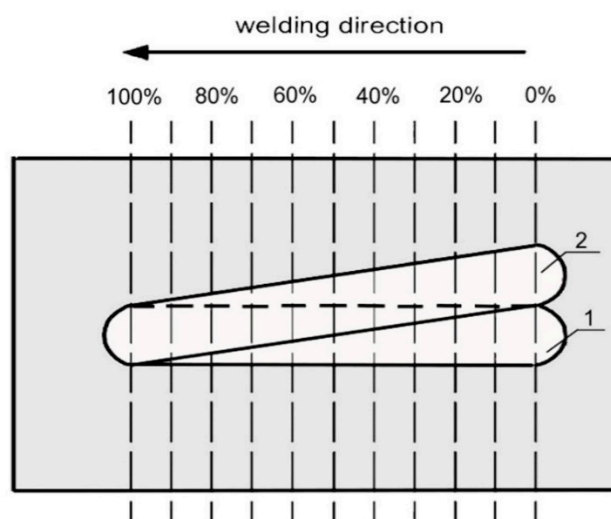
Figure 1. Scheme of the temper bead welding (TBW) technique specimen, 1—first (tempered) padding weld, 2—second (tempering) padding weld.

There are many weldability tests, for example the controlled thermal severity (CTS), Tekken, and implant tests [30–32]. For this study, the CTS test was chosen, because in a water environment the most popular welding method uses fillet welds. In addition, this test enables assessment of the susceptibility to cold cracking in all joint areas. In the next step, the TBW technique was used for pad welding to determine the influence of the pitch on the microstructure of the HAZ and the hardness of the joints. TBW specimens were made by varying the relative deposition of the beads according to methodology presented in the literature [25]. Weld beads for the TBW samples were made on 200 mm × 100 mm sections in a flat welding position. The welds were laid in order to obtain different distances between the axes of the beads (in a non-parallel manner). The welding schema with a temper bead is presented in Figure 1. This method allowed us to obtain specimens with different percentages of overlap of the second weld bead onto the first weld (pitch). Between two welds, 120 s time passed. All samples were made at a depth of 0.5 m. The diffusible hydrogen content in the deposited metal obtained by the glycerin method for wet welding with E 38 9 R 11 electrodes were in the range of 51.5 to 61.4 mL/100 g [33].

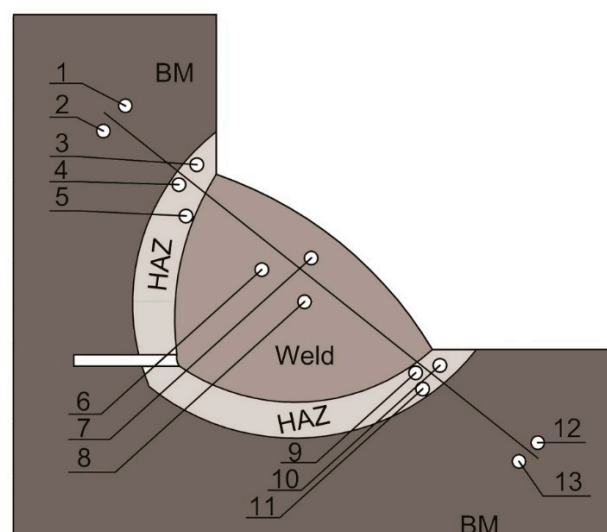
**Figure 2.** Hardness point distribution in the CTS specimens.

The hardness measurement scheme for CTS testing is presented in Figure 2. Figure 3 shows the regions of the TBW specimens in which the hardness was measured. The hardness measurements in the first padding weld of the normalization area of HAZ (HAZN) and the overheated area of the HAZ (HAZO) were located in the HAZ at the axis of the first bead.

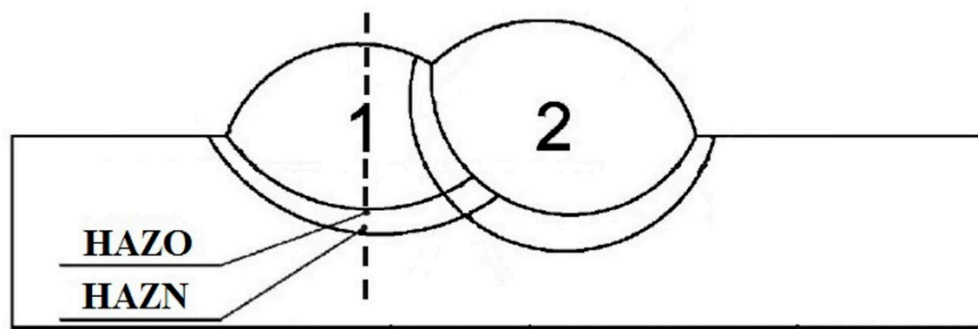
Figure 3. Hardness measurement areas of the heat affected zone (HAZ)—TBW specimens, overheated area of HAZ (HAZO) of the 1st padding weld in the weld axis, normalization area of HAZ (HAZN) of the 1st padding weld in the weld axis.

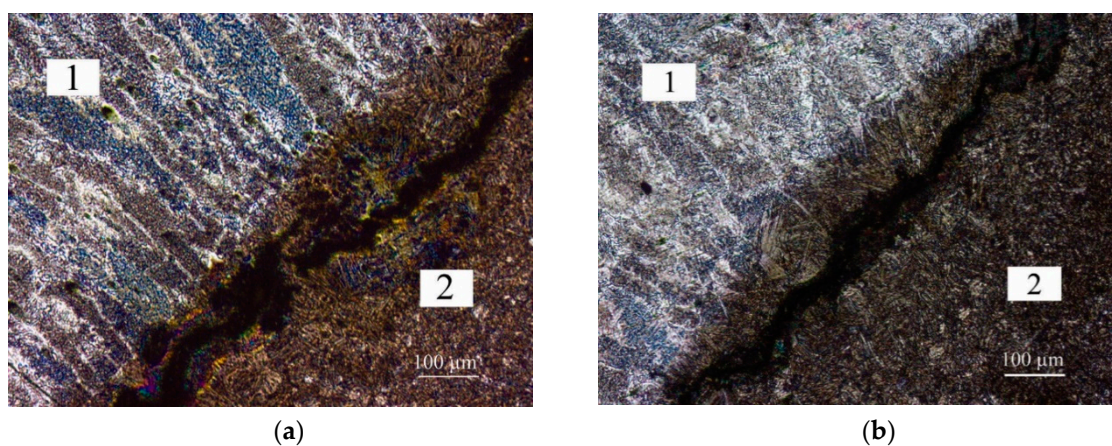
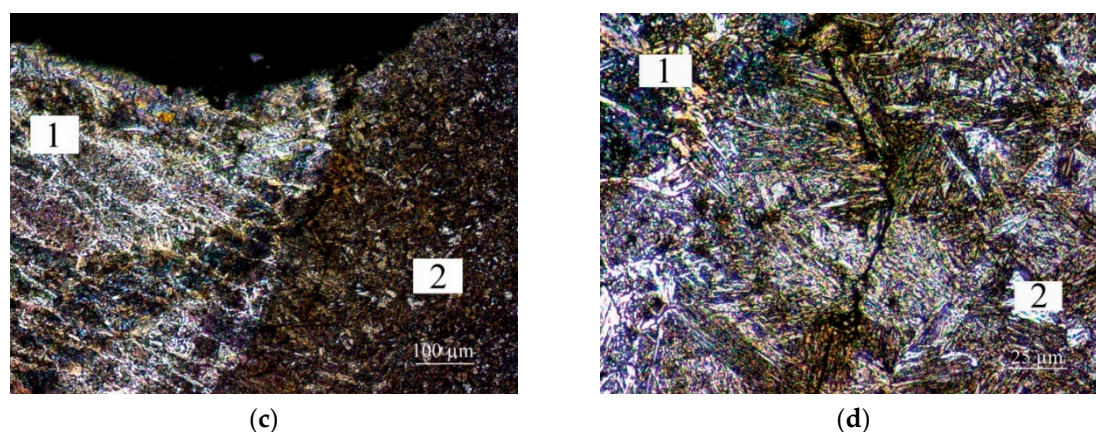
Figure 4. Results of CTS microscopic testing shows cracks in HAZ, 1—weld metal, 2—HAZ, (a) Specimen 1; (b) Specimen 2; (c) Specimen 3; (d) Specimen 6. Etch. Nital 4%.

After non-destructive testing, second welds from specimens 1, 2, 5 and 6 were rejected from further examinations due to significant imperfections. The remaining welds were capable of undergoing further examinations. In the HAZ of each specimen, acicular and martensitic structures were found, which are a result of rapid cooling during welding in the water. The short cooling time also caused high residual stresses and limited the extraction of diffusible hydrogen in the welding environment. The weld metal structure was built of dendrites. The results of the microscopic examination of CTS specimens are presented in Figure 4. During macroscopic testing, cracks in the HAZ of the two specimens (the first weld in specimen 4 and specimen 6) and in weld of one specimen (first weld in specimen 4) were observed. The cracks in the HAZ were initiated in the weld root and propagated along approximately 50% of the length of the fusion line. This area was characterized by an overheated, coarse grain, martensitic structure as is shown in Figure 4a,b. The cracks were observed in the welded joints that were made with the lowest value of heat input (ql). Microscopic examination of S460ML steel showed that cracks occurred in all joints welded in the water environment. These cracks were located in the HAZ, along the fusion line. It was estimated that the total length of these cracks were 30%–40% of the total length of the fusion line. Cracks in the weld also were revealed.

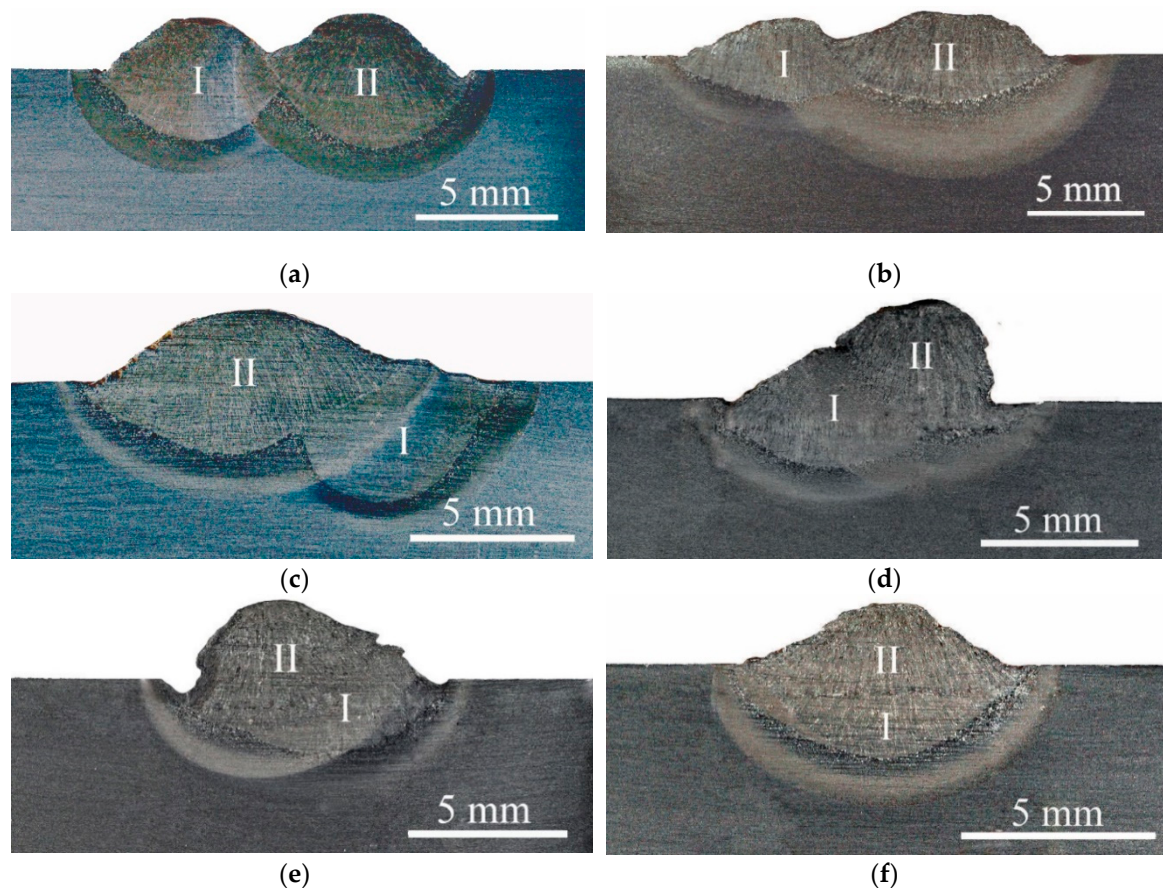
Figure 5. Results of the TBW macroscopic testing, I—first (tempered) bead, II—second (tempering) bead, (a) pitch 11%; (b) pitch 19%; (c) pitch 43%; (d) pitch 55%; (e) pitch 73%; (f) pitch 100%. Etch. Nital 4%.

In the first step of the examination, macroscopic tests were performed. The main aim of these examinations was to calculate the pitch between the two beads. After the macroscopic testing of specimens with a pitch of; 11%, 19%, 43%, 55%, 73%, and 100%, were selected for the next examinations. There were no cracks in these specimens. The results of the macroscopic testing are presented in Figure 5.

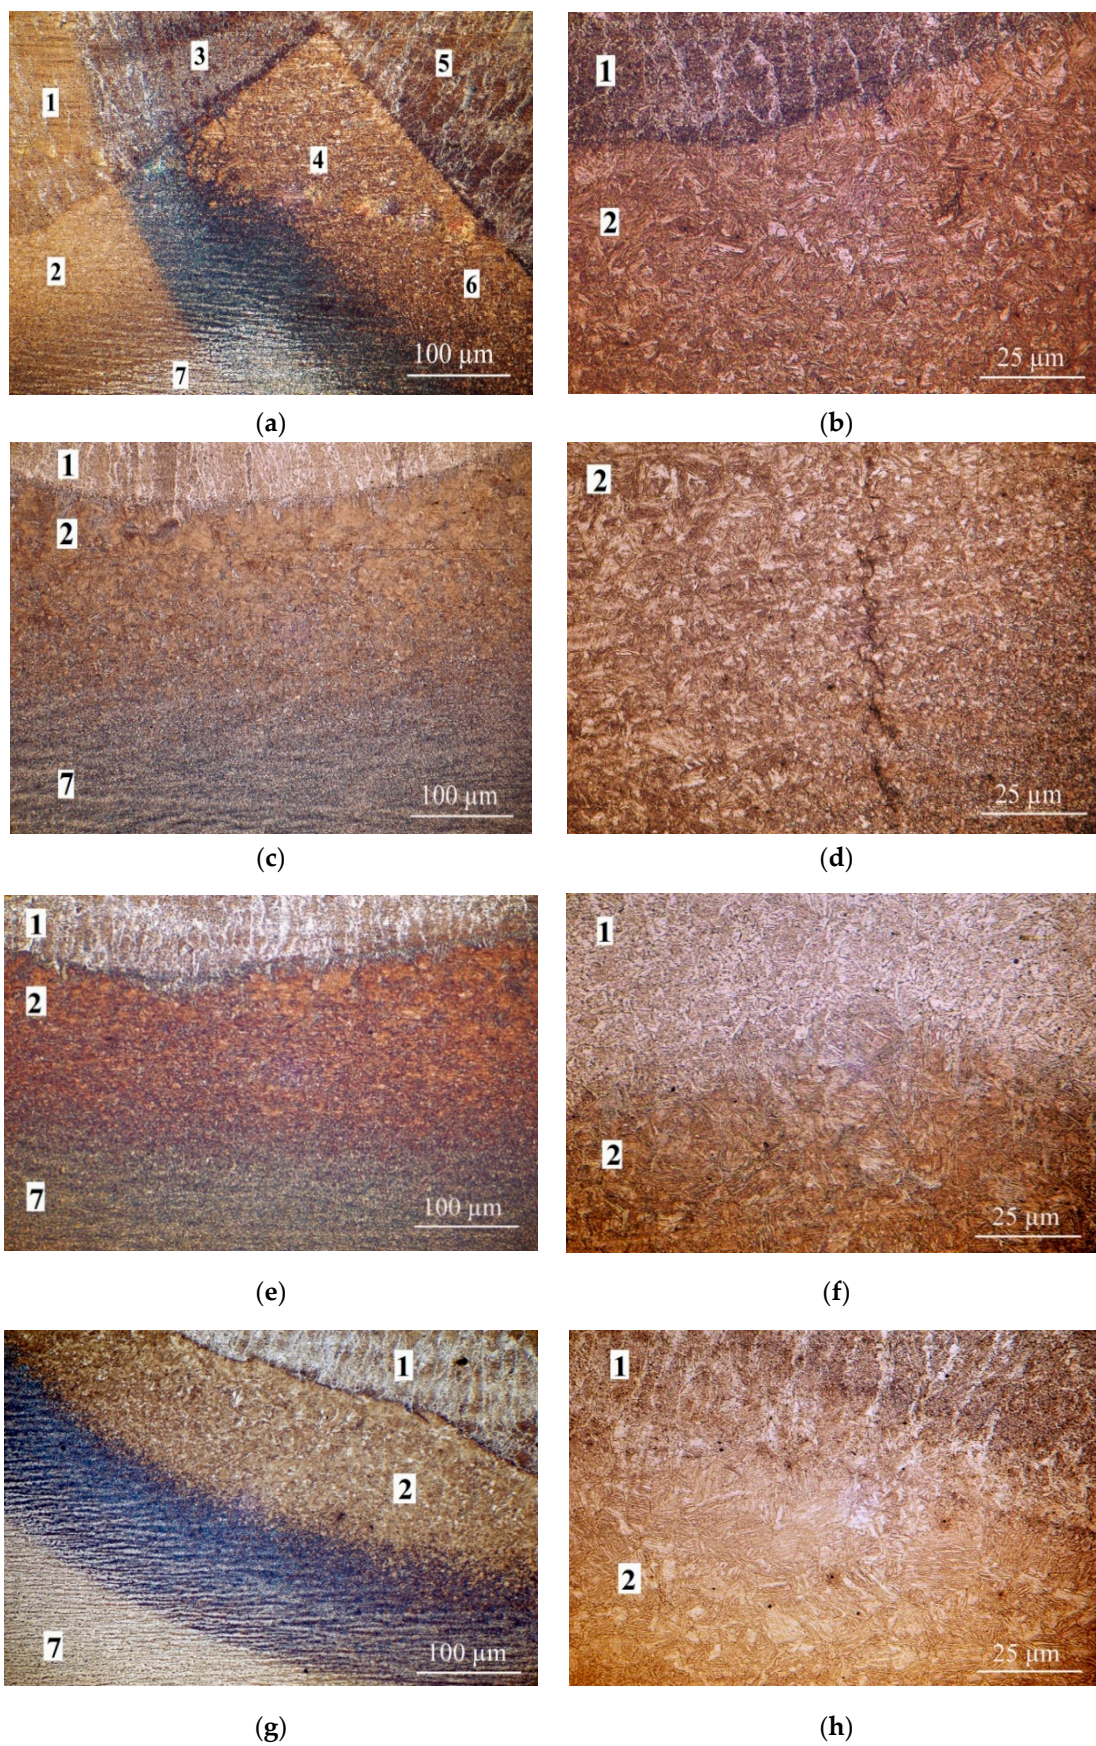
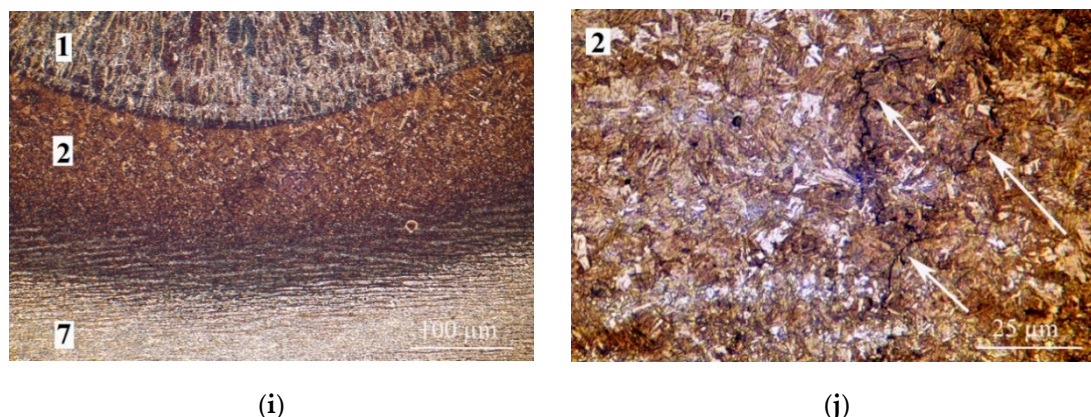
Figure 6. Results of TBW microscopic testing; 1—first bead, 2—HAZ under first bead, 3—area of the HAZ of the second bead overlapping the first bead, 4—HAZ of the second bead overlapping the HAZ of the first bead, 5—second bead, 6—HAZ under the second bead, 7—base metal. (a,b) pitch 11%; (c,d) pitch 43%; (e,f) pitch 55%; (g,h) pitch 73%; (i,j) pitch 100%. Etch. Nital 4%.

The results of the microscopic testing are presented in Figure 6. The welds in each of these specimens showed dendritic structures (Figure 6a, area 1). There was bright, fine-grained ferrite arranged in columns, from which grew acicular ferrite at the boundaries of the dendrites. Inside the dendrites there were fine ferrite grains. The structure of the HAZ was different. Near the fusion line, there were expanded quasiperlite grains with a structure following the Widmannstätten system (e.g., Figure 6b,c, area 2). The structure of this zone also indicated the presence of bainitic hardening structures and low-carbon martensite (Figure 6d). In the areas located the furthest distance from the fusion line, there were normalization structures with fine ferrite and pearlite. In all specimens, changes due to the tempering bead were observed. With the highest value of the pitch between two beads, there was a partial disappearance of the structure of the dendritic base bead and the formation of a ferritic fine-grained structure (e.g., Figure 6e,f, area 1). In the HAZ, the heat of the tempering beads refined and tempered the coarse-grained zone of the first bead (Figure 6g). When the pitch increased, the grain size decreased. TBW provided local heat treatment of the joints. The maximum hardness values for wet welding appeared in the coarse grained HAZ [37]. The grain size decreased during TBW (Figure 6h,i, compare with Figure 6a–d), which led to a reduction of hardness in the HAZ. The pitch increased and the number of cracks decreased. However, TBW could not repair the microcracks that occurred during the welding of the first bead and could even propagate these cracks (Figure 6j). Cold cracks can occur up to 48 h after welding is completed. TBW was used in the 120 s after first bead was laid, thus this technique reduced the probability of the occurrence of these cracks.

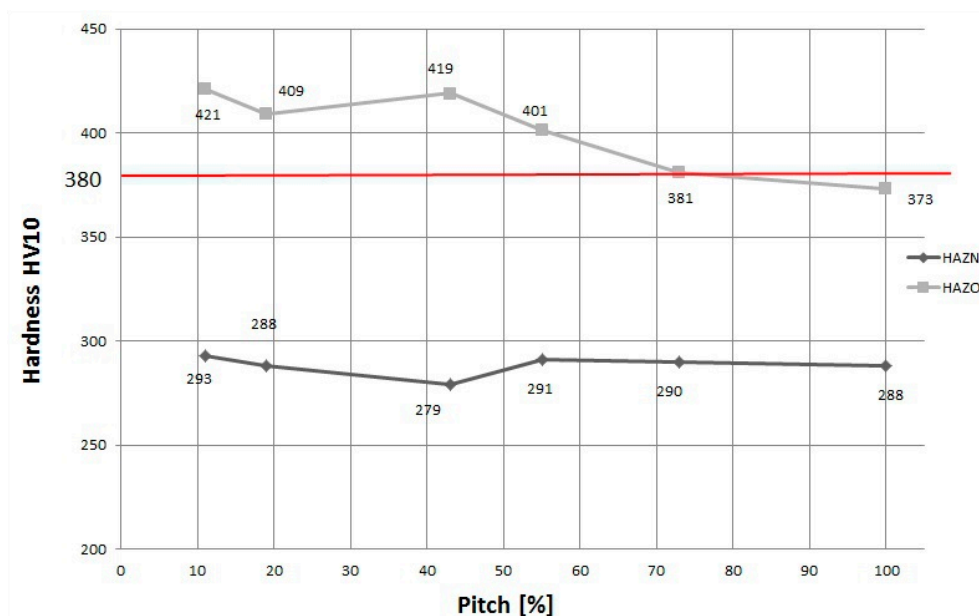
Figure 7. Hardness distribution for specimens with different overlap values in HAZO and HAZN areas of the first (tempered) weld.

The hardness measurements were performed on cross-sections of each specimen with all ranges of pitch. The hardness was measured at points in two specific areas of the HAZ (overheated and normalized) of the first tempered weld (Figure 3). The results of the hardness measurements are presented in Figure 7. When the pitch between two beads increased, the hardness in the HAZO of the first padding weld decreased. The HAZO area in the specimens with low pitch values was characterized by the presence of the coarse-grained brittle structures created by the highest cooling rate in the welded joint (Figure 6b). These types of structures are one of the factors responsible for cold cracking. Thus, the HAZO area has a crucial influence on the formation of cracks.

In all CTS specimens the hardness was greater than 405 HV10. The HAZ of the tempered beads showed a significant reduction in hardness after using the TBW technique. For specimens with a pitch in the range of 75%–100% the hardness values were below 380 HV10 in the overheated area. In the HAZN, no significant changes in hardness were observed. The comparison in hardness decreased in
