HYDRAULIC ANALYSIS OF CAUSES OF WASHOUT OF GDYNIA-ORŁOWO SEA-SHORE DURING THE FLOOD IN THE KACZA RIVER ESTUARY

Michał Szydłowski

Gdańsk University of Technology, Faculty of Civil and Environmental Engineering, Poland

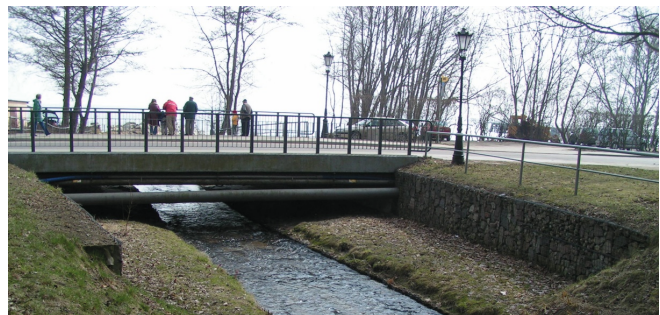
Fig. 4. The bridge over Kacza river in line of Orłowska street in Gdynia (a photo from this author's archive),

The second object (the bridge in line of Orłowska street) is built in the form of a reinforced concrete plate supported only on its heads (lack of abutments). Its breadth amounts to $11,0 \text{ m}$ and the height to $1,5 \text{ m}$. The upper ordinate of the plate is close to that of the surrounding terrain. Below the bridge there are located pipelines which obstruct a significant part of the free cross-section area under the bridge from the side of inlet. (Fig. 4).

As results from the calculations, a factor of a decisive impact on the excessive damming-up of the water and its breaking through Orłowska street was the reduction in the free cross-section area under the bridge resulting from the installation of the pipelines across the river bed (Fig.4). The fact of taking into account the reduction of the free cross-section under the bridge during

4. The reduction in the cross-section of flow passage area under the bridge due to the engineering infrastructure (pipelines) installed across the river valley above the bridge, proved by the calculations in variant 3, should be taken as the direct cause of the excessive water damming-up before the Orłowska street bridge and consequently the water overflowing above it towards the beach. Only the cumulated effect of the natural rainfall freshet, the breach in the Zapotoczna street embankment and the reduced cross-section of flow passage area under the bridge caused that the ordinate of Orłowska street was exceeded which in consequence triggered the water flowing down the reinforcements of sea shore and beach toward the sea, which resulted in their damage.

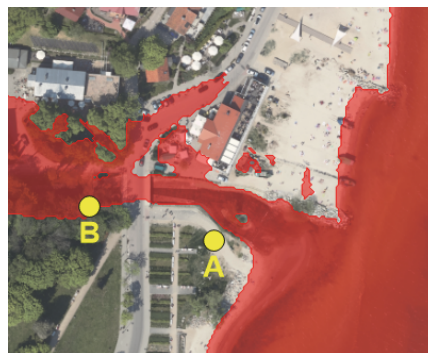
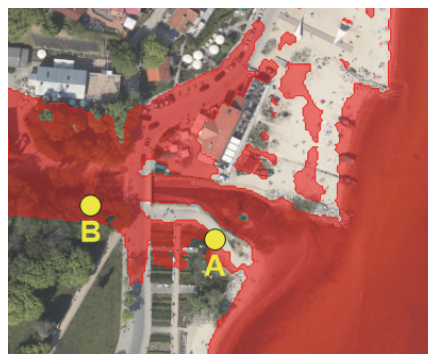
Fig. 6. Maximum depths [m] and range of flooded area in the region of Kacza river estuary and Gdynia- Orłowo beach together with depicted measurement points of maximum water level ordinates after the flood in July 2016 (A, B) (images prepared by this author on the basis of orthophotomap from municipal geodesic resources of Gdynia, Gdynia Municipal Council licence No. PND.6642.1.1697.2018_2262_N, without scale)

The differences in the calculated range of flooded area near the Orłowska street bridge and the beach are shown for particular simulation variants in Fig. 6. As can be seen, in successive variants the flooded area range increases and the zones of potential washing -out the sea shore belt and beach spread. Worth mentioning, that the flooded areas indicated in the last graph of Fig. 6 correspond to the location of the washout areas observed after the flood, shown in Fig. 1 (No. 1, 2 and 3). Simultaneously, neither in variant 1 nor 2 the flow streams north from the visible building and those on the southern side over the right bank of the river close to its estuary, were reproduced. This way the hypothesis has been proved on the decisive role of the reduced flow passage capacity of the cross-section under the Orłowska street bridge in forming the freshet run-off in the area of Kacza river estuary and its impact on the flood damages resulting in the washout of the sea-shore belt in Gdynia –Orłowo .

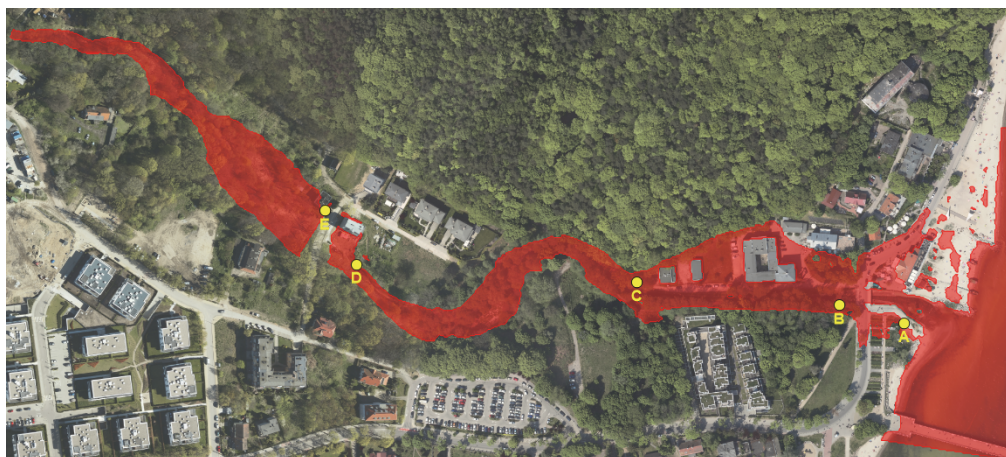
Fig. 7. Maximum range of flooded area along the whole analyzed section of Kacza river in variant 3 together with depicted measurement points (A, B, C, D, E) of maximum water level ordinates after the flood in July 2016 (image prepared by this author on the basis of orthophotomap from municipal geodesic resources of Gdynia, Gdynia Municipal Council licence No. PND.6642.1.1697.2018_2262_N, without scale)

In order to quantitatively verify the numerical simulation results as well as simultaneously evaluate the model, a comparison was made between the calculated maximum water level ordinates and the geodesic-measured ordinates of maximum water level in the valley after the flood in July 2016. The measurements were conducted by a team of Gdansk University of Technology during its on-site visit [9]. The points where the measurements were taken are denoted by letters A through E in Fig. 6 and 7. Point A is placed beneath Orłowska street on the right side of the river away its main bed ; point B is placed above the Orłowska street bridge on the right flooding area of the river ; point C is situated on the left side of the river directly at its main bed; point D lays directly below the road embankment of Zapotoczna street; point E is placed above the road embankment. The common list of measurement and calculation results is given in Tab. 2.

Comparing the particular variants, one is able to find differences between the measured and calculated values as well as between the simulation results themselves. Starting the analysis from the upper run of the analyzed section of the river one can observe that in variant 1 where the simulation of blocking the culvert in the Zapotoczna street embankment (point E) is omitted, water run-off over the embankment top (10.0 m above sea level) does not occur and no washout of its body happens. Such situation was reproduced in variants 2 and 3 where the calculated maximum water level ordinate is close to that observed. The difference between variant 1 and variant 2 and 3 can be also seen directly below the embankment (point D). In this place where occurrence of the breach in the embankment is not reproduced in the calculations (variant 1) the calculated value of water level ordinate is underestimated by 0.3 m in comparison to that measured. After taking into account the damage (variant 2 and 3) the difference decreases to 0.04 m in both the cases, that reflects well on correctness of reproduction of real situation by these simulations. The situation in the middle part of the analyzed section (point C) turned out to be similar. Here the simulation result of maximum water level ordinate in variant 1 is also underestimated by 0.12 m against that measured, whereas the taking into account presence of the breach gives

the same results in variant 2 and 3, however greater than that measured by 0.03 m. While in the points E, D and C there were observed differences between the results from variant 1 (without the breach) and those from variants 2 and 3 (with the breach), in points B and A some difference additionally appears between the simulation results from variant 2 (with the breach in the Zapotoczna street embankment and the passable cross-section area under the Orłowska street bridge) and variant 3 (with the breach and the partly blocked cross-section passage area under the bridge). And, in point B it can be observed that, out of the three simulations, the result from variant 3 is closest to that measured, and in point A (placed directly near the beach, below the bridge) the flooding of this area was reproduced only in variant 3, whereas neither in variant 1 nor in variant 2 the flow over the bridge was properly reproduced. Generally, only the results achieved in the last calculation variant may be considered quantitatively close to the measurements, therefore credible, that has been the aim of validation of the model.
