HYDRAULIC ANALYSIS OF CAUSES OF WASHOUT OF GDYNIA-ORŁOWO SEA-SHORE DURING THE FLOOD IN THE KACZA RIVER ESTUARY

Michał Szydłowski

Gdańsk University of Technology, Faculty of Civil and Environmental Engineering, Poland

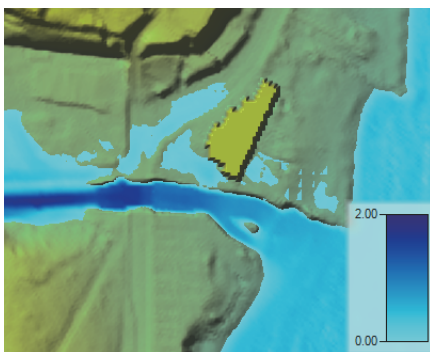
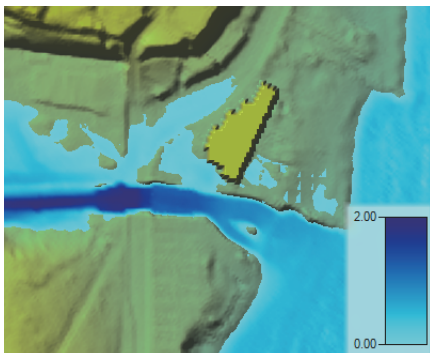
Fig. 6. Maximum depths [m] and range of flooded area in the region of Kacza river estuary and Gdynia- Orłowo beach together with depicted measurement points of maximum water level ordinates after the flood in July 2016 (A, B) (images prepared by this author on the basis of orthophotomap from municipal geodesic resources of Gdynia, Gdynia Municipal Council licence No. PND.6642.1.1697.2018_2262_N, without scale)

The differences in the calculated range of flooded area near the Orłowska street bridge and the beach are shown for particular simulation variants in Fig. 6. As can be seen, in successive variants the flooded area range increases and the zones of potential washing -out the sea shore belt and beach spread. Worth mentioning, that the flooded areas indicated in the last graph of Fig. 6 correspond to the location of the washout areas observed after the flood, shown in Fig. 1 (No. 1, 2 and 3). Simultaneously, neither in variant 1 nor 2 the flow streams north from the visible building and those on the southern side over the right bank of the river close to its estuary, were reproduced. This way the hypothesis has been proved on the decisive role of the reduced flow passage capacity of the cross-section under the Orłowska street bridge in forming the freshet run-off in the area of Kacza river estuary and its impact on the flood damages resulting in the washout of the sea-shore belt in Gdynia –Orłowo .

Comparing particular variants one can observe distinct differences in maximum values of the freshet wave hydraulic parameters. First of all values of the culmination flow resulting from the damage in the road embankment of Zapotoczna street (variant 2 and 3) are, below the damaged object, significantly greater (by almost 7.5 m³/s) than the crest of the wave running through the intact object (variant 1). The maximum flows increased as a result of the damage are also observed in the river estuary above Orłowska street. However in variant 3 where the limited flow passage capacity under the bridge is taken into account the reduction of freshet wave culmination is greater due to the greater water damming-up before the bridge and the greater water retention in the flooded areas in the river valley. In the valley cross-section before Orłowska street the damage of the road embankment results, in case of the full water flow cross-section under the bridge (variant 2), in the water damming up to the ordinate of 2.80 m above sea level, that is greater by almost 0.3 m than that resulting from the simulation without taking into account the object's damage (variant 1), but still not exceeding the bridge plate top ordinate of 2.95 m above sea level and that of the adjacent terrain. This results in a lack of water flow over the road toward the beach. It means that the freshet wave itself and the forming of the breach could not be the only cause of the observed washout in the river estuary area.
