Marine propeller shaft bearings under low-speed conditions: water vs. oil lubrication

Wojciech Litwin

Gdansk University of Technology

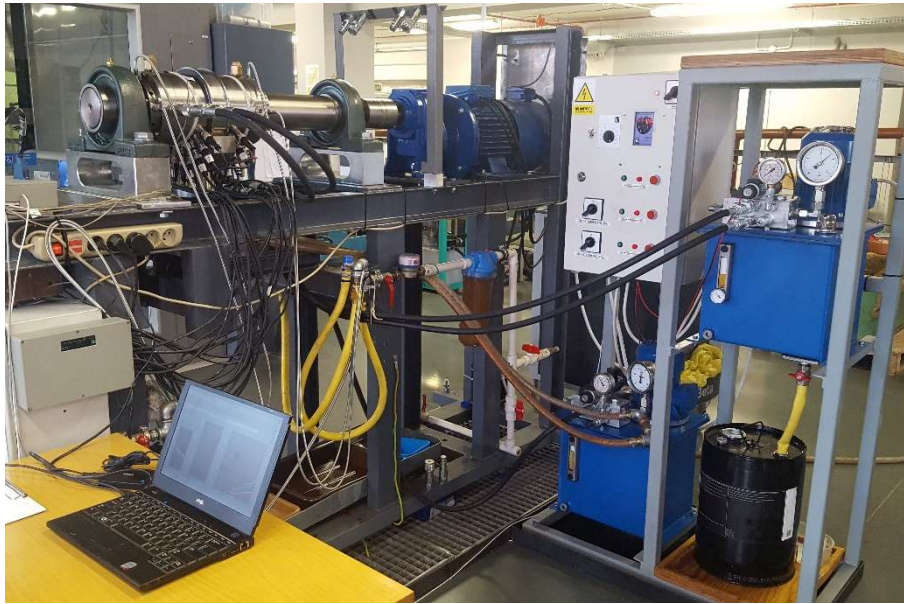
Figure 1. Test stand for marine stern tube bearings during tests of oil lubricated bearings

A modernized test stand for low-speed tests is shown in Fig. 1.
