# Improvement of the load capacity of the road overpass as a result of repairs after breakage caused by vehicle impacts

**Abstract.** Damages of spans of the overpass caused by impact of underpassing vehicles are relatively frequent. Objects that use prefabricated load-bearing elements that are not designed for such impacts are particularly exposed. After impact, such structural elements suffer extensive damage that must be repaired. Taking advantages of this recovery actions it is worth to perform strengthening that will protect object against possible future impacts. In this study the influence of the structural strengthening of the damaged overpass on its strength parameters is investigated. For this purpose the advanced computational model was created. The numerical model includes the response of the reinforcement and prestressing tendons. This model enables precise description of damage caused due to the vehicle's impact and further analysis of re-impact of the strengthened structure.

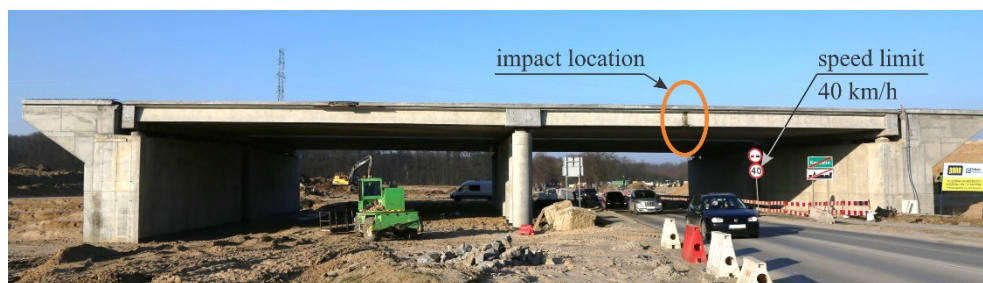
The considered WD-113 overpass (Fig. 1) is located along the S-6 expressway at km 2+842.39, near the Koszalin (Poland). Object consists of two independent structures, namely: WD-113L and WD-113P. They have been designed as a two-span concrete objects. The load-bearing elements are T-type prefabricated prestressed concrete beams (length 24.0 m, height 1.0 m) and a reinforced concrete slab over the T-beams (height 0.24 m). The crossgirders are located over the abutments and over the intermediate supports. The total length of the WD-113P object is equal to 48.90 m and the total width is 18.95 m.

**Fig. 1.** Overall view of the bridge. The location of the impact is marked orange.

During the inspection, the failure of the prestressing tendons was not confirmed. As a result of the second accident (01.12.2017) the bottoms of the girders were scratched which did not endanger the safety of the structure. Therefore, it was decided to only analyse the first collision event. The impact point is shown in Fig. 1 and the summary of the damage is given in Fig. 2.

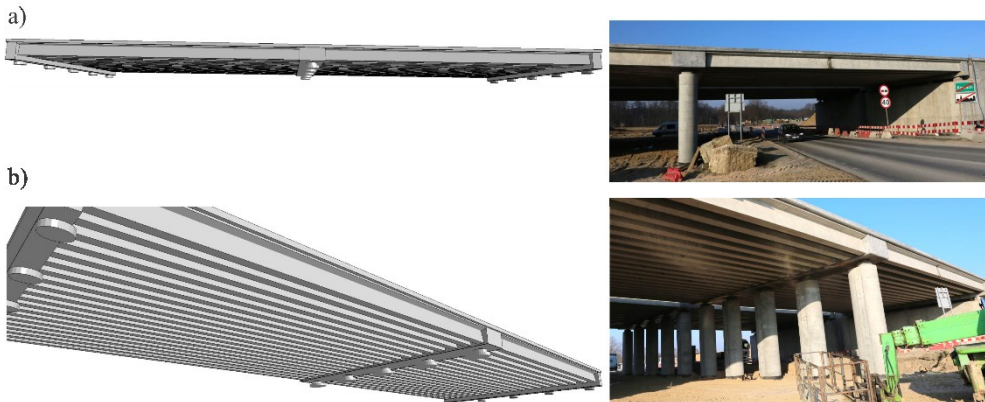
In order to assess the impact condition the computational model of the viaduct based on design documentation [8] was developed. The numerical model of the impact event consists of 1 312 278 nodes and 1 061 836 finite elements. Fig. 3 shows the comparison between the created model and the full-scale WD-113P object.

Fig. 3. The comparison of the computational model and real structure, a) side view, b) bottom view.

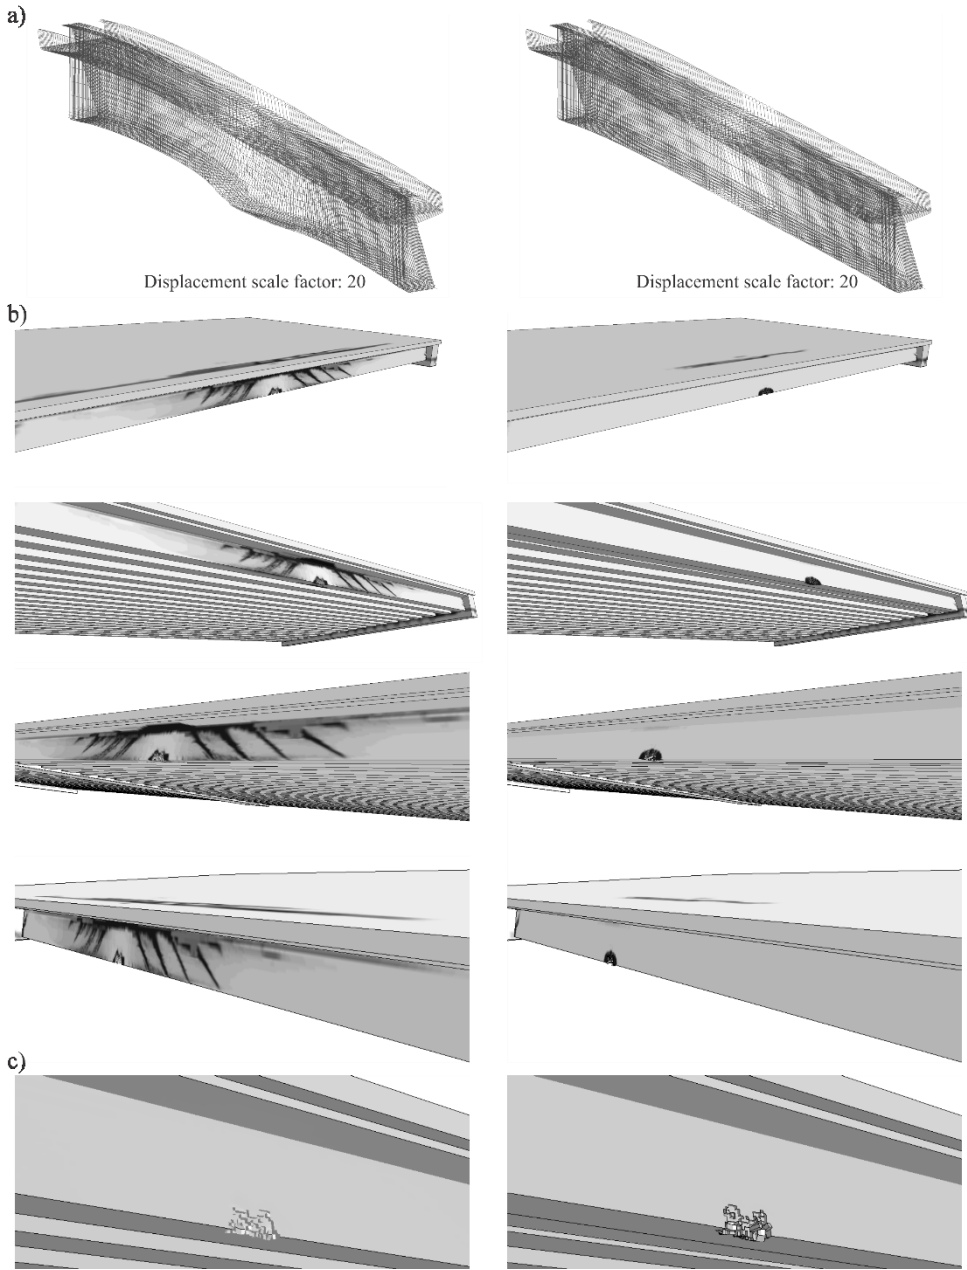
Due to the impact the concrete was damaged and the losses in concrete showed up. The scratches emerged around the impact area as well and an insignificant longitudinal crack appeared under the flange. The longitudinal cracks also showed up on the upper surface of the bridge slab. It should be noted that the aforementioned cracks were much smaller comparing to the situation without the structural strengthening. Moreover, diagonal cracks on both sides of the impact point did not appear. The tendons did not break and the maximum force was 188.3 kN, 6% less than in the case of impact into the non-strengthened structure. The additional beam significantly reduced the displacement of reinforcement and prestressing tendons in the most outer T-beam. The influence of strengthening can be clearly visible in Fig. 8 where results of two numerical simulations are compared.

**Fig. 8.** Comparison of damage of structure with strengthening (right) and without (left), a) displacement of the reinforcement and tendons (note: displacement scale factor is 20), b) cracks, c) losses in concrete.

As a result of constructing the additional beam between the two end girders the stiffness of the structure increases and this allows for significant reduction of potential damage and cracks resulting from the re-impact. Nevertheless, local damage to the concrete and possible scratches under the beam's flange as well as on the upper surface of the bridge slab might arise and shall be repaired.
