Improvement of the load capacity of the road overpass as a result of repairs after breakage caused by vehicle impacts

Mikołaj Miśkiewicz¹, Dawid Bruski^{1}, Jacek Chróścielewski¹ and Krzysztof Wilde¹*

¹Gdańsk University of Technology, Faculty of Civil and Environmental Engineering, Department of Mechanics of Materials and Structures, 11/12 Gabriela Narutowicza Street, 80-233 Gdańsk, Poland

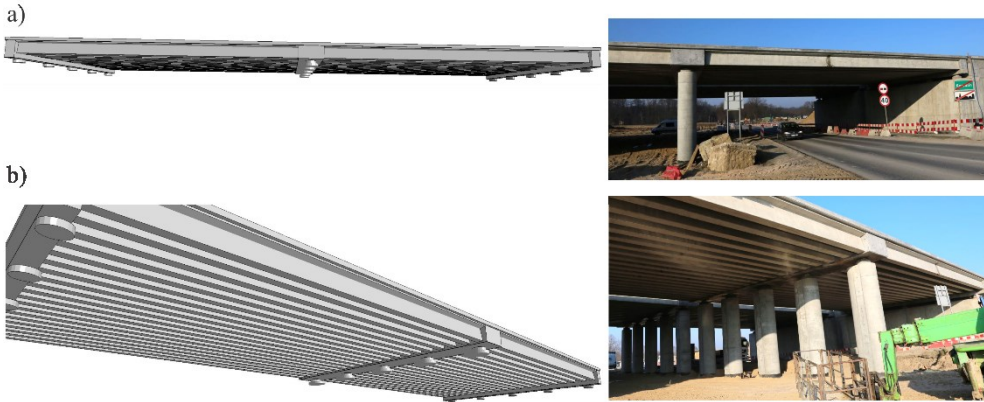
In order to assess the impact condition the computational model of the viaduct based on design documentation [8] was developed. The numerical model of the impact event consists of 1 312 278 nodes and 1 061 836 finite elements. Fig. 3 shows the comparison between the created model and the full-scale WD-113P object.

Fig. 3. The comparison of the computational model and real structure, a) side view, b) bottom view.
