Improvement of the load capacity of the road overpass as a result of repairs after breakage caused by vehicle impacts

Abstract. Damages of spans of the overpass caused by impact of underpassing vehicles are relatively frequent. Objects that use prefabricated load-bearing elements that are not designed for such impacts are particularly exposed. After impact, such structural elements suffer extensive damage that must be repaired. Taking advantages of this recovery actions it is worth to perform strengthening that will protect object against possible future impacts. In this study the influence of the structural strengthening of the damaged overpass on its strength parameters is investigated. For this purpose the advanced computational model was created. The numerical model includes the response of the reinforcement and prestressing tendons. This model enables precise description of damage caused due to the vehicle's impact and further analysis of re-impact of the strengthened structure.

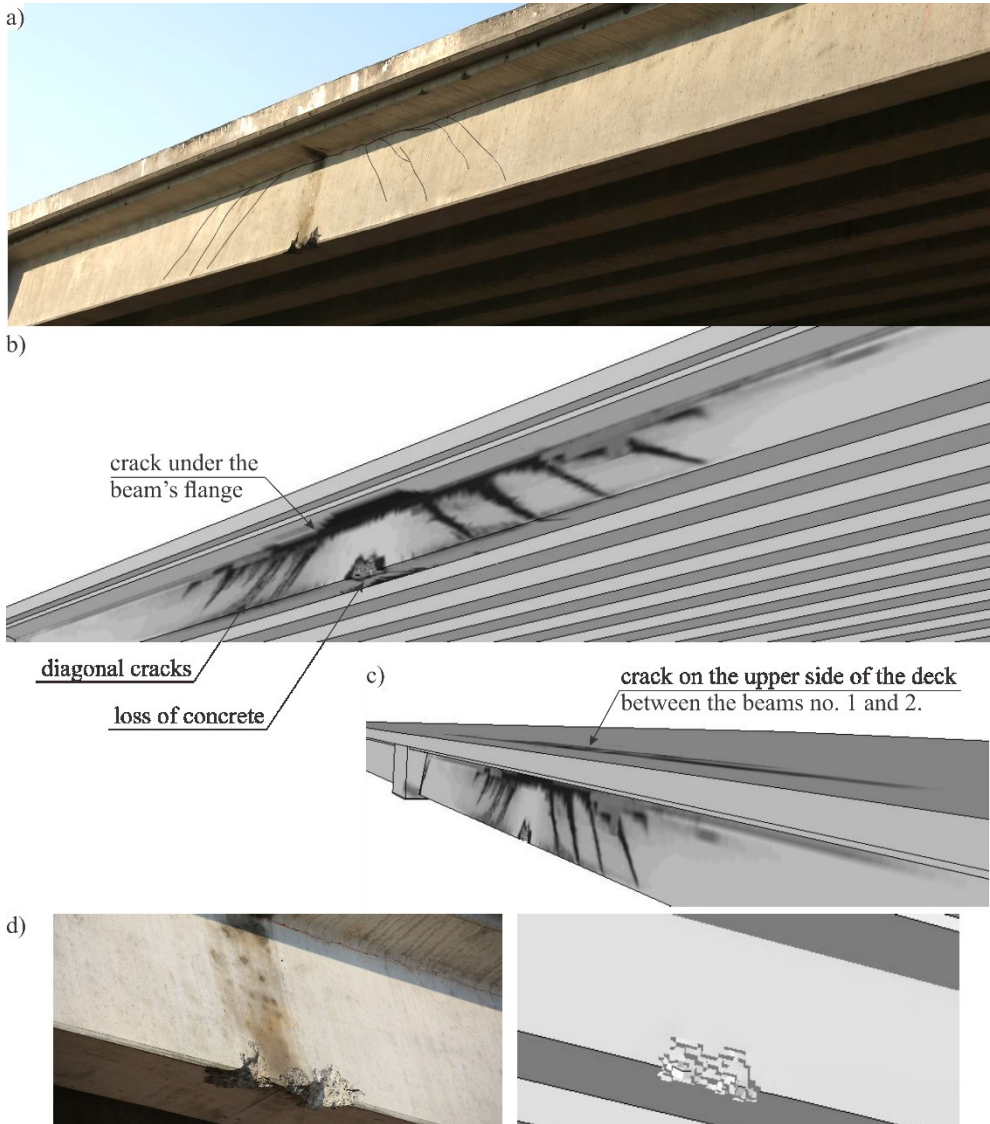
The damage obtained in the numerical simulations corresponds to damage of the real structure. In particular: losses in concrete in the impact location, long horizontal crack under the flange of the t-beam on both sides, diagonal cracks on both sides of the impact point, hairline crack on the upper surface of the bridge's slab placed between the two end girders. The numerical simulations reveal that the prestressing tendons were not destroyed by the impact. The maximum axial force in the tendons is calculated to be 199.6 kN.

Cracking and damage is assumed to be represented by the maximum of brittle and ductile damage form [10]. Fig. 5 shows the comparison of damage of the real structure with the results from numerical simulations. The horizontal and diagonal cracks are marked black in Fig. 5a for the purpose of visibility.

Fig. 5. Damage of concrete, a) reality, b, c) numerical simulation, d) losses in concrete.
