# Travelling Architecture: Vanishing heritage of Gypsy caravans in Poland

**Lucyna Nyka, & Jakub Szczepański**  
Gdańsk University of Technology,  
Faculty of Architecture,  
Poland.

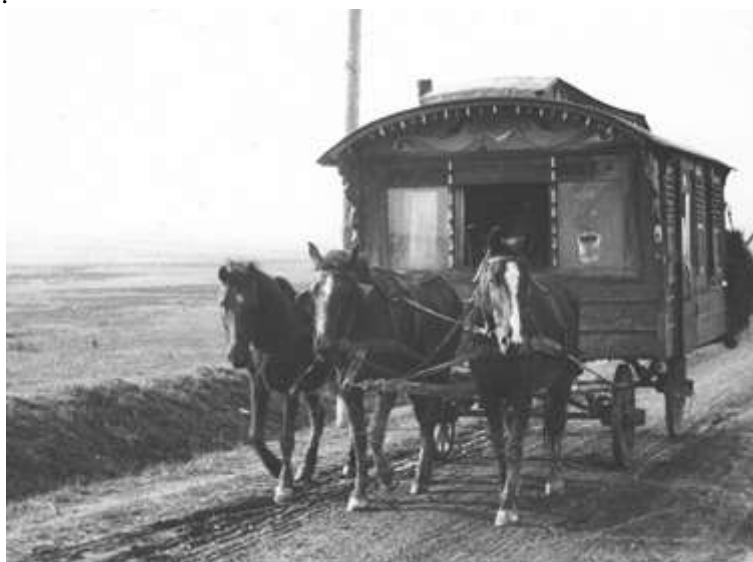
**Fig. 1:** Gypsy wagon dated about 1930

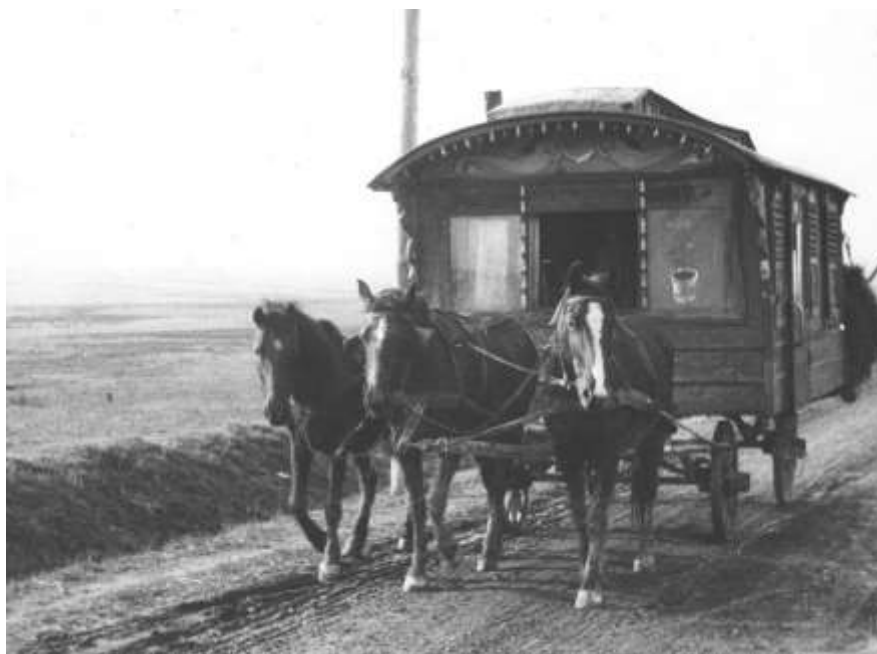
**Fig. 1:** Gypsy wagon dated about 1930

photographs were imported to the AutoCAD programme, which allowed the authors to build 3D models and establish the approximate dimensions and proportions of the photographed wagons and their details. Results confirmed that this method of digital restitution is reliable since the received dimensions were the same as the dimensions of the existing measured wagons; the differences were less than 5%. This allowed for preparing a hypothetical reconstruction drawing for one exemplary non-existent wagon illustrated in the archive photograph from the first decades of the twentieth century (Fig. 1).

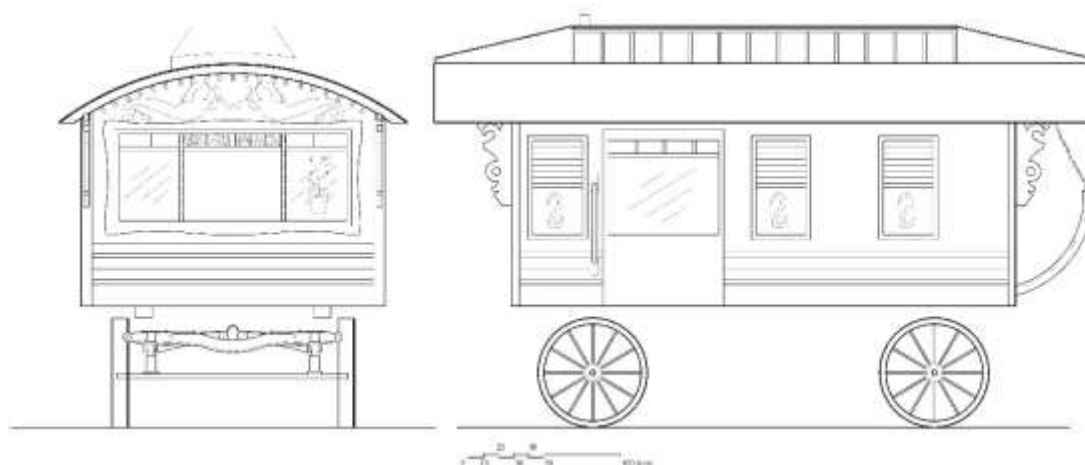
**Fig. 4:** Exemplary reconstruction of the historical Gipsy wagon

The inventory drawings allowed the recognition of architectural components and provided the necessary information in respect of the scale of the wagon, the size of the bottom platform, the track of wheels and the scale of detail. Comparative analysis of the inventory, texts and photographic material offered a key for developing the hypothetical reconstruction drawings of the exemplary historical wagons presented in archive photographs. For this exemplary reconstruction, a wagon dated from the 30s of the twentieth century was chosen (Fig. 4). This reconstructive study indicates that already in the first decades of the twentieth century, Gypsy wagons were fully developed architectural forms with meticulously disposed detail and ornamentation.
