# Non-Destructive Testing of a Sport Tribune under Synchronized Crowd-Induced Excitation Using Vibration Analysis

**Keywords:** non-destructive testing; reinforced concrete grandstand stadium; vibration analysis; crowd-induced excitation; structural tuning

The Swiss Krono Arena motorbike speedway stadium is located in Zielona Góra (Poland). The grandstand was erected in 2009–2010 and its geometry is a circular sector with a center angle of  $150^\circ$  (Figure 2).

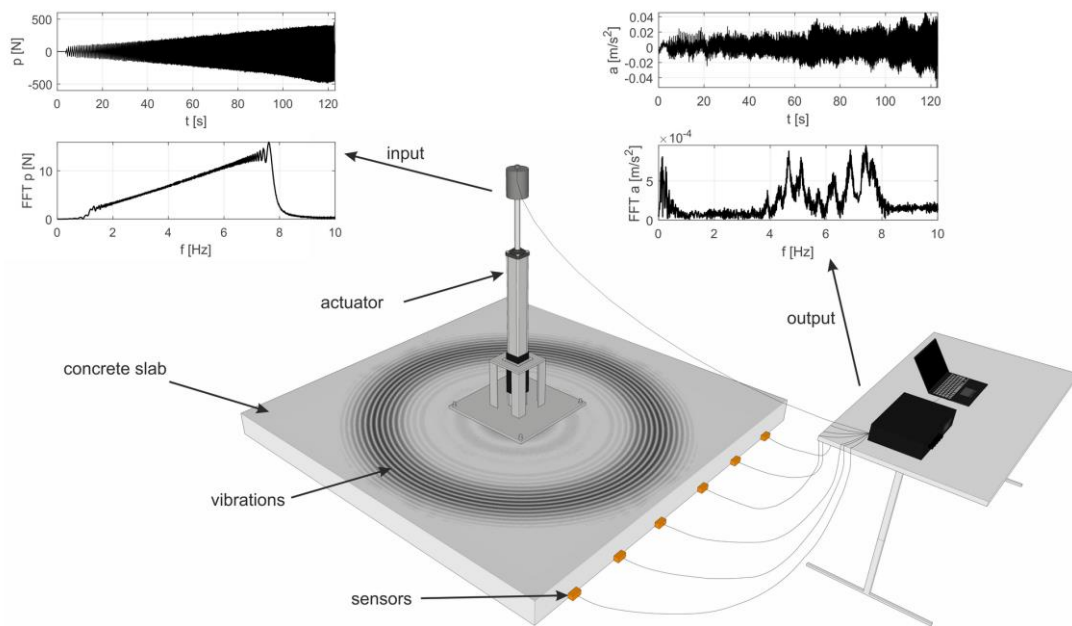
Modal analysis is a method of determining dynamic properties of structures (i.e., natural frequencies, modal shapes and damping coefficients) under vibrational excitation. The analysis involves the registration of vibrational signals and the application of different signal processing techniques. In general, two types of modal analysis can be distinguished: operational modal analysis (OMA) [16–19] and experimental modal analysis (EMA) [20–24]. Environmental excitations (e.g., wind, sea waves, micro-seismic vibrations, traffic loads, etc.) are used in the OMA technique, and only the structure’s response is recorded. In the case of EMA, both excitation and response are measured. The most common approach in EMA is the impulse test, which is based on the excitation of the structure using a modal hammer and the harmonic test, in which electromechanical or piezoelectric actuators are usually applied (Figure 1).

Figure 1. Scheme of the experimental modal analysis technique.

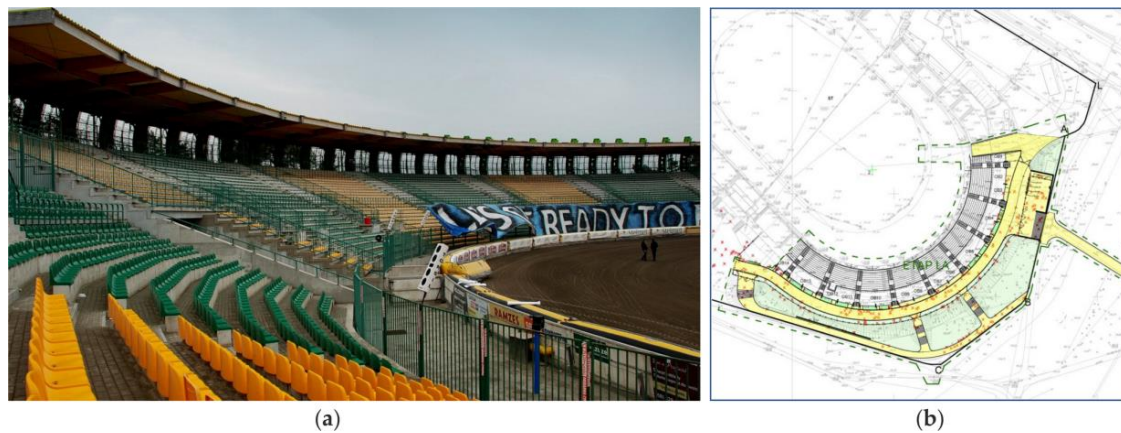
**Figure 2.** Swiss Krono Arena: (a) the view on the grandstand, (b) the location of the grandstand on the land development plan.

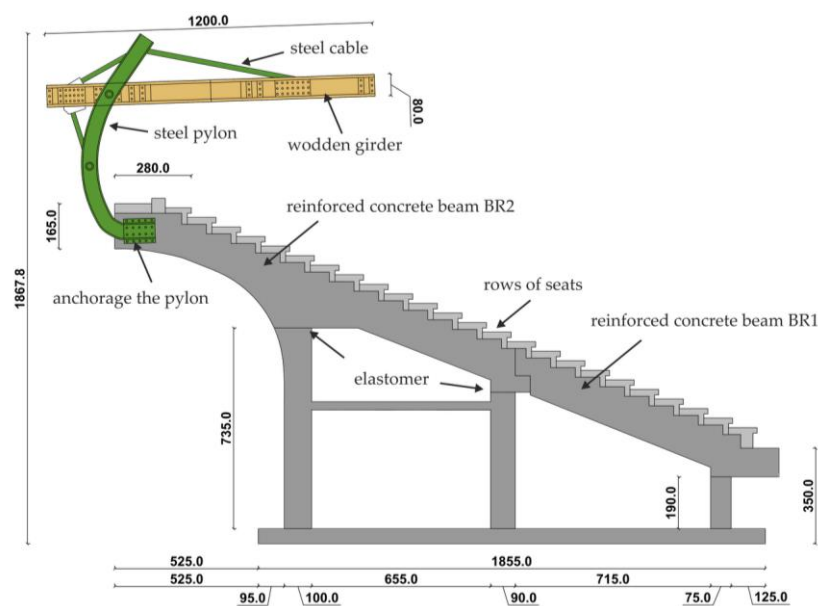
The stand consists of a reinforced concrete structure in which prefabricated under-seat beams rest on the main beams of reinforced concrete girders. The main girder is composed of two parts and it is supported on three reinforced concrete columns. The first part of the main girder (BR1) is an inclined simply supported beam, located in the bottom part of the stand. The second part of the girder (BR2),

with a variable cross-sectional height, also works as a simply supported beam, and it is finished with a cantilever beam located in the upper part of the stand.

Both girders are connected to each other by an articulated joint. The main beams are based on columns via elastomeric pads. Steel anchors prevent horizontal displacement of the main beams against columns. The columns and the monolithic wall supporting the main girder are located on reinforced concrete strip foundations. The walls of additional objects are made of silicate brick, while the stairs structure is made as a prefabricated reinforced concrete element (Figure 3).

**Figure 3.** Cross-section of the stand (dimensions in cm).

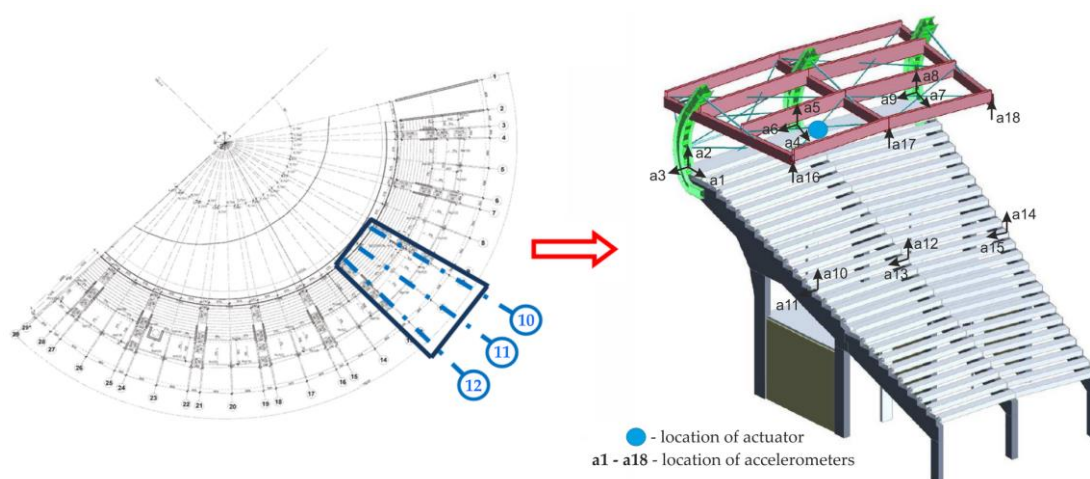
The measurements were conducted on a selected section of the stand, as shown in Figure 4. The experimental program included a sweep sine test and two types of people-induced vibrations, namely single jumps and synchronous Labado dancing.

**Figure 4.** The stand section selected for field tests.

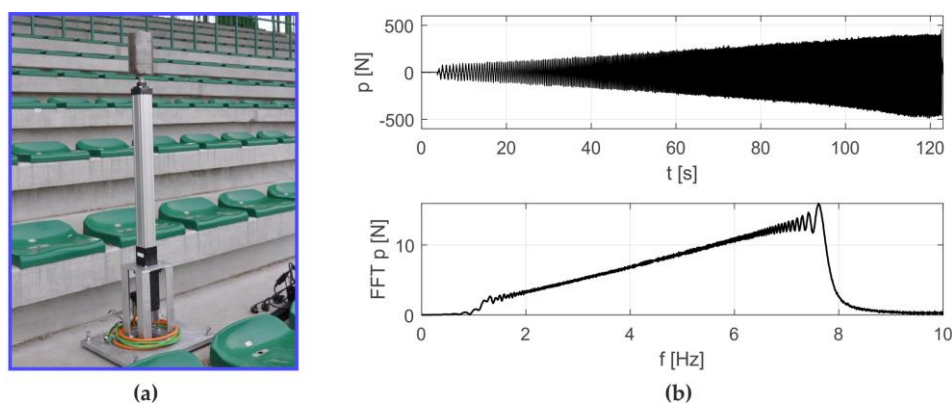
In the first stage, the experimental modal analysis was conducted. The harmonic load was excited by means of the electromechanical actuator shown in Figure 5a. The excitation signal, created by an arbitrary signal generator, was a sweep sine of a smoothly adjustable frequency from 1 Hz to 8 Hz (Figure 5b).

**Figure 5.** Experimental setup: (a) electromechanical actuator, (b) excitation signal in the time and frequency domains.

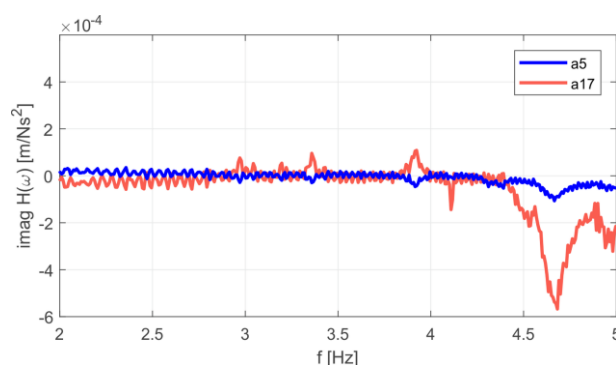
Dynamic parameters were determined based on the frequency response functions, according to procedure described in Section 2. The imaginary parts of the FRFs for signals registered on the girder and on the roof are given in Figure 6. Several peaks can be distinguished. The experiment allowed the identification of three natural frequencies in the range from 2 to 5 Hz (Figure 6). Their

values were: 3.36 Hz, 3.92 Hz and 4.68 Hz. Experimentally determined mode shapes are presented in Figure 7. The directions and values of displacements for particular degrees of freedom are shown by means of vectors and numerical values. The shapes of modes of the girder and roof are similar, wherein the amplitude for the roof is much larger. The dominant vibration types for each identified form are vertical mode shapes. The main displacements of the girder and roof occurred as a result of vertical motion.

**Figure 6.** Imaginary parts of the frequency response function (FRF) for acceleration signals a5 (girder) and a17 (roof).

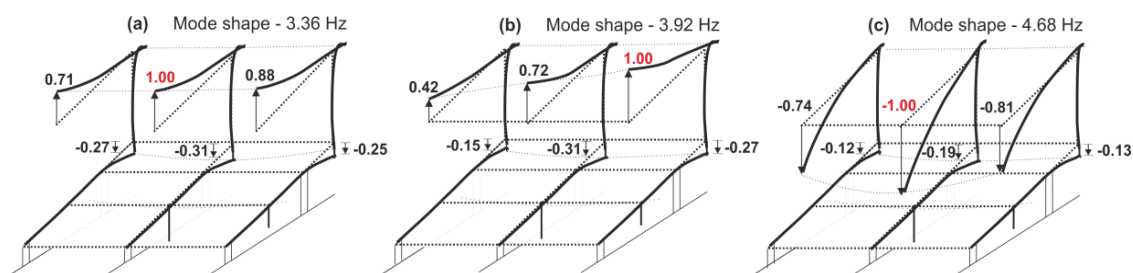
**Figure 7.** Identified mode shapes and natural vibrations: (a) 3.36 Hz, (b) 3.92 Hz, (c) 4.68 Hz.

- (1) The key natural vibration frequency of 4.68 Hz coincided with the frequency of the higher harmonics of the excitation force (approximately 4.4 Hz).

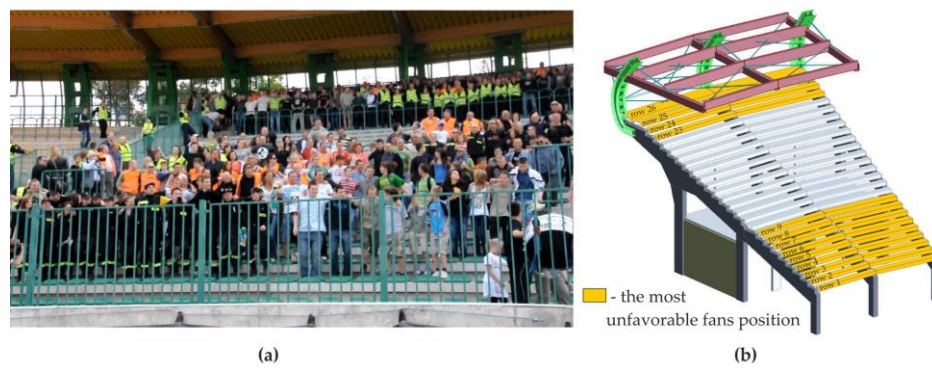
During the research, one of the most important tasks was to find the most unfavorable load combination. Different combinations of fans' arrangement on stadium stand rows were tested. One of the most unfavorable combinations, resulting in the greatest vibrations of the cantilever part of the stand, was selected for the purpose of the tests. Figure 8 presents the most unfavorable setting in which the dancing fans are located at the bottom of the stand (beam BR1) and on the upper part of the stand (four rows at the cantilever part of beam BR2).

**Figure 8.** Dynamic tests with fans: (a) experimental setup, (b) scheme showing the arrangement of people during tests (orange color—rows indicating the most unfavorable fan positions).

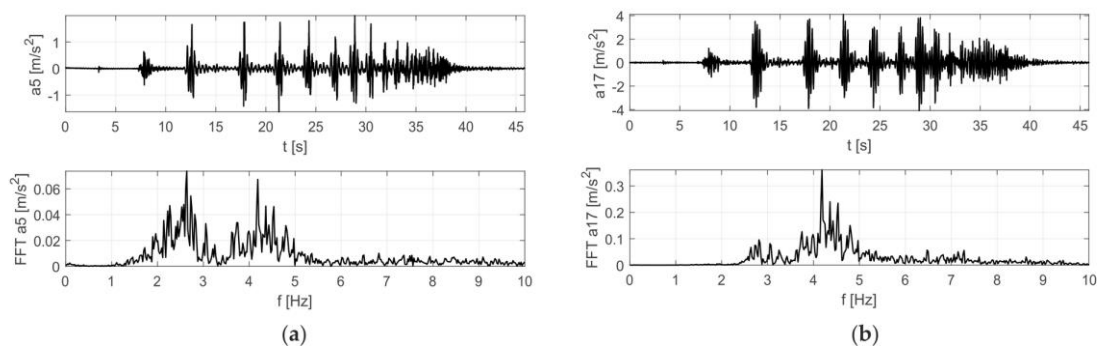
The results of the in situ tests are shown in Figures 9 and 10 for the Scotland-type jumps and the Labado dance, respectively. In the case of the Scotland-type jumps, many jump events are visible, with decreasing time between individual jumps. In the Fourier transformation results, two wide peaks are visible, the first around 2.5 Hz and the second around 4.5 Hz. The Labado dance, in which jumps were more regular, resulted in narrower peaks concentrated at 2.2 and 4.4 Hz.

**Figure 9.** Accelerations registered during dynamic tests with fans (Scotland-type jumps) at: (a) girder, (b) roof.

Based on the obtained results, it was found that the frequency of vibrations of the end of the cantilever girder was equal to 2.2 Hz, coinciding with the frequency of the exciting force, which was caused by jumping supporters. The end of the roof structure vibrated at 4.4 Hz, which means that the roof vibrated twice as fast as the end of the girder.

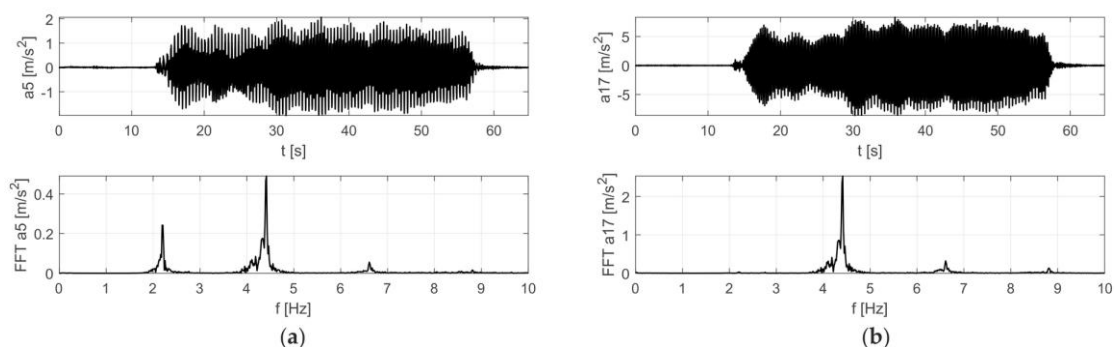
**Figure 10.** Accelerations registered during dynamic tests with fans (Labado dance) at: (a) girder, (b) roof.

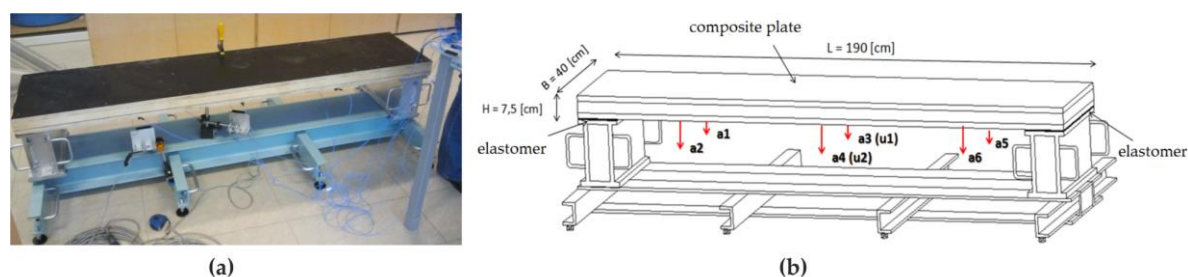
Experimental tests were conducted in the laboratory of the Gdańsk University of Technology in order to identify the jump load function. The test object was a composite plate with dimensions of 190 cm  $\times$  7.5 cm  $\times$  40 cm (Figure 11a). The plate was made of two sheets of poplar plywood of a thickness of 2 cm. Between them, C 20 class wood with a 3.5 cm thickness was inserted. Material parameters adopted for testing were: bending strength 20 MPa, stretching along fibers 12 MPa, compression along fibers 19 MPa, modulus of elasticity along fibers 10 GPa, average density 330 kg/m<sup>3</sup>. The plate was placed on supports using elastomer pads with dimensions of 7 cm  $\times$  40 cm  $\times$  0.5 cm.

**Figure 11.** Experimental setup: (a) general view, (b) geometry of the tested plate and the location of points for measurement of accelerations (a1 to a5) and displacements (u1, u2).

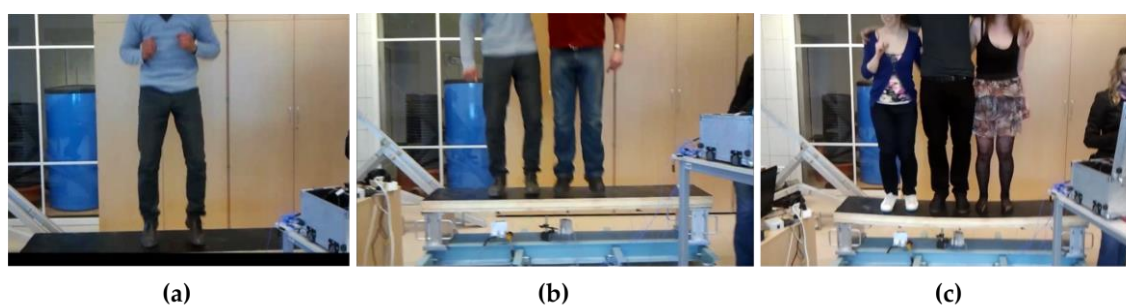
The plate was subjected to dynamic tests. The acceleration measurements (a1 to a6) were performed at six points by means of the PCB accelerometers model 356A16, while displacement measurements were taken at two points (u1 to u2) by means of optoNCDT 1302 laser sensors, as shown in Figure 11b. The LMS SCADAS vibration measurement system was used to record the time histories. The research agenda included measurements of free vibrations as well as measurements of forced vibrations in the form of synchronized jumps performed by one, two and three people (Figure 12).

**Figure 12.** Implementation of excited vibrations in the form of rhythmical jumps of (a) one person, (b) two people, (c) three people.

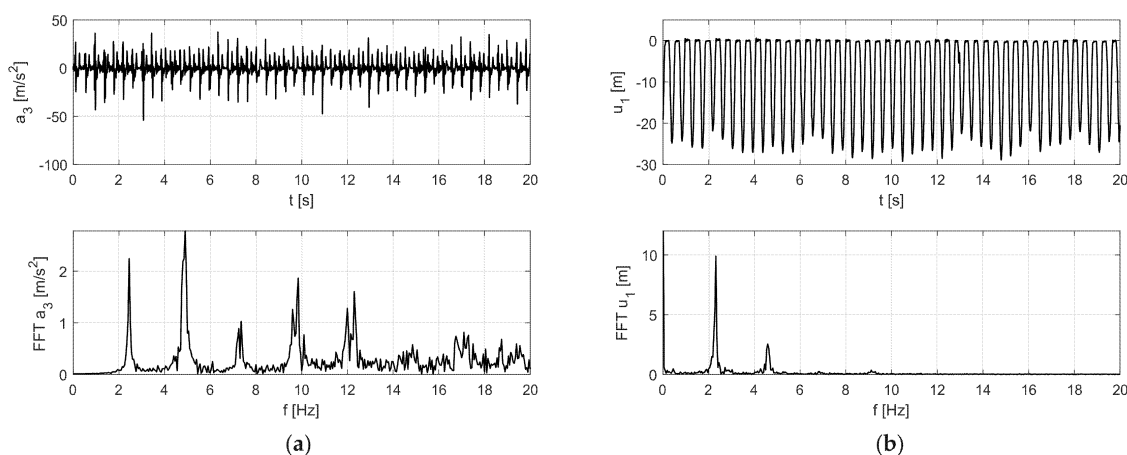
The first natural frequency of the plate was identified using a typical impact test. Its value was 26 Hz. Figure 13 present the results of vibrations in the form of accelerations and displacements recorded during the jumps of three people. Apart from the jump frequency, further components of harmonically excited vibrations are visible in the Fourier transform diagrams. Eight harmonic components are visible on the Fourier transforms diagrams on acceleration, while the Fourier transforms of displacement signals show four harmonic components.

**Figure 13.** Results of vibrations in the form of (a) accelerations and (b) displacements recorded during the jumps of three people.

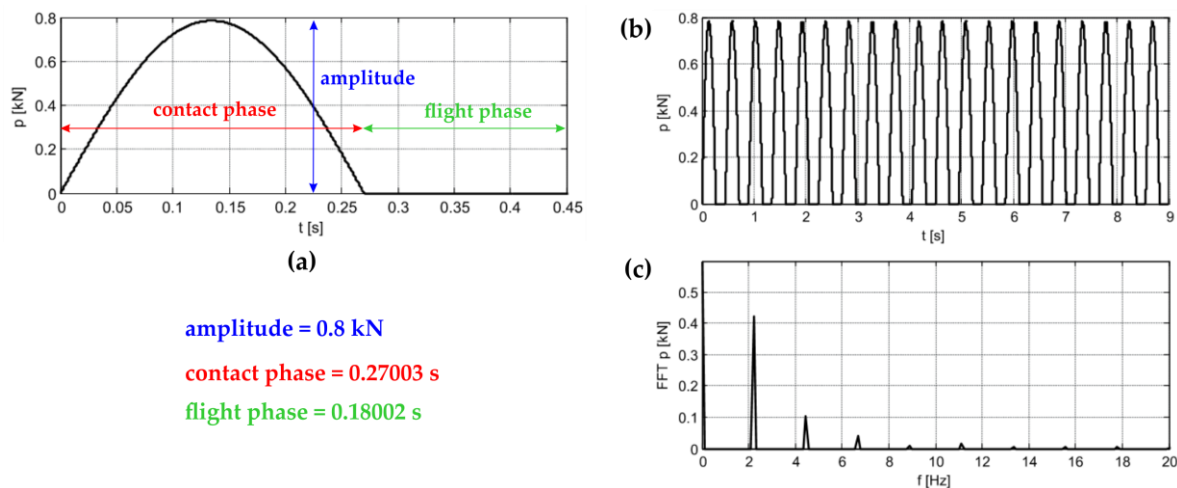
The dynamic impact function during the jumping was described by means of an impulse shaped in half of the sinus function period form. The loading cycle for the Labado dance includes the flight phase and the contact phase. On the basis of the measurement results, the duration of the periodic force full period was identified as 0.45005 s, which is composed of: the phase of load contact with the plate equal to 0.27003 s and the flight phase equal to 0.18002 s. The shape of a single dance cycle is shown in Figure 14a. The in situ tests indicated the jump frequency to be 2.2 Hz. The amplitude of the load function was determined as the average value of the weight of fans participating in the experiment, and was equal to approximately 0.78 kN.

**Figure 14.** Labado function: (a) one jump, (b) 20 jumps, (c) Fourier transformation of the Labado function.

Figure 14b,c shows excitation over time during 20 rhythmic jumps and the corresponding Fourier transform. The Fourier transform graph proves that, in addition to the 2.2 Hz jump frequency, further harmonics are present in the spectrum. The occurrence of higher harmonics is characteristic of this periodic signal. Higher harmonic components are also present on transforms from the experimental data.

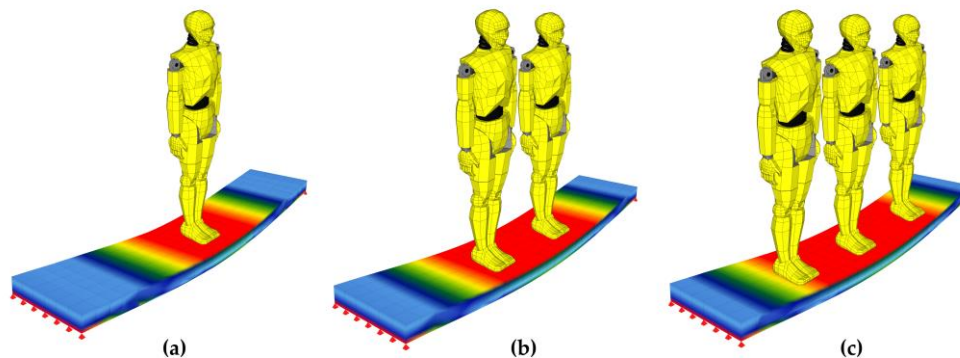
In order to validate the laboratory tests results, numerical simulations for the composite plate were performed. The calculated plate length was set as 183 cm. It was assumed that the plate works in a simply supported scheme. In the discretization process, the slab was divided into 504 solid elements in

accordance with the results obtained during the convergence division analysis. Numerical calculations were performed for excitation caused by one, two and three people (Figure 15).

**Figure 15.** Numerical simulations of the implementation of excited vibrations in the form of rhythmic jumps performed by: (a) one person, (b) two people, (c) three people.

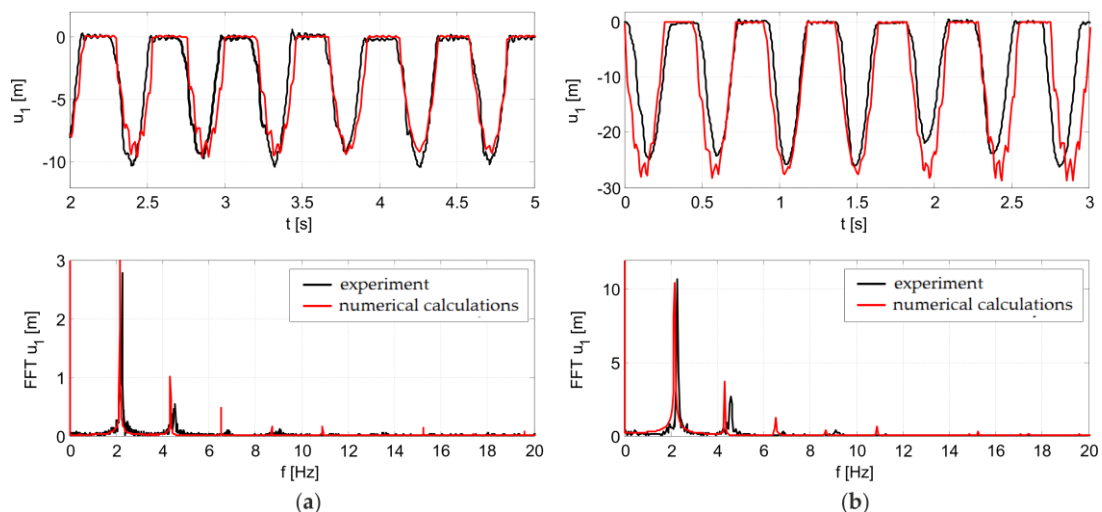
Figure 16 presents a comparison of the numerical and experimental results in the form of displacement in time, registered at the middle of the span, and their Fourier transforms for the cases of one and three people jumping. In the flight phase, plate vibrations occurred at a frequency of 26 Hz for both the experimental and numerical results. Slight phase shifts between the experimental and numerical graphs can be observed. The reason for the shifts lies in the fact that the real jumps were not perfectly repetitive. A very good experiment consistency of the numerical simulations was obtained, which proves the correctness of the assumed load model for the Labado dance. The excitation frequency was approximately 2.2 Hz during both the experimental and numerical tests. Later in the article, the obtained Labado dance load model is used to simulate vibrations and structure tuning of the stand at the Swiss Krono Arena speedway stadium.

**Figure 16.** Numerical model validation results for jumps performed by: (a) one person, (b) three people.

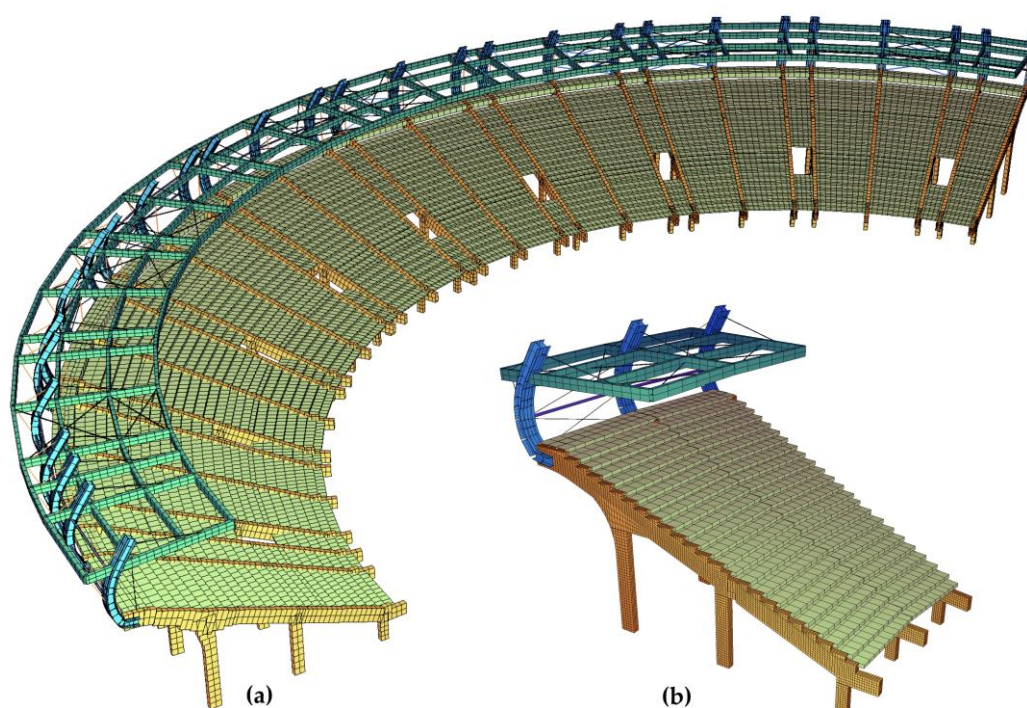
The creation of the 3-D FEM model of the stand at the Swiss Krono Arena stadium was implemented in two stages with the use of the commercial FEM software SOFiSTiK (SOFiSTiK AG, Oberschleißheim, Germany). In the first stage, models of the main structural parts of the stand were performed using solid elements (Figure 17b), while in the second stage they were performed with the use of beam elements (Figure 17a). The construction of beam models was verified based on the results of numerical

analyses carried out on solid models, due to which a very high consistency was obtained between the results of the static and dynamic tests. The FEM calculation model of the entire prefabricated 3-D stadium contains approximately 3008 beam elements and 2001 nodes, in accordance with the results collected during the convergence analysis. Substitute cross-sections were applied in the beam model, in which the cross-section of concrete and steel was replaced with a representative cross-section of a homogeneous material. The under-seat beams of the stand were modeled as beam elements. The columns were articulately connected with the girders, and an articulated joint can also be found at the connection of the two main girders. Glued laminated timber girders were modeled as beam elements, and steel bracings and bar elements model the truss elements. In models that consider various stand strengthening methods, the tensile elements are modeled using tensile elements (cable) taking into account the prestressing force. Non-structural elements of significant weight (e.g., non-structural steel columns) were modeled as concentrated masses applied at the place of mounting. The material parameters taken for the purpose of the numerical analysis were adopted in accordance with the construction and structural design.

**Figure 17.** (a) Numerical model of the stadium, (b) numerical model of a single section of the stand.

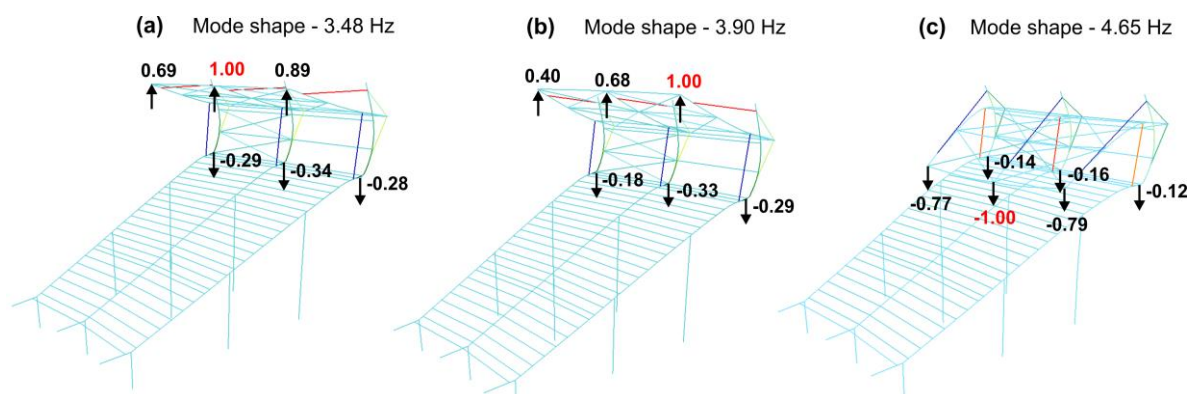
The eigenvalues were calculated at the beginning. Thirty eigenvalues of the system were calculated. The total mass contributions in the dynamic response were more than 90% in directions: X (longitudinal), Y (transverse) and Z (vertical), which complied with the standard recommendations. The first three eigenvalues and their corresponding natural vibration frequencies determined on the basis of modal analysis are presented below (Figure 18).

**Figure 18.** Mode shapes and frequencies of natural vibrations of a single stand section obtained from numerical simulations: (a) 3.48 Hz, (b) 3.90 Hz, (c) 4.65 Hz.

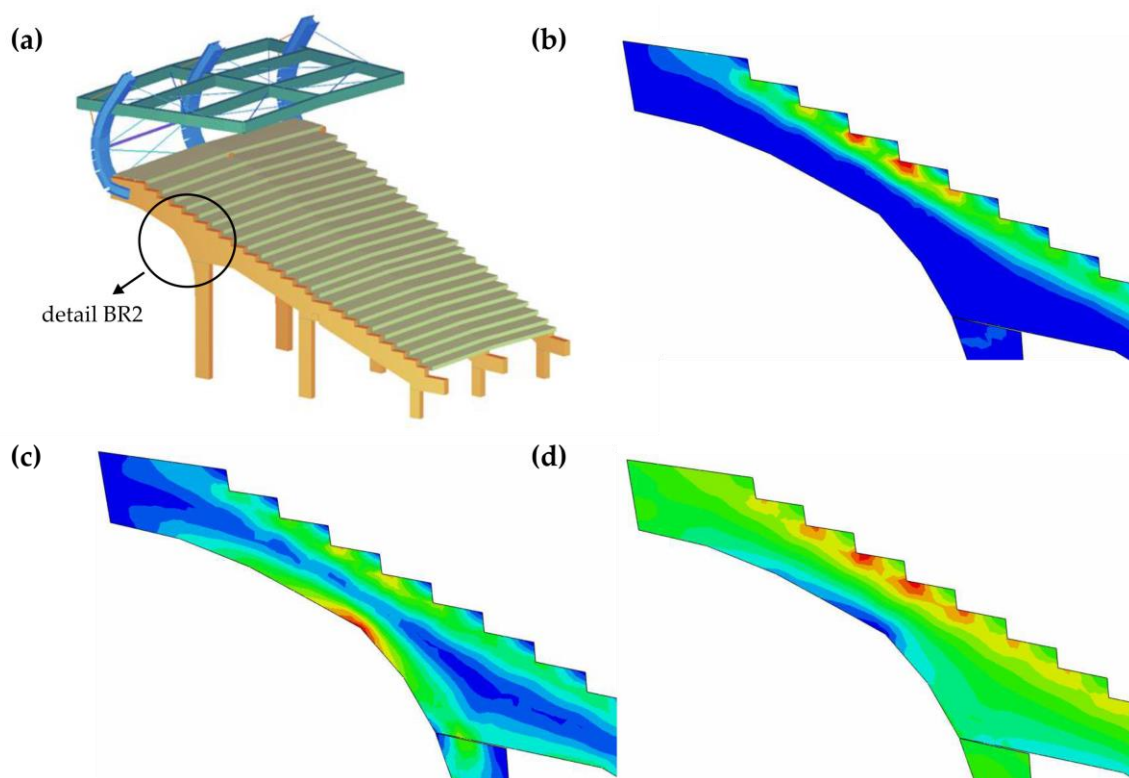
Figure 19 shows the stresses in the BR2 girder. Figure 19b shows equivalent von Mises stresses, Figure 19c presents the main tensile stresses and Figure 19d demonstrates the normal horizontal stresses in the girder plane (in the global coordinate system). The main tensile stress in the upper part of the BR2 beam was greater than the concrete tensile strength, i.e.,  $\sigma_1 = 8 \text{ MPa} > \sigma_{cr} = f_{ctm} = 3.2 \text{ MPa}$ , which means that the reinforced concrete section becomes scratched.

**Figure 19.** (a) Placement of the highest stress concentrations in the main girder of the stadium stand. (b) von Mises map of stresses in the BR2-reinforced concrete girder area (red color—maximum stress equal to 10 MPa). (c) Map of the main tensile stresses within the BR2-reinforced concrete girder (red color—maximum tensile stress equal to 8 MPa). (d) Map of the horizontal normal stress  $s_{11}$  within the BR2-reinforced concrete girder (red color—maximum tensile stress equal to 8 MPa, blue color—maximum compressive stress equal to 8 MPa).

The decrease in the stiffness of the scratched girder was equal to about 50%. The decrease of the stiffness of the reinforced concrete section after scratching was determined on the basis of the obtained

- (2) The reinforced concrete cross-section of the BR2 main girder was scratched. The calculated decrease in the stiffness after scratching was equal to about 50%. The inclusion of scratches reduced the calculated initial natural vibration frequencies of the structure by 5%–10% in comparison with the unscratched cross-section.

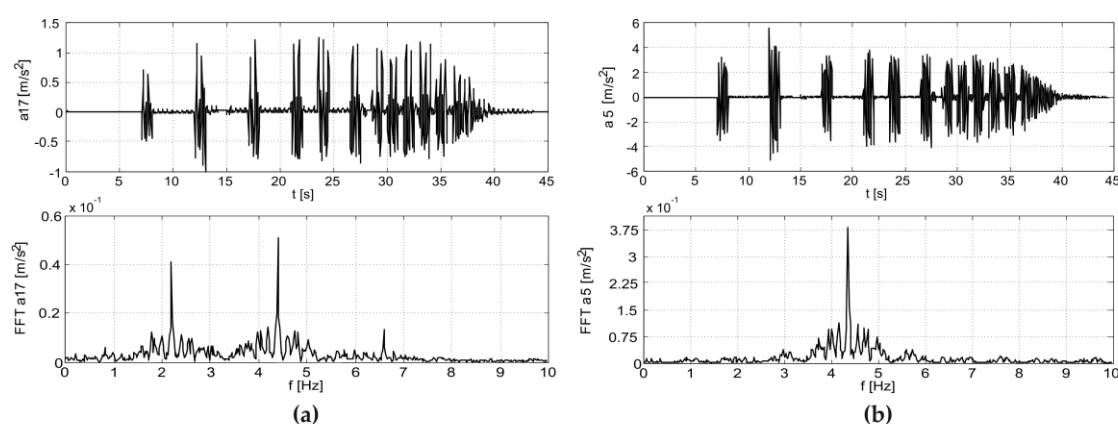
In the further stage of the numerical analysis, the stadium structure was loaded with jumping fans. Each of the fans was replaced by a single concentrated force with a load value of 0.8 kN, as this load corresponded to the average human weight. A jump function determined during experimental research was assigned to every concentrated force. The duration time was equal to 40 s. The forces were set in the most unfavorable load combination, i.e., at the bottom of the stand (chairs on the whole BR1 beam width) and on the upper part of the stand (four rows above the cantilever section). Simulations of stand vibrations for the excitation form of non-synchronized Scotland-type jumps were carried out at the beginning (Figure 20). Afterwards, an analysis for the form of the synchronized Labado dance was performed (Figure 21).

**Figure 20.** Results of numerical simulations from the excitation of vibrations by jumping fans (Scotland-type jumps): (a) girder, (b) roof.

On the basis of the results obtained during non-destructive tests and numerical simulations, it was concluded that as a result of dynamic interactions, the phenomenon of higher harmonic resonance occurred on the stand and the roof structure. The vibrations frequency at the end of the roof was equal to approximately 4.7 Hz, which coincides with the second harmonic of the excitation force, i.e., 4.4 Hz, caused by jumping fans. The form and dynamic characteristics of the Labado dance can be considered as vandalism. A large number of jumping fans with their synchronized movements drives the tribune structure's vibrations, and their regular dance could cause the collapse of the entire object. The results of non-destructive tests and numerical simulations showed a significant excess of the serviceability limit state.

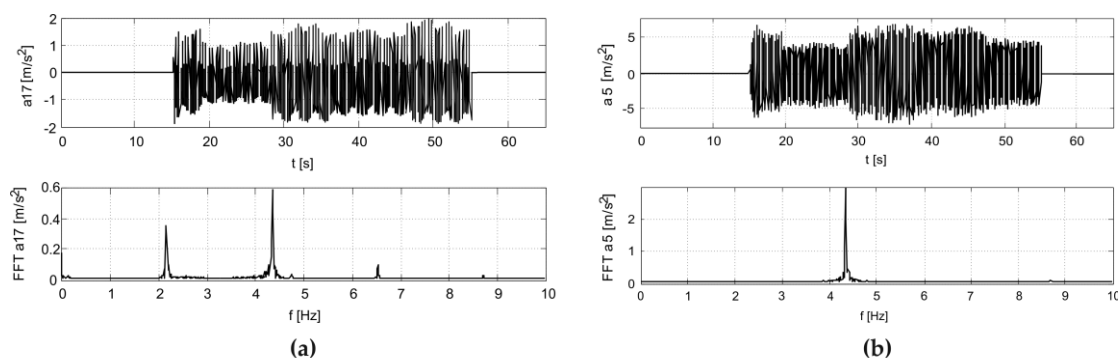
**Figure 21.** Results of numerical simulations from the excited vibrations caused by jumping fans (Labado dance): (a) girder, (b) roof.

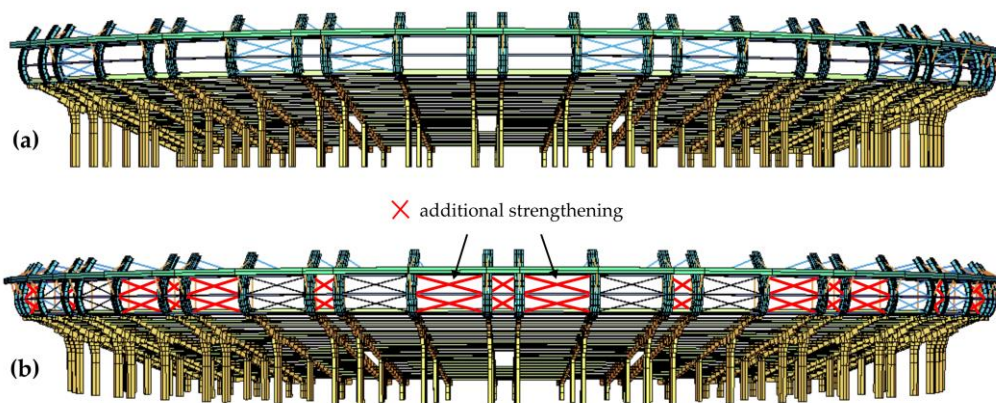
Figure 22. Additional wall bracings (a) before structural tuning, (b) after structural tuning.

An original method of stand structural tuning was proposed in response to the excess of the serviceability limit state. This method assumed the implementation of wall bracings stiffening the steel roofing columns, as well as roof bracings on the wooden roof structure (Figures 22 and 23). The main goal of the concept of bracing of all columns and roof girders was to significantly limit the free end of the wooden roof vibration amplitudes, and hence reduce the concrete cantilever displacements. The bracing cross-sections were the same as those of the bracings already installed in the stand structure. The bracings were made from Macalloy bar rods with a yield point of 520 MPa and tensile strength of 690 MPa.

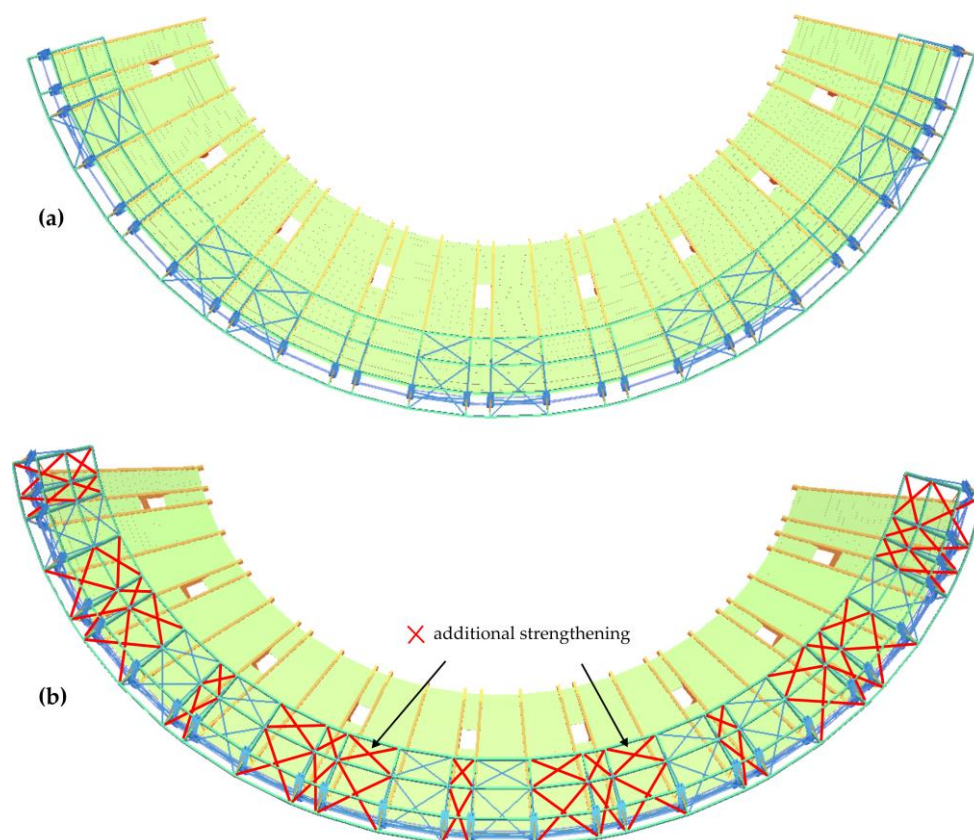
Figure 23. Additional roof bracings (a) before structural tuning, (b) after structural tuning.

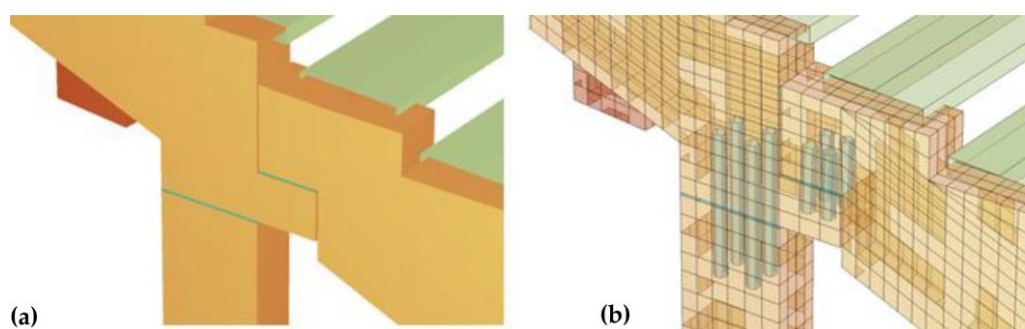
The stand FEM model with additional roof bracings and vertical bracings was implemented in SOFiSTiK software. The beam stand model was made on the basis of the object design documentation (Figure 24). The basic model parameters were determined on the basis of detailed models with the use of solid elements, in which the location of reinforcement bars and details of beams support, such as elastomer pads and anchors, were taken into account. The models include the scratching of concrete elements by reducing the value of the concrete modulus of elasticity. The FEM model parameters were updated on the basis of the obtained measurement data.

**Figure 24.** Detailed view of the stand's load-bearing beams: (a) support, (b) connection.

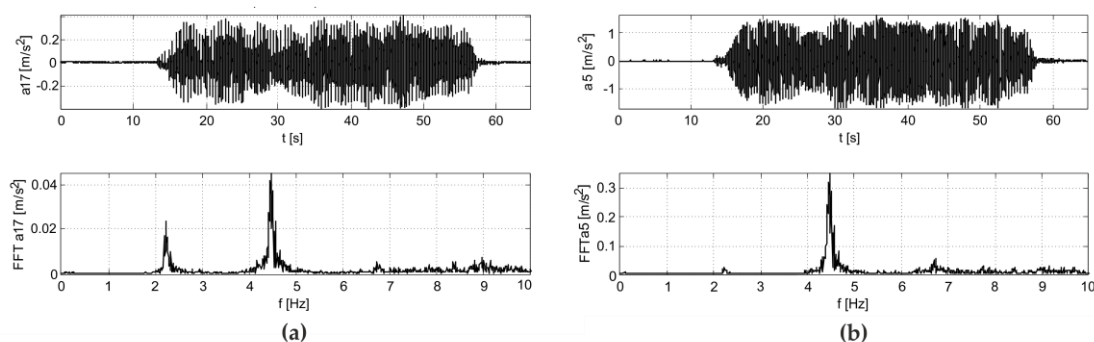
Figure 25 presents the numerical results obtained during the calculations for the load induced by excitation fans, for the purposes of post-strengthening the stadium structure. The exemplary first form of natural vibration frequencies determined numerically is shown in Figure 26. The dynamic analysis proved that in the range of 2.9 Hz to 5 Hz, there are at least 15 natural vibration frequencies. Such a large number of natural vibration frequencies is ordinary for a spatial structure made of repetitive elements. The strengthening target was to improve the spatial structure performance and reduce natural vibration frequencies within the range of 4.3–4.7 Hz, in order to eliminate the phenomenon of the beat and characteristic of the excitation of two very close natural vibration frequencies.

**Figure 25.** The results of numerical simulations after stand structural tuning from vibrational excitation by the jumping supporters: (a) girder, (b) roof.

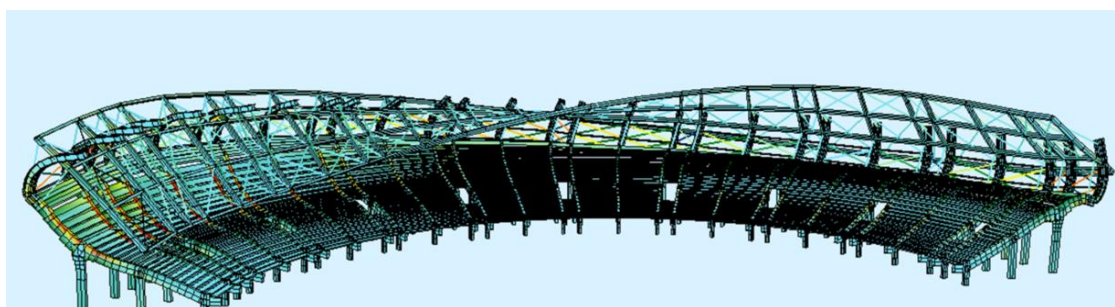
**Figure 26.** The first numerical form of natural vibrations of the stand after structural tuning.

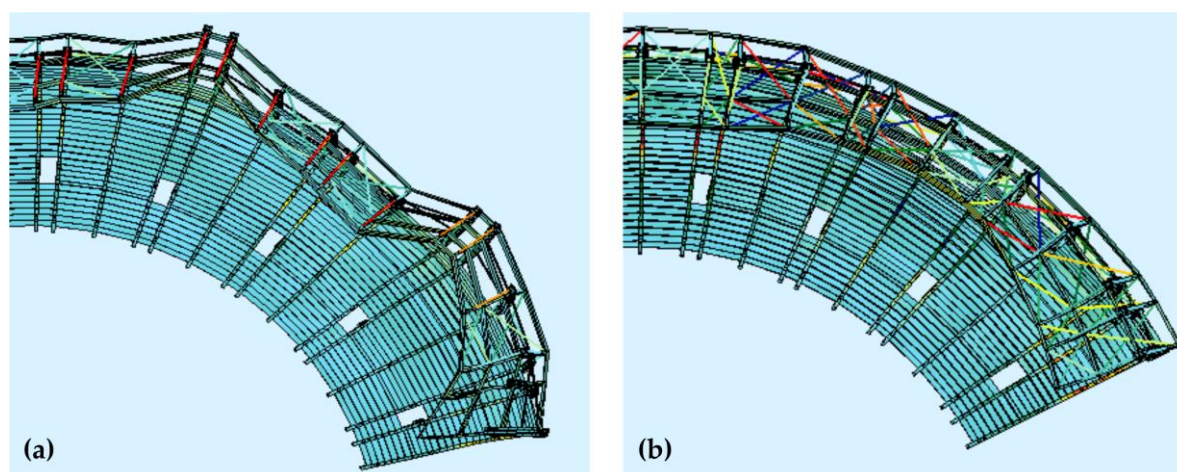
Figure 27 shows the visualization of vibrations induced by synchronized dancing of the crowd in the stands, located in rows 22–25 throughout the stadium. The applied dynamic load was a periodic function consisting of a contact phase (sinusoidal impulse) and a flight phase (no load). The load function of a jumping crowd is typically not included in standard regulations. The integration of motion equations was carried out using the Newmark–Wilson method. Figure 27a shows a plane view of the relations of the object degrees of freedom vibration amplitudes in the case when the roof and vertical bracings were fixed in accordance with the design, i.e., every two fields. Figure 27b presents the nature of vibrations for bracings installed in each roofing field. The bracings installation resulted in the roof structure stiffening and in the change of its vibrational spatial character. The calculated amplitude of vibrations from the fans' synchronized dance on the whole structure in rows 22–25 was equal to 3.6 mm at the end of the concrete cantilever, and 5 mm at the free end of the roof. The strengthening method caused a slight reduction in the vibrations of the concrete cantilevers and a significant reduction in the vibration amplitudes of the free end of the roof. A requirement for the correct bracing performance during vibrations was the presence of an initially prestressing force. However, the reduction of concrete cantilevers vibration amplitudes was problematic, because they took over the main part of the dynamic forces generated by fans dancing directly on them.

**Figure 27.** Top view of the stand's roof loaded with synchronous jumps of people showing the vibration amplitudes (a) before structural tuning, (b) after structural tuning.

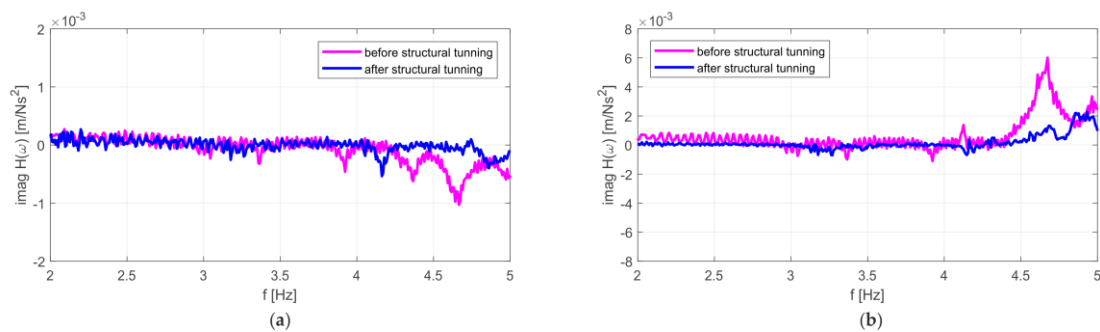
Repeated in situ tests were carried out in order to verify the correctness of the original concept of stadium stand tuning. The results of measurements made after structural tuning are shown in Figures 28 and 29. It can be seen that that frequencies identified during crowd-induced vibrations are similar to the measurements before tuning (see Figures 9 and 10), because the same nature of the jumping load. It is important, however, that the natural frequencies of the structure were shifted after structural tuning (see Figure 28), decreasing resonance significantly. The individual resonance zones moved towards the higher frequencies.

**Figure 28.** Experimental transition functions for the end of the concrete cantilever (a) before and (b) after stand structural tuning.

- (5) The proposed original concept of stadium structural tuning significantly reduced the amplitude of the stand structure vibrations. Individual resonance zones were moved towards higher frequencies after tuning, which allowed for safe use of the stadium.

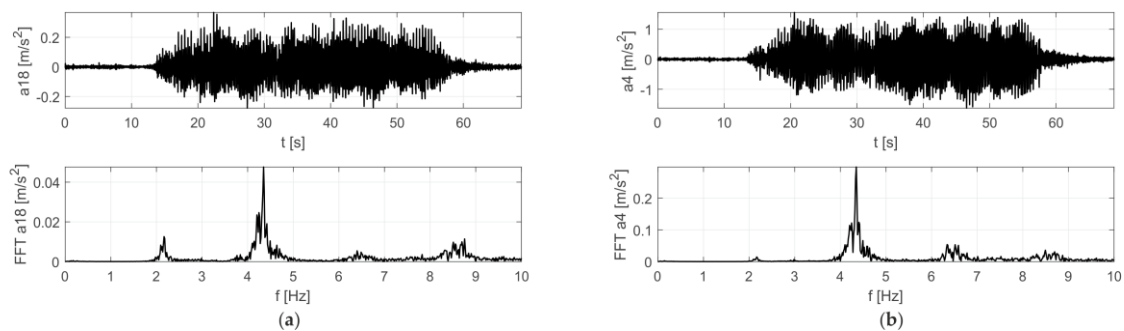
**Figure 29.** Results of in situ tests after the stand structural tuning from vibration excitation with the jumping supporters: (a) girder, (b) roof.
