Non-Destructive Testing of a Sport Tribune under Synchronized Crowd-Induced Excitation Using Vibration Analysis

Abstract: This paper presents the concept of repairing the stand of a motorbike speedway stadium. The synchronized dancing of fans cheering during a meeting brought the stand into excessive resonance. The main goal of this research was to propose a method for the structural tuning of stadium stands. Non-destructive testing by vibration methods was conducted on a selected stand segment, the structure of which recurred on the remaining stadium segments. Through experiments, we determined the vibration forms throughout the stand, taking into account the dynamic impact of fans. Numerical analyses were performed on the 3-D finite element method (FEM) stadium model to identify the dynamic jump load function. The results obtained on the basis of sensitivity tests using the finite element method allowed the tuning of the stadium structure to successfully meet the requirements of the serviceability limit state.

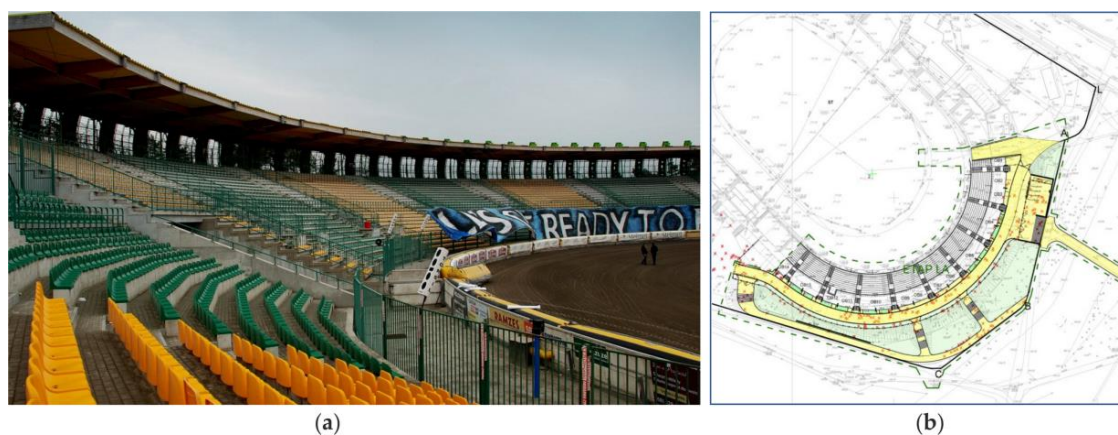
Figure 2. Swiss Krono Arena: (a) the view on the grandstand, (b) the location of the grandstand on the land development plan.

The Swiss Krono Arena motorbike speedway stadium is located in Zielona Góra (Poland). The grandstand was erected in 2009–2010 and its geometry is a circular sector with a center angle of 150° (Figure 2).

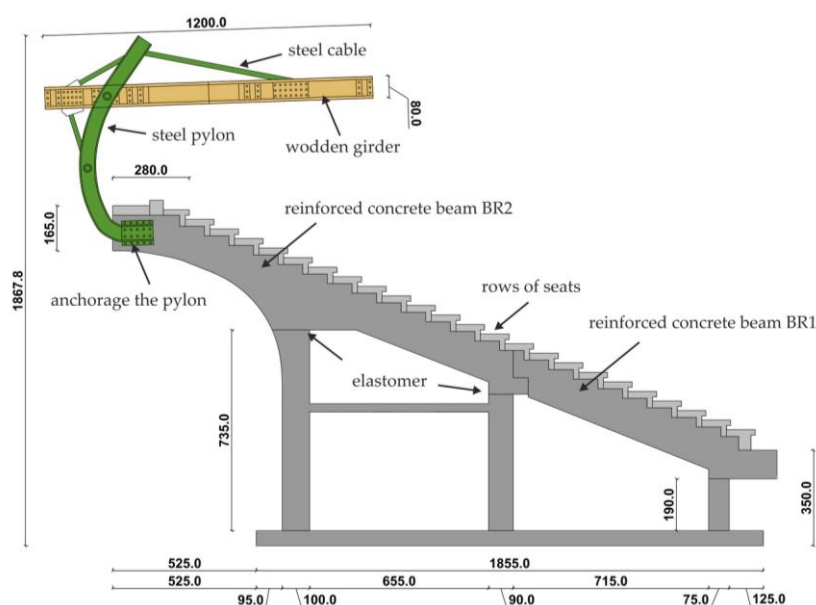
Figure 3. Cross-section of the stand (dimensions in cm).

Both girders are connected to each other by an articulated joint. The main beams are based on columns via elastomeric pads. Steel anchors prevent horizontal displacement of the main beams against columns. The columns and the monolithic wall supporting the main girder are located on reinforced concrete strip foundations. The walls of additional objects are made of silicate brick, while the stairs structure is made as a prefabricated reinforced concrete element (Figure 3).

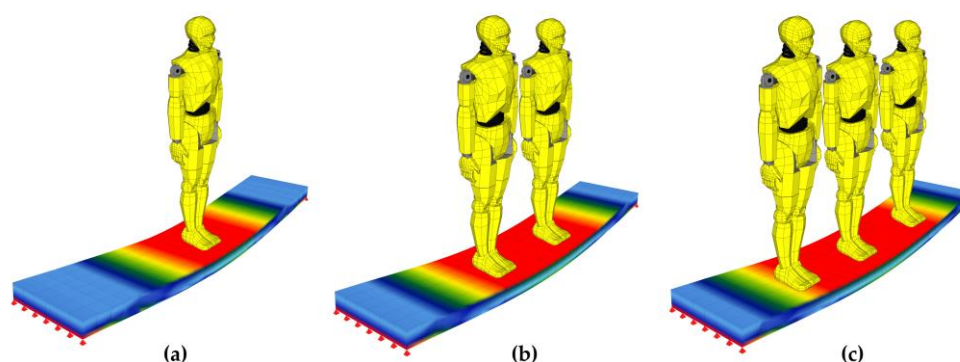
Figure 15. Numerical simulations of the implementation of excited vibrations in the form of rhythmic jumps performed by: (a) one person, (b) two people, (c) three people.

accordance with the results obtained during the convergence division analysis. Numerical calculations were performed for excitation caused by one, two and three people (Figure 15).

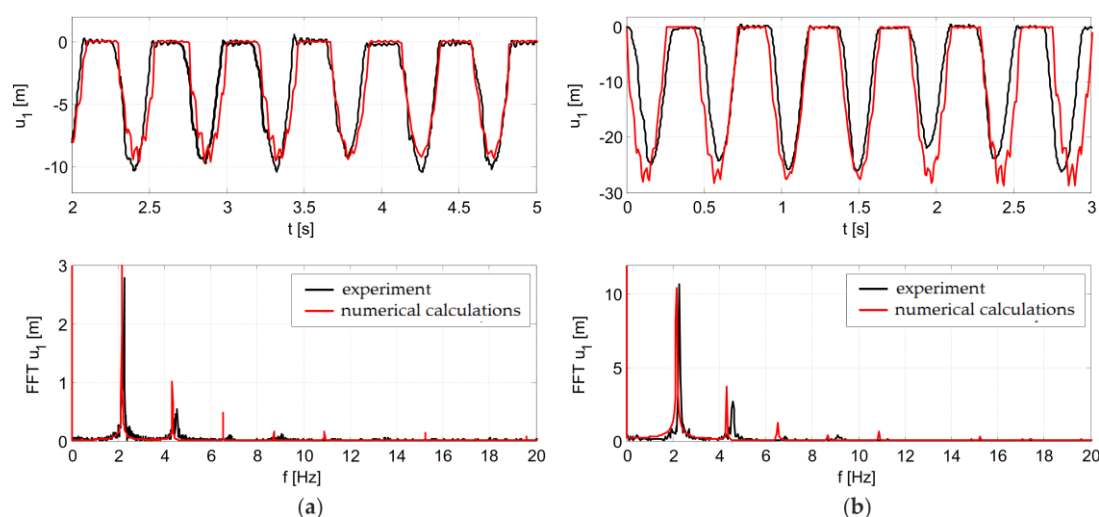
Figure 16. Numerical model validation results for jumps performed by: (a) one person, (b) three people.

Figure 16 presents a comparison of the numerical and experimental results in the form of displacement in time, registered at the middle of the span, and their Fourier transforms for the cases of one and three people jumping. In the flight phase, plate vibrations occurred at a frequency of 26 Hz for both the experimental and numerical results. Slight phase shifts between the experimental and numerical graphs can be observed. The reason for the shifts lies in the fact that the real jumps were not perfectly repetitive. A very good experiment consistency of the numerical simulations was obtained, which proves the correctness of the assumed load model for the Labado dance. The excitation frequency was approximately 2.2 Hz during both the experimental and numerical tests. Later in the article, the obtained Labado dance load model is used to simulate vibrations and structure tuning of the stand at the Swiss Krono Arena speedway stadium.

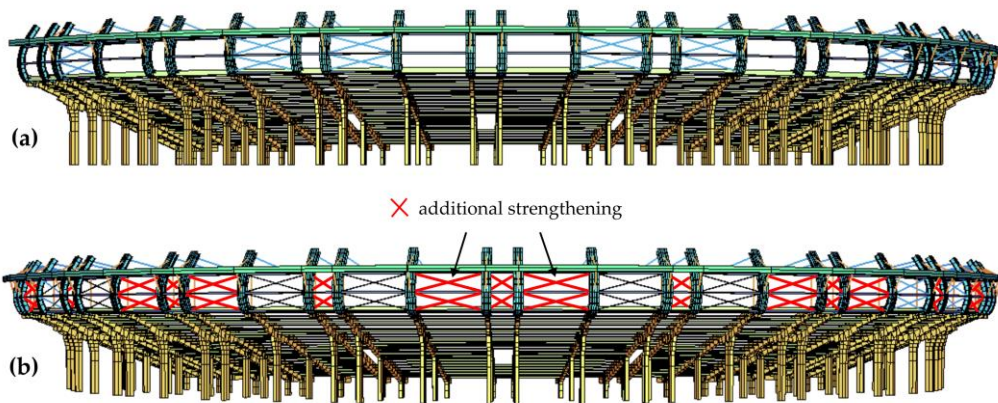
Figure 22. Additional wall bracings (a) before structural tuning, (b) after structural tuning.

An original method of stand structural tuning was proposed in response to the excess of the serviceability limit state. This method assumed the implementation of wall bracings stiffening the steel roofing columns, as well as roof bracings on the wooden roof structure (Figures 22 and 23). The main goal of the concept of bracing of all columns and roof girders was to significantly limit the free end of the wooden roof vibration amplitudes, and hence reduce the concrete cantilever displacements. The bracing cross-sections were the same as those of the bracings already installed in the stand structure. The bracings were made from Macalloy bar rods with a yield point of 520 MPa and tensile strength of 690 MPa.
