# Stability Assessment of Coastal Cliffs Incorporating Laser Scanning Technology and a Numerical Analysis

Rafal Ossowski, Marek Przyborski

Faculty of Civil and Environmental Engineering, Gdansk University of Technology, 80-233 Gdansk, Poland

**Abstract:** We investigated the cliff coast in Jastrzebia Gora, Poland. The measurements that were taken between 2014 and 2018 by applying terrestrial, mobile, and airborne laser scanning describe a huge geometric modification involving dislocations in a 2.5 m range. Differential maps and a volumetric change analysis made it possible to identify the most deformed cliff's location. Part of the monitoring of coastal change involved the measurement of a cliff sector in order to determine the soil mass flow down the slope. A full geometric image of the cliff was complemented by a stability assessment that incorporated numerical methods. The analysis showed that the stability coefficients, assuming a particular soil strata layout and geotechnical parameters, are unsafely close to the limit value. Moreover, the numerical computations, which were performed under simplifying assumptions, were not able to capture a multitude of other random factors

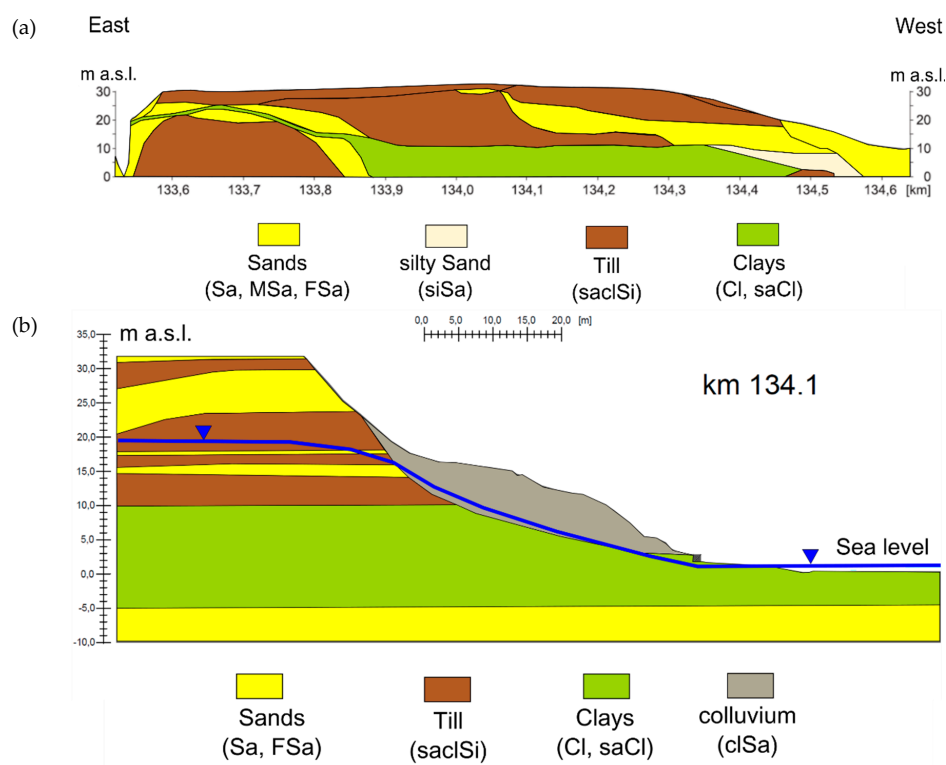
Figure 2. (a) Longitudinal (b) and transverse geological cross-sections of the cliff (based on [48]).

Figure 2a,b show longitudinal and transverse geological cross-sections of the cliff, respectively.

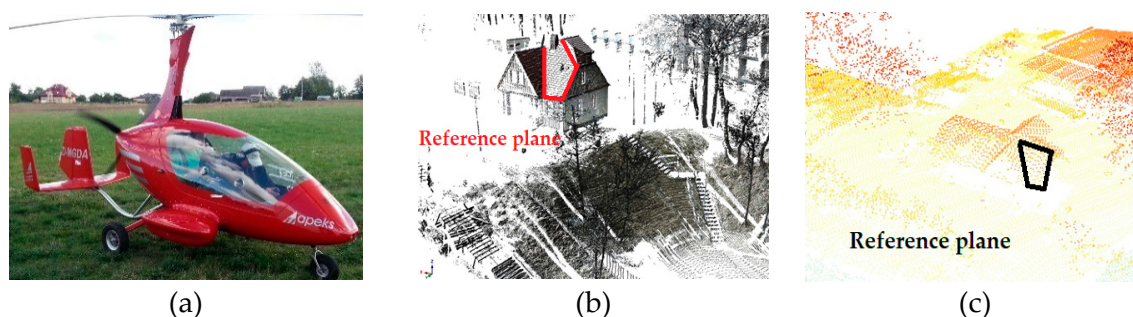
**Figure 3.** (a) The airborne system; (b) the reference planes at a laser view from the Terrestrial Laser System; (c) the reference planes at a laser view from the Airborne Laser System. The Airborne Laser-Scanning measurements were referenced to the EPSG:2177 ETRS89/Poland CS2000 zone 6 coordinate system.

For airborne laser scanning, we used a Riegl VQ-580 laser scanner (Manufacturer: Riegl GmbH, Horn, Austria). According to the Riegl VQ-580's specifications, the scanner's precision and accuracy are equal to 25 mm. The measurement accuracy was assumed to be the same. In practice, the accuracy thresholds were found to differ, which was addressed in further work stages. The errors in the scanner's position were complemented by the accuracy of the Inertial Measurement Unit/Global Navigation Satellite System (IMU/GNSS) system [20]. We designed and performed an experimental flight over the investigated area. Figure 3 shows the airborne system (a gyrocopter with a laser scanner attached to it), the reference planes that were registered with the help of the terrestrial laser-scanning system, and the same planes measured with the help of the airborne laser-scanning system. The designed flight lines along the coast were complemented by additional ones along the return route due to the low coverage between the flight rows. The air-scanning data were collected twice (in 2014 and in 2017). The missions aimed to obtain a sufficient point density (10 points/m<sup>2</sup>).

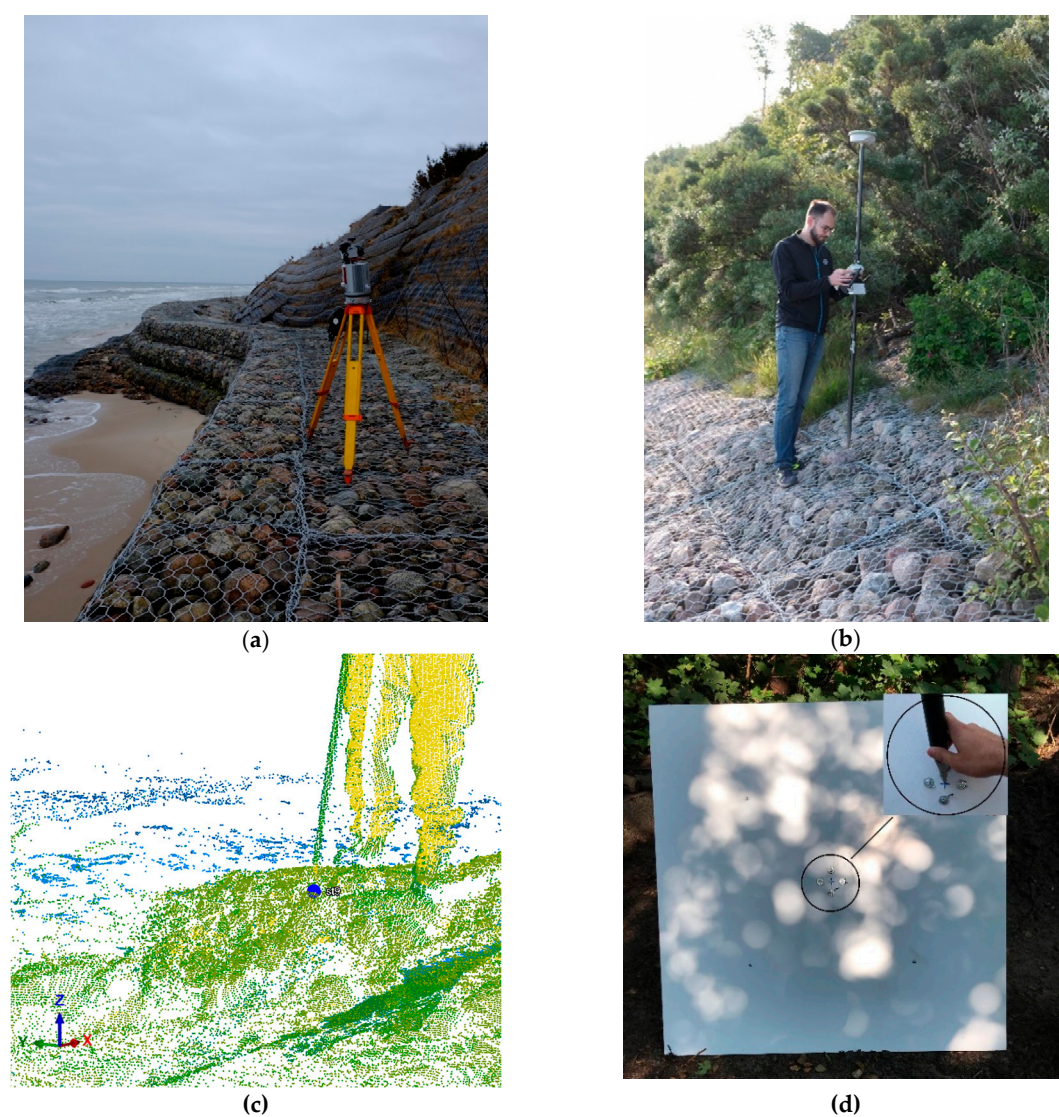
**Figure 4.** (a) The laser scanner working on the investigated object; (b) the Global Navigation Satellite System (GNSS) receiver; (c) the point cloud with the marked bottom of the pole; and (d) the materialized tie point z with a marked sighting cross on which we put a pole.

For terrestrial laser scanning, we used a Riegl VZ-400 laser scanner (Manufacturer: Riegl GmbH, Horn, Austria). This scanner allows for the remote acquisition of 3D data at high speed (122,000 pulses per second) and uses an infrared laser beam and a fast scanning mechanism. Compared to other instruments of this type, the Riegl device is a compact and lightweight measurement unit that can be installed in any orientation and does not require levelling. Note that the meteorological conditions, e.g., rain and snow, have a substantial impact on the device's measurement quality [19]. Figure 4 shows photos of the scanner's coverage of measurement courses in the Jastrzebia Gora region. The views are as follows: (a) a view of the scanner alone on the investigated object; (b) measurement of characteristic points using the GNSS technique in order to align 3D data that were referred to the EPSG:2177 coordinate system due to various measurement cycles; (c) the marked bottom of the pole on a point cloud, which represents a measured point in the EPSG:2177 coordinate system; (d) a materialized point that we deployed on an object of interest in order to unambiguously identify the reference points on scans. The size of this point is approximately  $1\text{ m} \times 1\text{ m}$ , and it has a sighting cross marked on the inside, on which we put a pole.

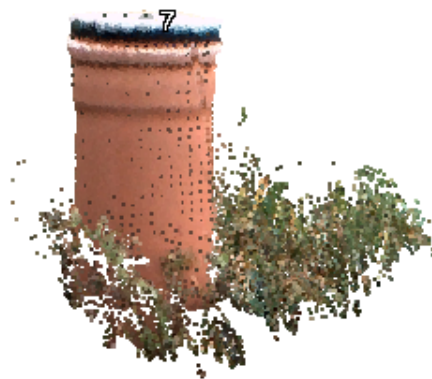
**Figure 5.** A representation of a measured object in the local coordinate system below the lower hummus layer.

In order to study the exact pattern of a landslide's behaviour and assess its threat to nearby infrastructure, we performed an experiment to measure the stabilized points at the top of the cliff under the hummus layer (Figure 5) in the local coordinate system. In this instance, we decided to change our assumption that the data were aligned with the EPSG:2177 coordinate system due to the fact that, locally, we were able to obtain greater accuracy. For this particular case, we used a Leica P30 Laser Scanner (Manufacturer: Leica Geosystems AG—Part of Hexagon). We used this instrument because it is possible to level it. This provided us with a simple orientation of the local system in such a way that the Y axis extended towards the sea, the Z axis extended upwards, and the X axis extended to the left according to the rule of the right hand. Figure 6 shows the location of the measurement points together with the orientation of the local coordinate system on an orthophotomap.

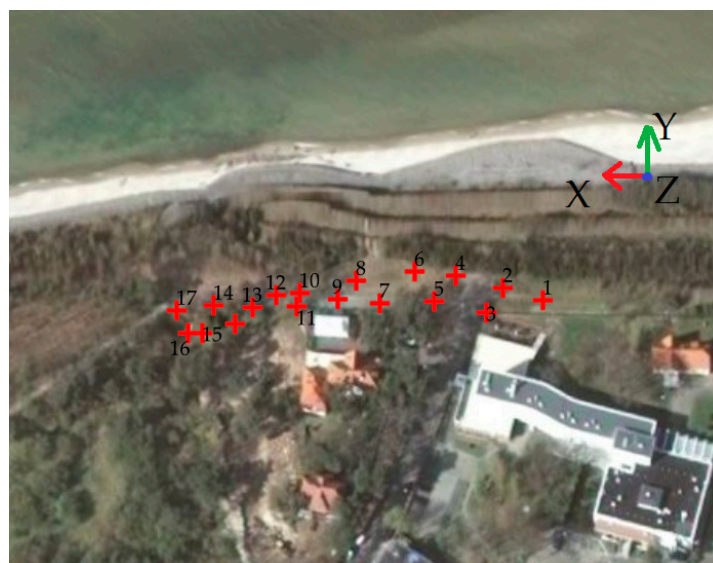
**Figure 6.** Locations of the measurement points.

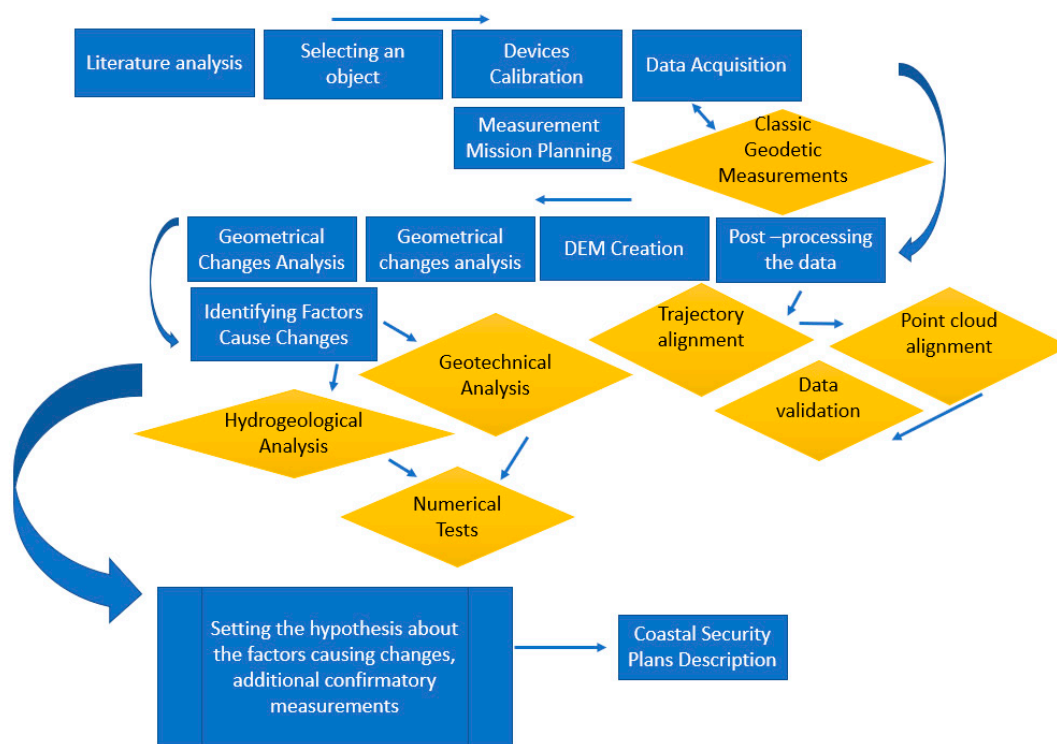
Figure 7. A flowchart of the research.

As shown in the scheme in Figure 7, we first performed a review of the state-of-the-art publications on the subject of coastal changes. Based on a prior study, we chose the investigation zone to carry out measurements and a computational solution for the accurate estimation of the displacement range and the origin. The measurement methods include classical surveying techniques that employ GNSS receivers and the Terrestrial, Mobile, and Airborne scanning systems.

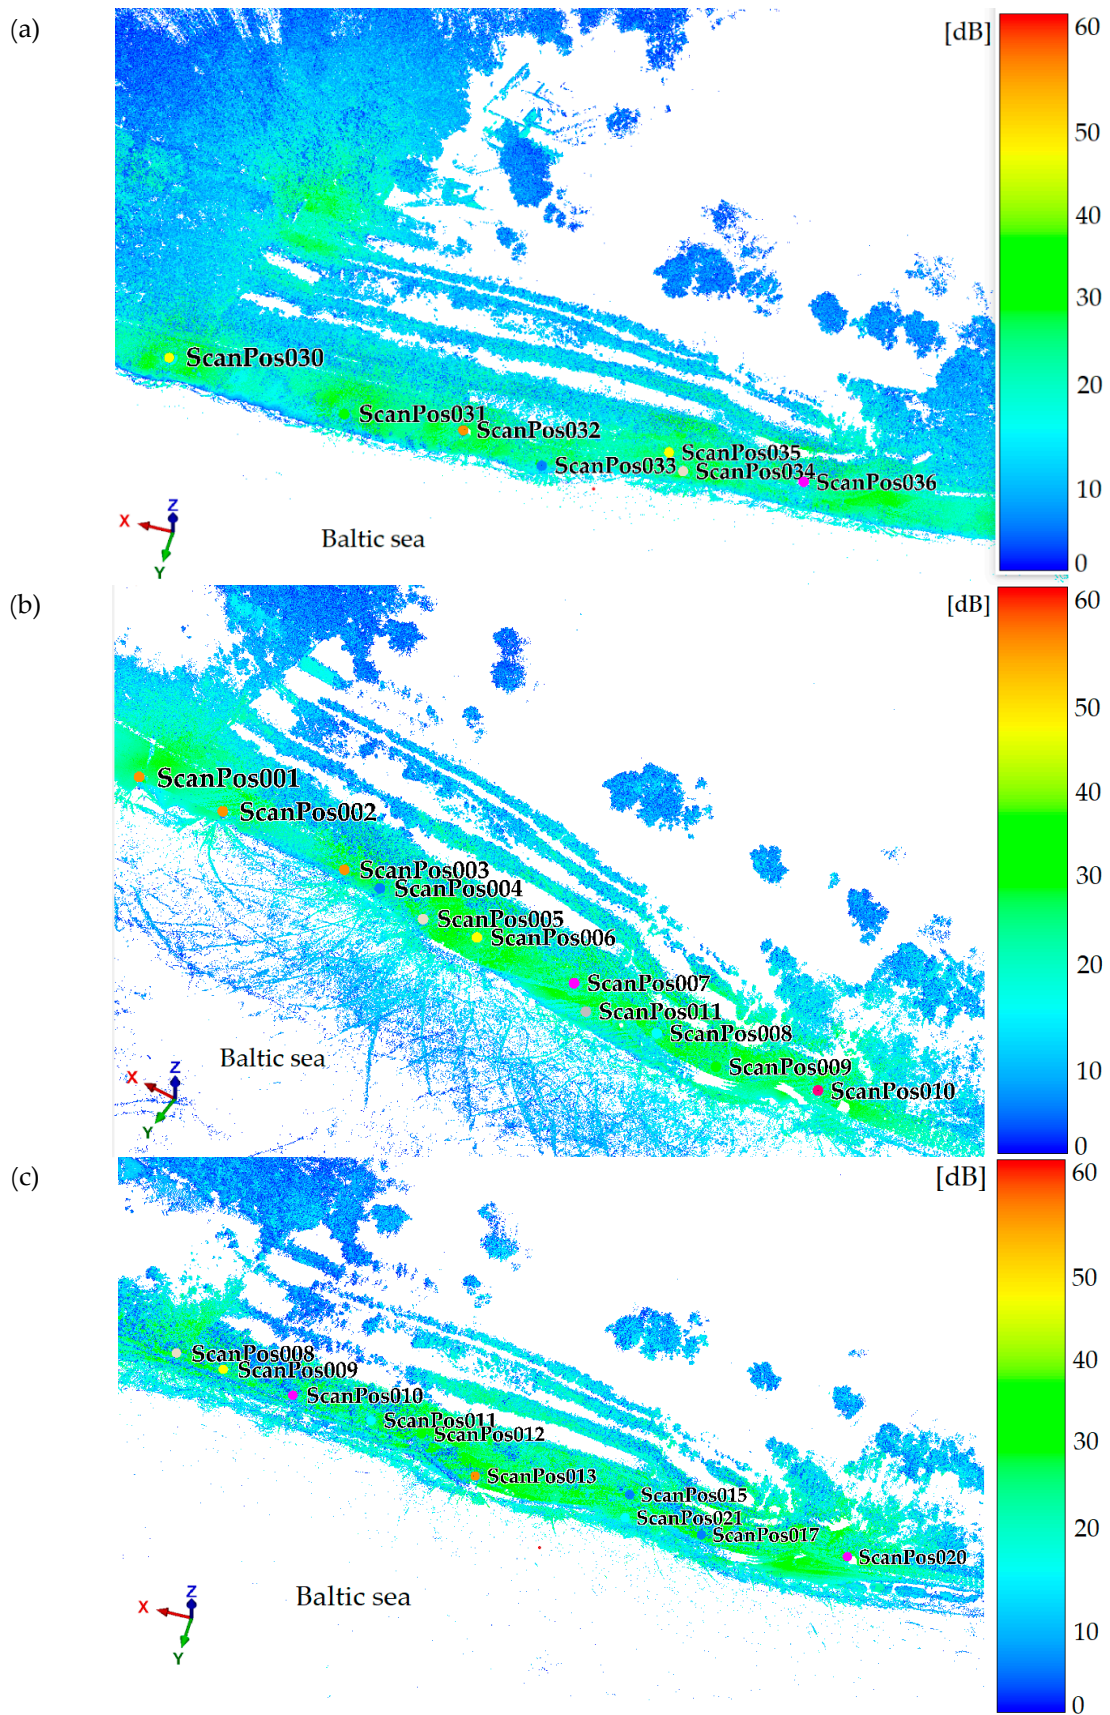
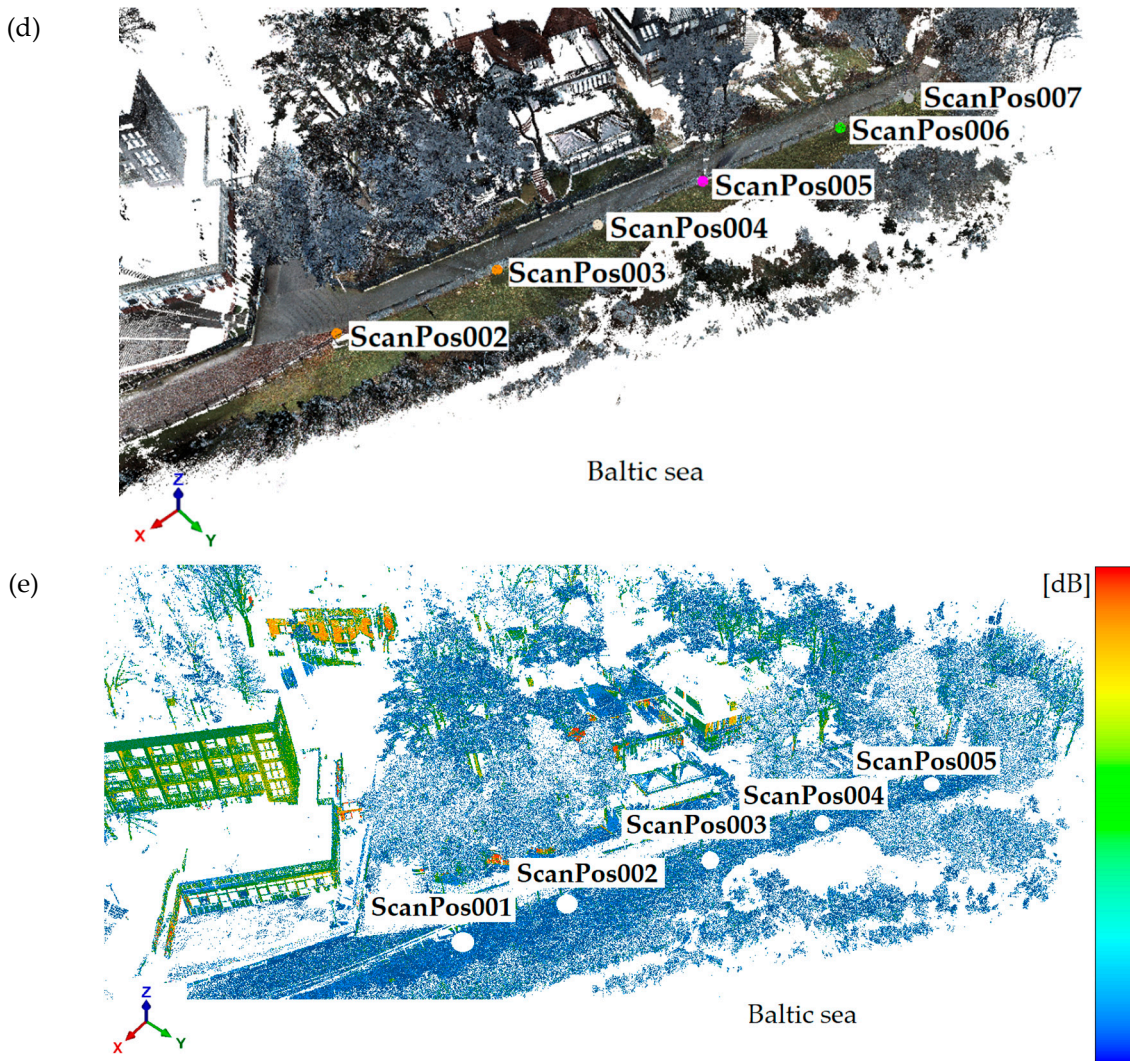
**Figure 8.** The scanner locations for the (a) February 2015, (b) March 2017, (c) July 2017, (d) November 2018, and (e) March 2018 measurement missions.

Figure 8 presents the location of the scan positions for each of the February 2015, March 2017, and July 2017 measurement missions and the deployment of positions in the local system in November 2017 and March 2018. The point density for each measurement mission was equal 4200 pts/m<sup>2</sup>. In Figure 8a–c,e respectively, colours are presented as a function of light reflection amplitude, while Figure 8d shows the fragment of the upper part of the cliff in RGB (Red-Green-Blue) colours.

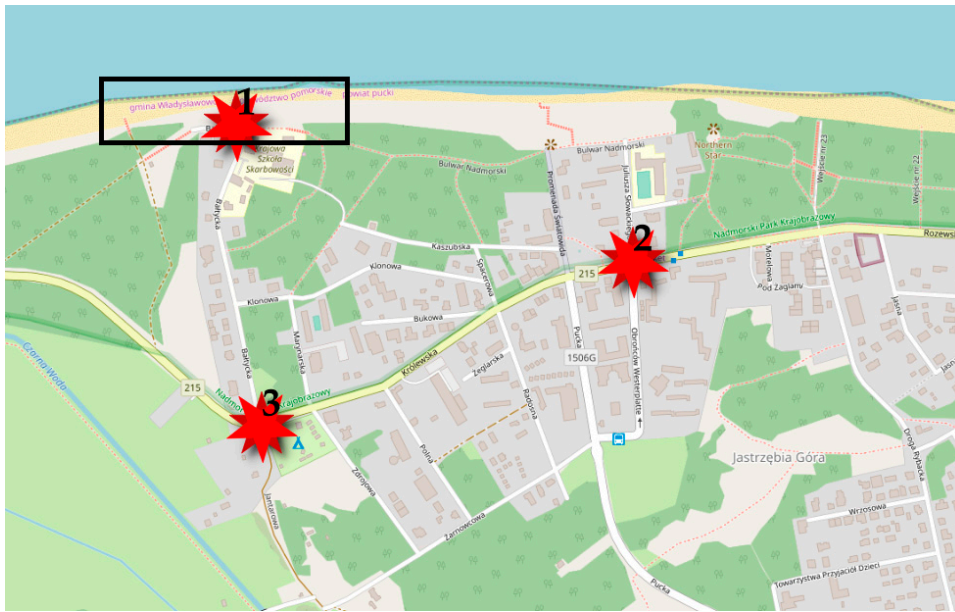
**Figure 9.** The distribution of objects in close proximity to our area of interest (marked with a black rectangle) (source: OpenStreetMap).

To measure the control points that are necessary for a proper data alignment with the EPSG:2177 coordinate system, we used a GNSS Topcon HyperV receiver (Manufacturer: Topcon Corporation, Tokyo, Japan) and a Riegl VZ-400 laser scanner (Manufacturer: Riegl GmbH, Horn, Austria). The idea was to place the laser scanner near the characteristic points, e.g., roofs of buildings, acquire data from one scan position, and then align them with the EPSG:2177 coordinate system based on the previously measured points by a GNSS technique. In each case, the measurement required us to establish a minimum of four points. Figure 9 shows the location of objects we measured (using the OpenStreetMap map) in close proximity to our area of interest.

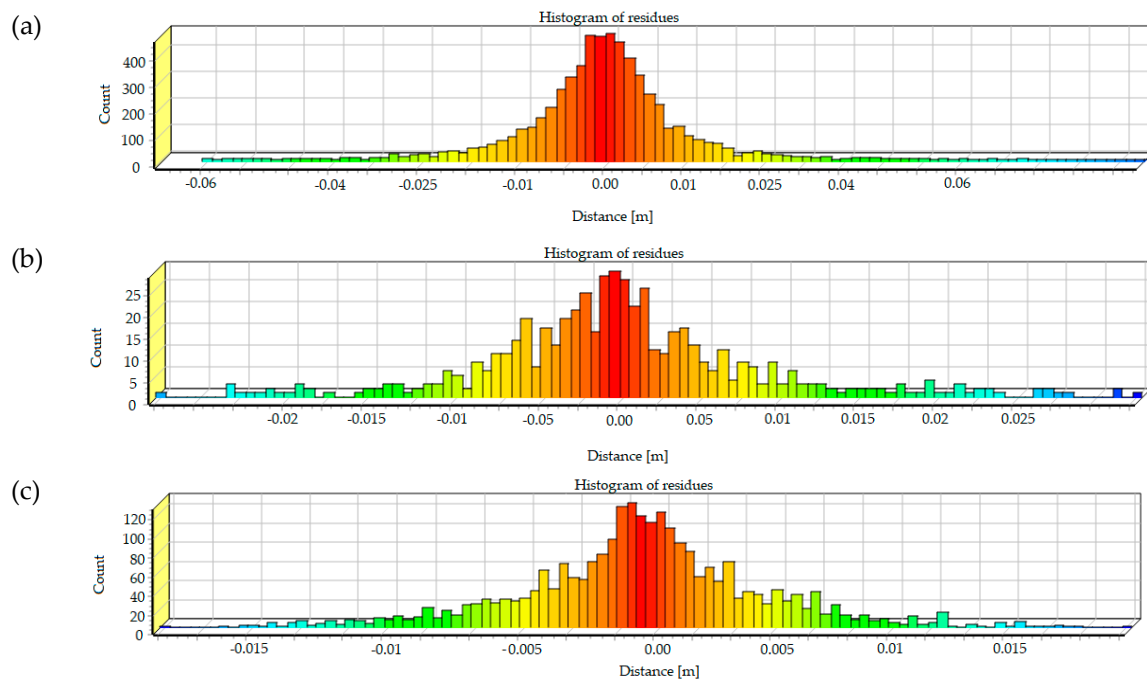
**Figure 10.** Residuals showing the equalization of point clouds using the Iterative Closest Points (ICP) algorithm in (a) February 2015, (b) March 2017 and (c) July 2017.

The validation of the terrestrial laser scanning data was based on a histogram of the distance between the control points. We applied the ICP algorithm (Figure 10) and the standard deviation and attached a point cloud to the EPSG:2177 coordinate system (Table 2). We needed to provide a fixed GNSS receiver solution where the error in the calculation of the average position would be no more than 1 cm. In the case of an erroneous measurement by satellite technology, the standard deviation of such an aligned point cloud to the EPSG:2177 coordinate system would be a decimetre, or even higher, and thus easy to detect. Based on the obtained results from Figure 10 and Table 2, we assumed that the accuracy of the comparative analyses may fluctuate around 10 cm ( $2.5\sigma_1$ ) when using Terrestrial Laser Scanning. For this reason, the precision of the displacement reading will also be in the range of 10 cm. Table 2 presents the transformation matrix in the first column, number of reference points used in alignment process in the second, and the value of the calculated standard deviation in the third. The presented residues show the differences in distance between the tie points in the case of automatic extraction described in Section 2.4.1.

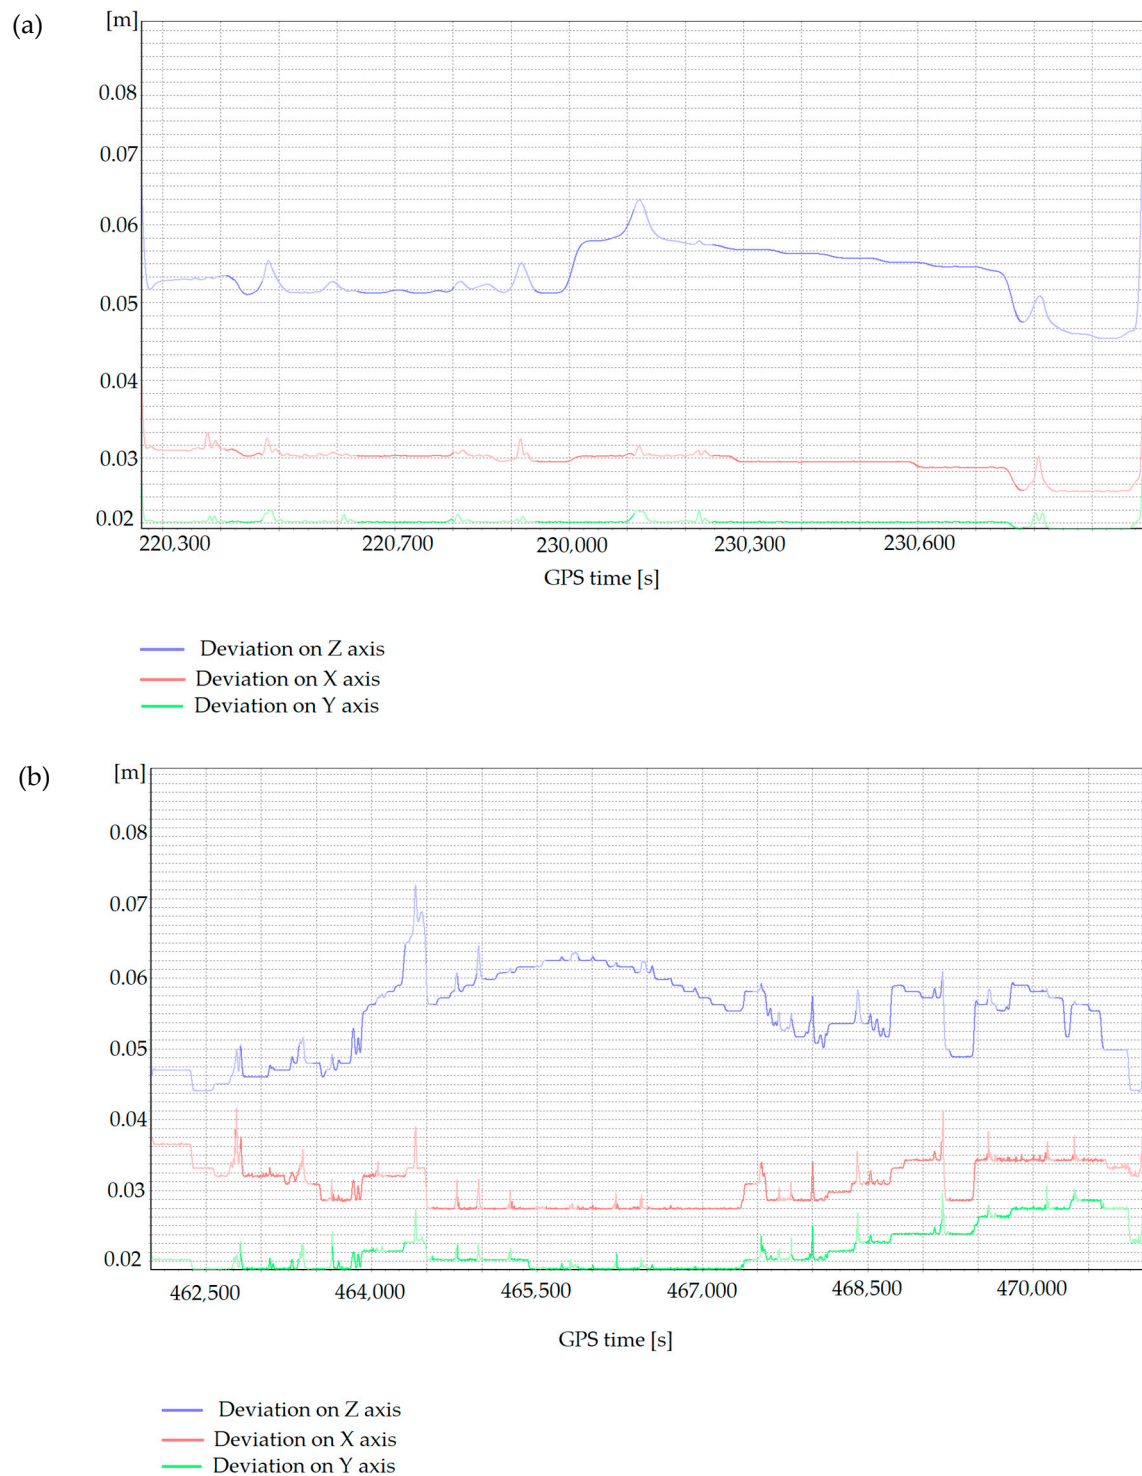
**Figure 11.** Deviations from the approximated trajectory on each axis for (a) the flight from 2014 and (b) the flight from 2017.

Furthermore, analyses of the airborne system’s data were conducted. Figure 11 shows a diagram of the INS position deviation based on trajectory, and Table 3 shows a histogram of differences among control points. As can be noticed in Figure 11a, which shows the deviation from the flight that was performed in 2014, the elevation has the highest value of deviation of 6 cm. Figure 11b, which shows the deviation from the flight that was performed in 2017, has similar values to those in Figure 11a. This means that the trajectory was correctly aligned. An assessment of the accuracy was carried out after establishing individual records of scans between them and the EPSG:2177 coordinate system. The resulting differences between the accuracy of alignment of individual axes result primarily from

the measurement characteristics, where the aircraft fluctuated, but also from the emerging drift of the device. Seen offsets can be removed during strip-adjustment procedures.

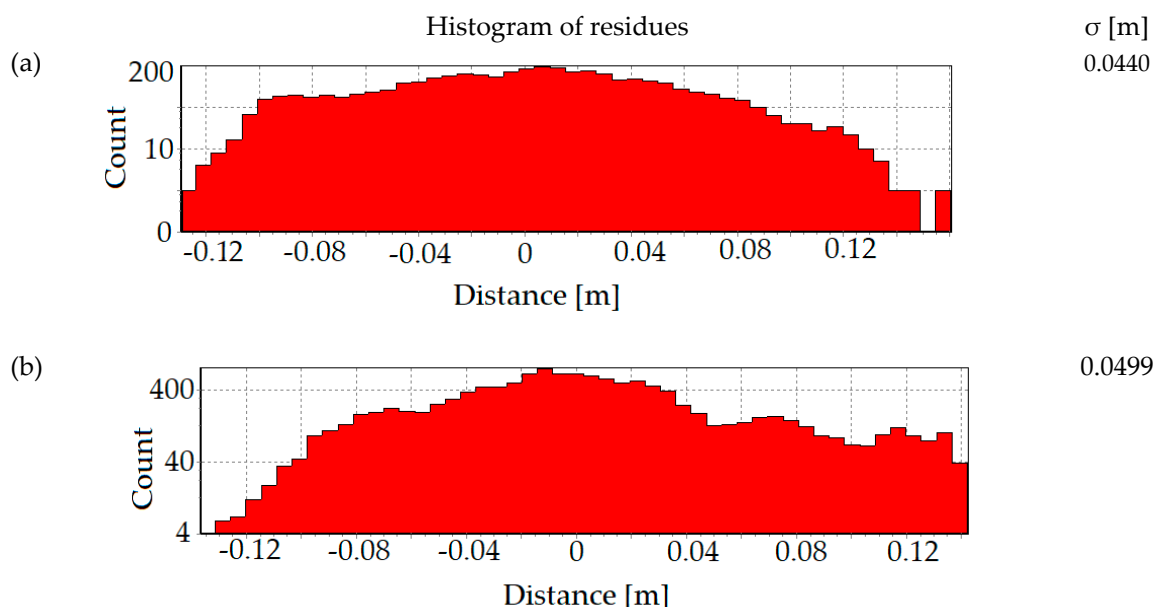
**Figure 12.** A histogram of the data alignment residues for (a) 2014 and (b) 2017.

Based on the results obtained from the alignment of laser strips with each other as shown in Figure 12, the standard deviation values for these values (for the 2014 flight,  $\sigma = 0.044$  m; for the 2017 flight,  $\sigma = 0.0499$  m) and the irregularities that are visible in the trajectory shown in Figure 11, we assumed that the accuracy of one model varied at the level of  $3\sigma$ , which is 0.132 m for the flight from 2014 and 0.149 m for the flight from 2017. These values mean that the summed accuracy of the comparative model will be in the range of 20–30 cm. The presented residues show the differences in distance between the tie points measured by surveying methods and in the case of automatic extraction described in Section 2.4.1.

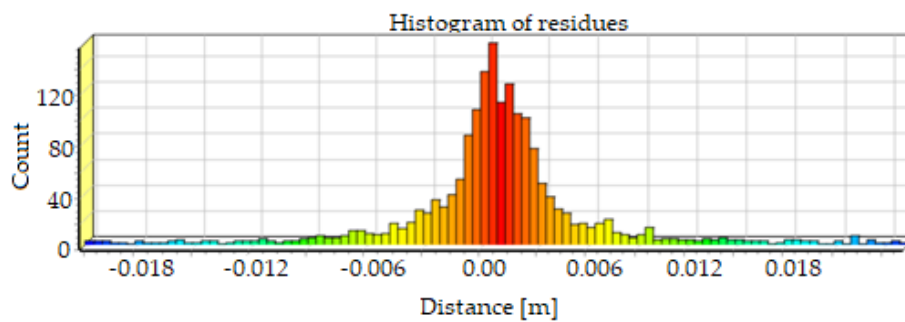
**Figure 13.** A histogram of the residues that resulted from the alignment of two point clouds on objects that have not moved in time.

We analysed the accuracy of the measured points in the form of sewer pipes that were located at the top of the cliff. We wanted to achieve greater accuracy (at the level of 1 cm) to check our assumptions about the landslide's origin and to verify whether there is a threat of a landslide being initiated (the elevation should decrease locally in this case). First, we analysed a histogram of the distance among control points and then checked the quality of the alignment by creating cross-sections through buildings that the landslide did not have an impact on (in theory, they should be located in exactly the same place). Figure 13 shows the histogram of the distance among control points. Figure 14 shows the analysed building cross-sections.

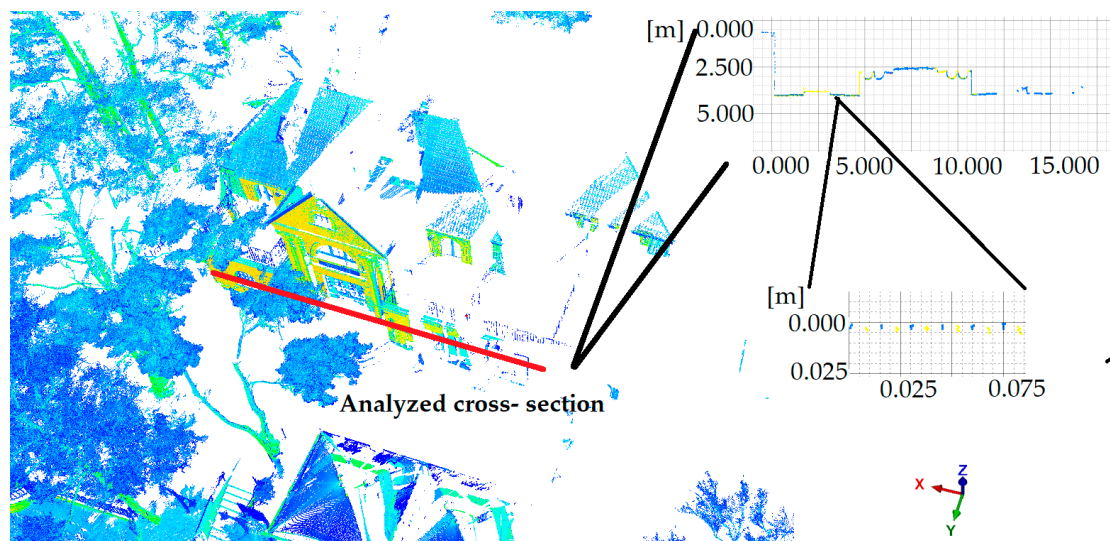
**Figure 14.** The structure of points between two elements representing the same object that has not changed in time (yellow colour represents point cloud from 2017 and blue—from 2018).

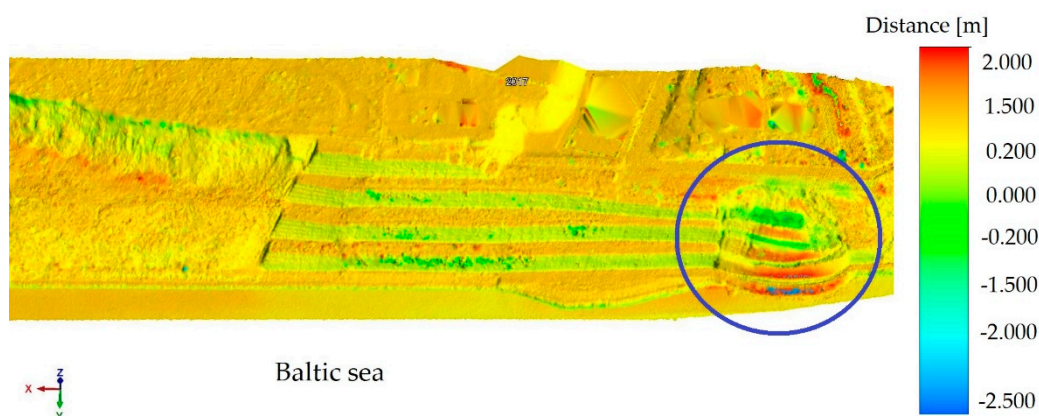
Figure 16. The variations in distance in both models.

The geometric analysis features a volume comparison between the 2014 and 2017 models computed from the airborne scanning system's data. The main concern is understanding the geometric changes in the cliff. To calculate the volume, we created a plane on the zero level in the EPSG:2177 coordinate system (as described in Section 2.3.3). In order to identify the highest deformations, we compared

the 2014 and 2017 models; Figure 16 shows the results. Based on the comparison, we found the location of the most significant change in the cliff's geometry. First, we defined a  $10\text{ m} \times 10\text{ m}$  grid in the investigated area to perform a more detailed analysis. Figure 17 shows: (a) the location of the analysed area; and (b) the defined  $10\text{ m} \times 10\text{ m}$  grid. Each grid square was used to compute the volume in order to choose a section to analyse (the geotechnical stability analysis). Figure 18 shows the resulting sub-quantity volumes. In addition, Table 4 present the percentage error in the calculation of this volume (as described in Section 2.3.3). The computation of this error consisted in calculating the quotient between the determined volume, and the volume increased by  $3\sigma$  separately for the data from 2014 and 2017 (the  $3\sigma$  for the flight from 2014 is 0.132 m, and the  $3\sigma$  for the flight from 2017 is 0.149 m). The detailed description of obtaining the  $\sigma$  value is described in Chapter 2, respectively, in Sections 2.4 and 2.4. The idea of showing the percentage error in volume calculation was obtained from Reference [66] where, according to standards, the numerical modelling method can be used to calculate the volume of masses, while the relative error in the volume calculation should not exceed: (a) 6% of the volume for between 0 and 20,000  $\text{m}^3$ , (b) 5% by volume for between 20,000 and 50,000  $\text{m}^3$ , (c) 4% by volume for between 50,000 and 200,000  $\text{m}^3$ , (d) 3% by volume for between 200,000 and 500,000  $\text{m}^3$ , and (e) 2% by volume for the range over 500,000  $\text{m}^3$ . Therefore, the relevant rows A and partially B from Tables 4 and 5 should not be taken into account in the analysis of changes in the volume of earth masses, however, due to the very small volume values in these rows, this does not affect the estimation of the overall mass flow down the slope.

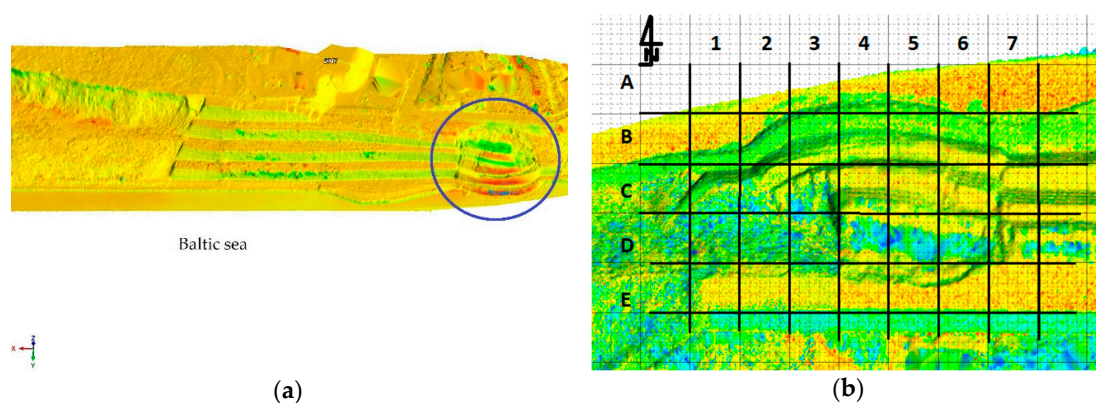
Figure 17. (a) The location of the highest variations; (b) the defined  $10\text{ m} \times 10\text{ m}$  grid.

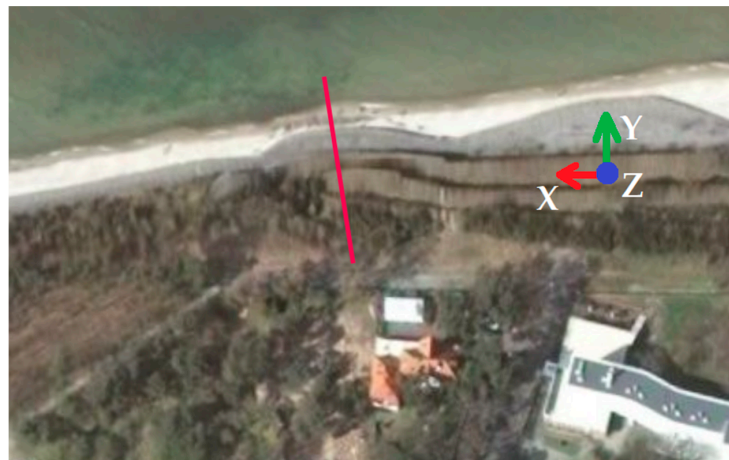
**Figure 19.** The location of the geometric analysis, marked on an orthophotomap.

Based on the volumetric results, we chose for further investigation a section between the mesh columns marked C and D. The deviations in the same section (as shown in Figure 19) that were obtained
