# Stability Assessment of Coastal Cliffs Incorporating Laser Scanning Technology and a Numerical Analysis

Rafal Ossowski, Marek Przyborski

Faculty of Civil and Environmental Engineering, Gdansk University of Technology, 80-233 Gdansk, Poland

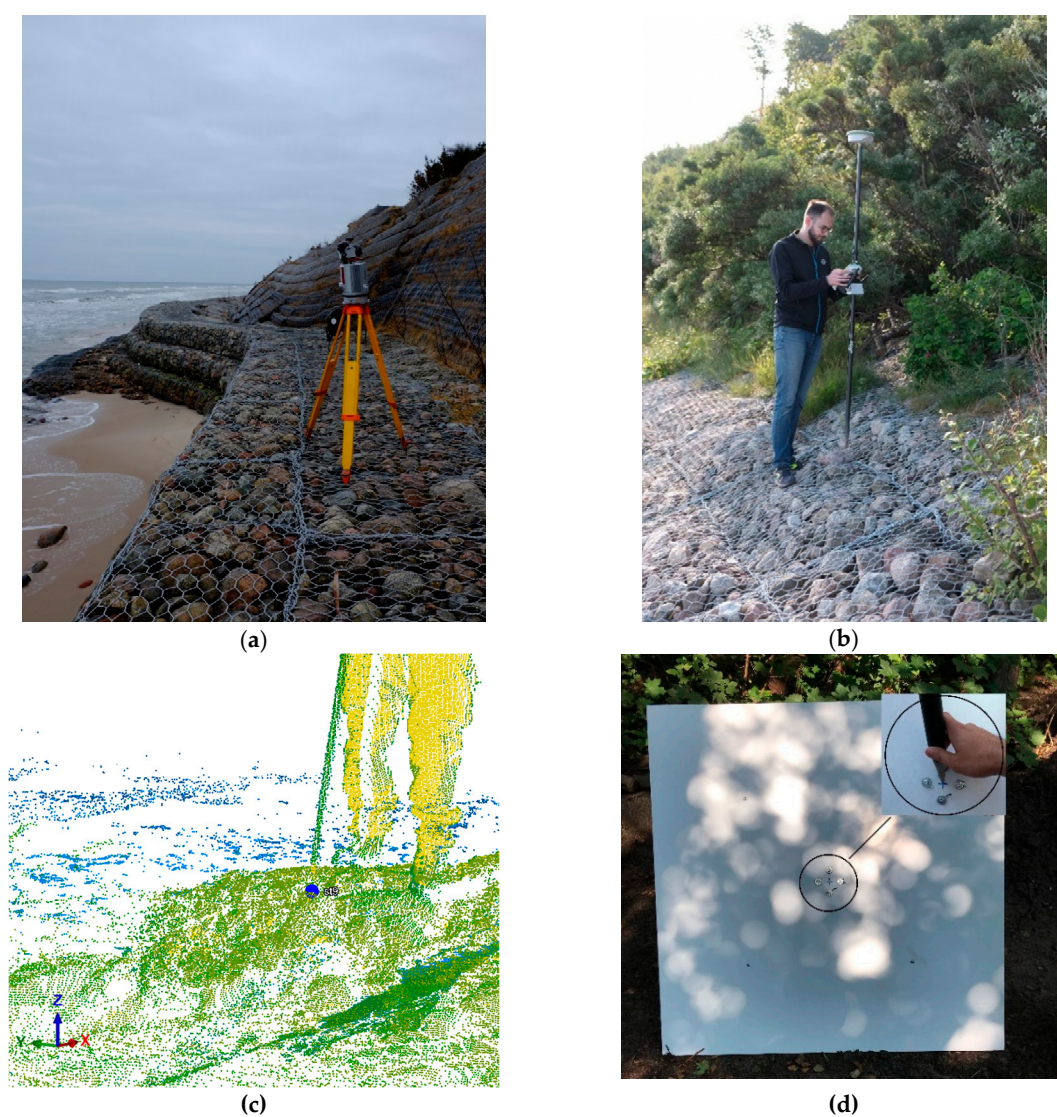
**Figure 4.** (a) The laser scanner working on the investigated object; (b) the Global Navigation Satellite System (GNSS) receiver; (c) the point cloud with the marked bottom of the pole; and (d) the materialized tie point z with a marked sighting cross on which we put a pole.

For terrestrial laser scanning, we used a Riegl VZ-400 laser scanner (Manufacturer: Riegl GmbH, Horn, Austria). This scanner allows for the remote acquisition of 3D data at high speed (122,000 pulses per second) and uses an infrared laser beam and a fast scanning mechanism. Compared to other instruments of this type, the Riegl device is a compact and lightweight measurement unit that can be installed in any orientation and does not require levelling. Note that the meteorological conditions, e.g., rain and snow, have a substantial impact on the device's measurement quality [19]. Figure 4 shows photos of the scanner's coverage of measurement courses in the Jastrzebia Gora region. The views are as follows: (a) a view of the scanner alone on the investigated object; (b) measurement of characteristic points using the GNSS technique in order to align 3D data that were referred to the EPSG:2177 coordinate system due to various measurement cycles; (c) the marked bottom of the pole on a point cloud, which represents a measured point in the EPSG:2177 coordinate system; (d) a materialized point that we deployed on an object of interest in order to unambiguously identify the reference points on scans. The size of this point is approximately  $1\text{ m} \times 1\text{ m}$ , and it has a sighting cross marked on the inside, on which we put a pole.

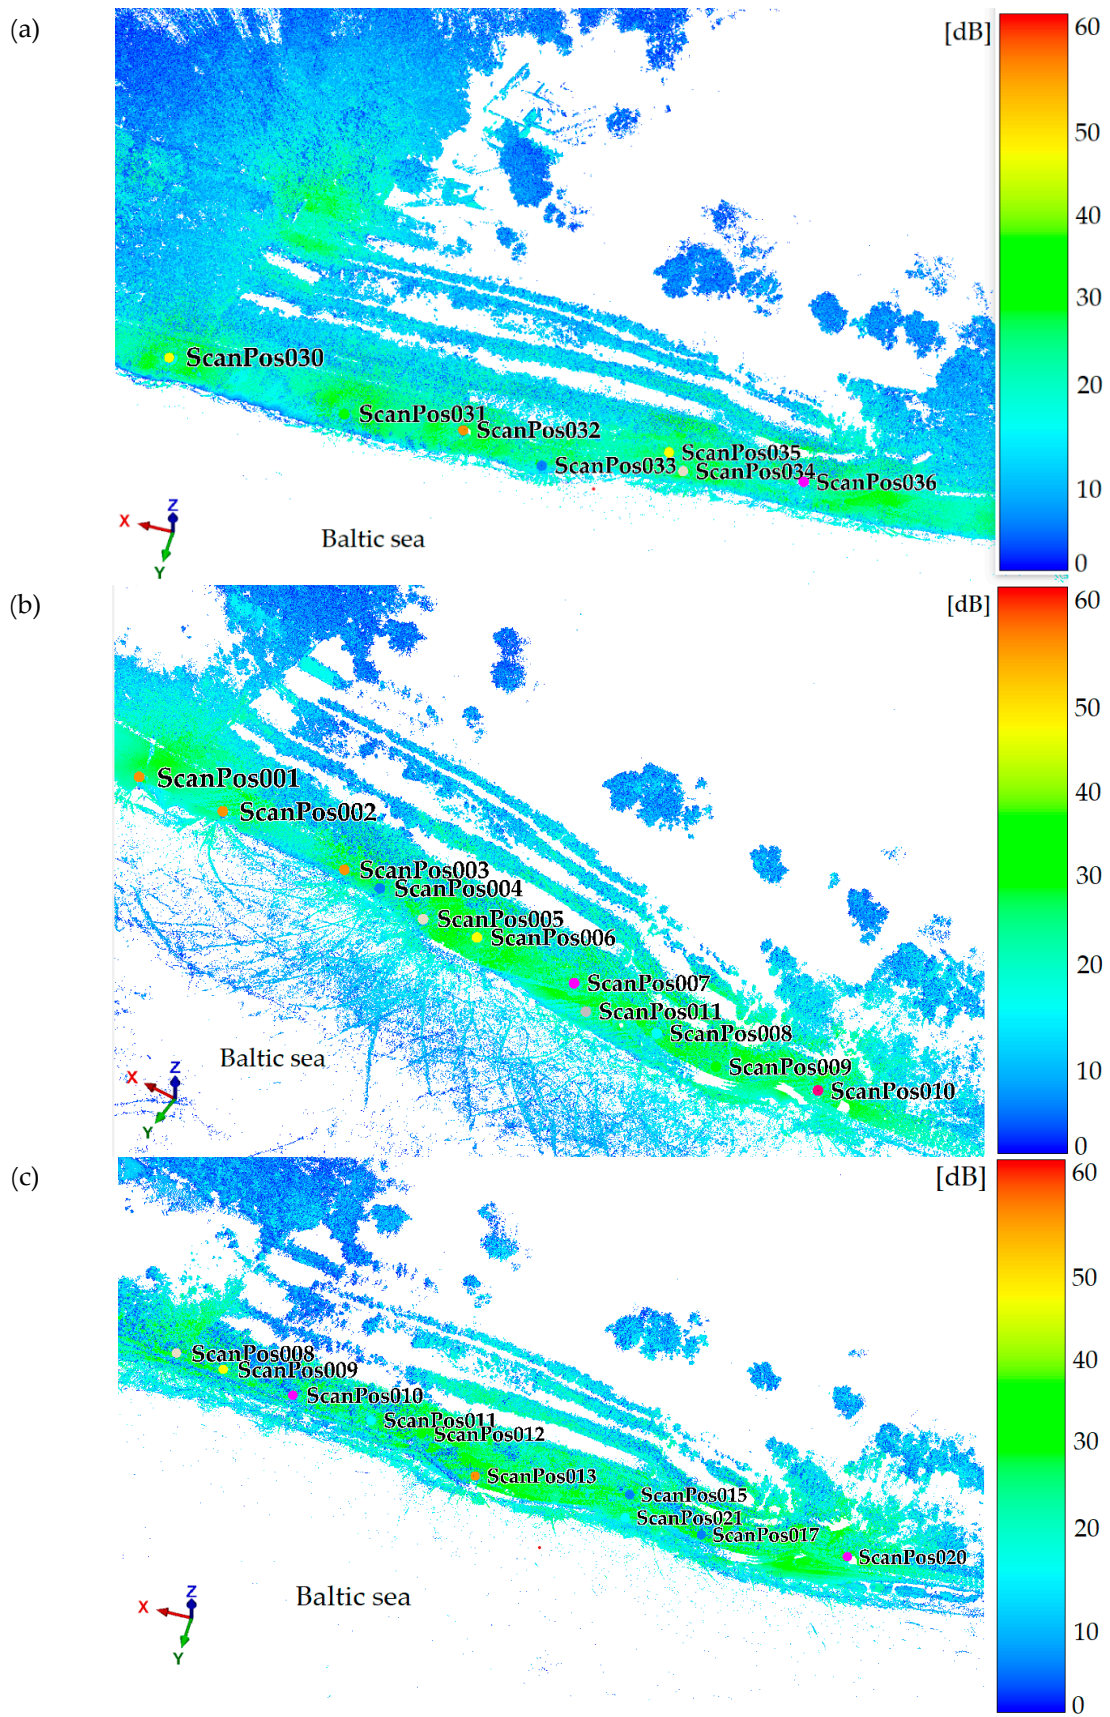
Figure 8. Cont.

**Figure 8.** The scanner locations for the (a) February 2015, (b) March 2017, (c) July 2017, (d) November 2018, and (e) March 2018 measurement missions.

Figure 8 presents the location of the scan positions for each of the February 2015, March 2017, and July 2017 measurement missions and the deployment of positions in the local system in November 2017 and March 2018. The point density for each measurement mission was equal 4200 pts/m<sup>2</sup>. In Figure 8a–c,e respectively, colours are presented as a function of light reflection amplitude, while Figure 8d shows the fragment of the upper part of the cliff in RGB (Red-Green-Blue) colours.

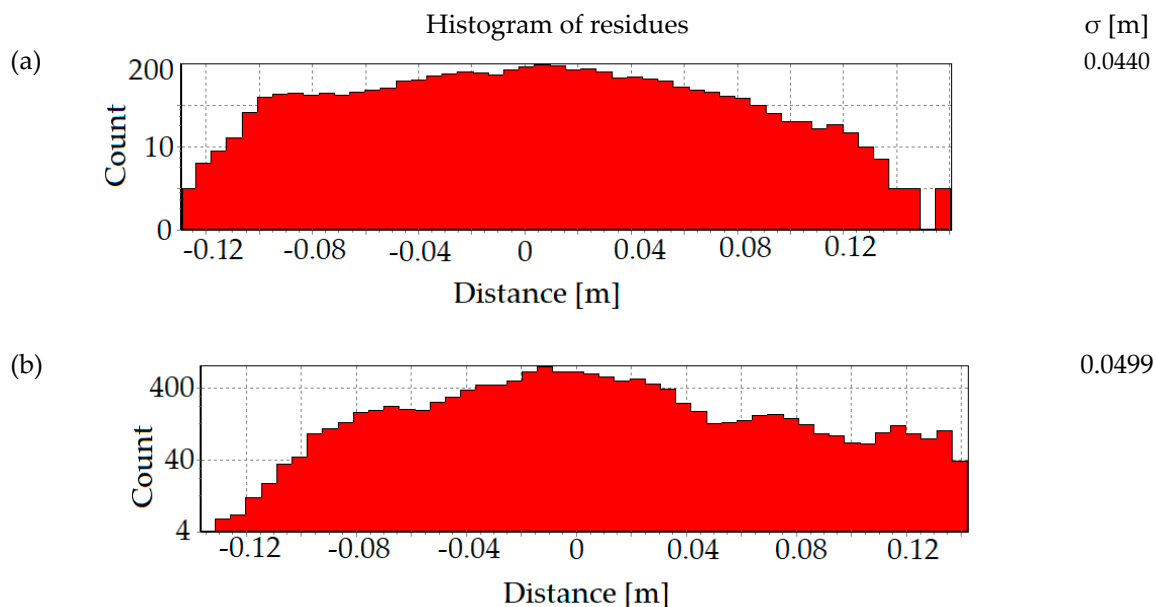
**Figure 12.** A histogram of the data alignment residues for (a) 2014 and (b) 2017.

Based on the results obtained from the alignment of laser strips with each other as shown in Figure 12, the standard deviation values for these values (for the 2014 flight,  $\sigma = 0.0444$  m; for the 2017 flight,  $\sigma = 0.0499$  m) and the irregularities that are visible in the trajectory shown in Figure 11, we assumed that the accuracy of one model varied at the level of  $3\sigma$ , which is 0.132 m for the flight from 2014 and 0.149 m for the flight from 2017. These values mean that the summed accuracy of the comparative model will be in the range of 20–30 cm. The presented residues show the differences in distance between the tie points measured by surveying methods and in the case of automatic extraction described in Section 2.4.1.

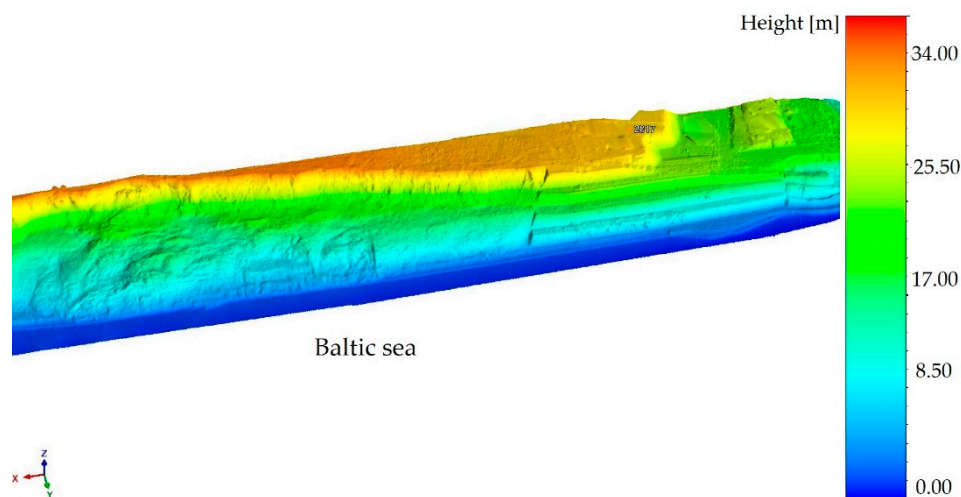
**Figure 15.** A three-dimensional (3D) model of the coastal cliff.

Figure 15 shows the terrain model that was created as a result of the measurements in the form of a triangulated point cloud for the airborne system's data that were acquired in 2017.

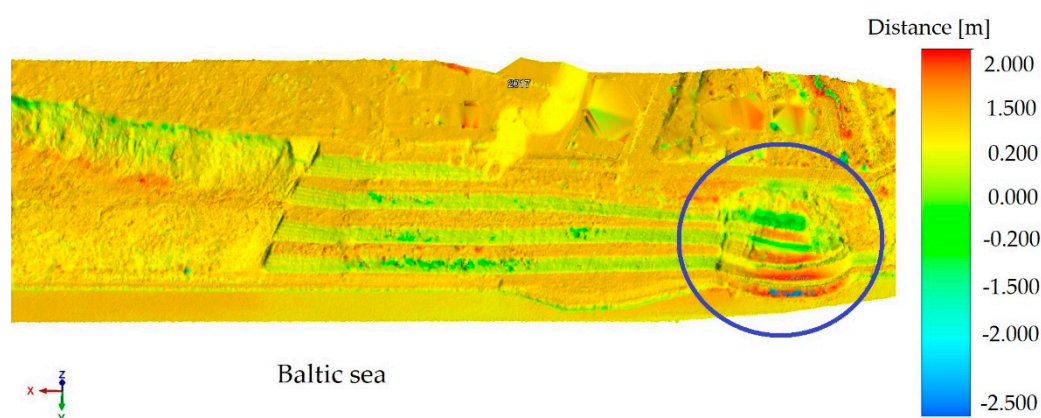
Figure 16. The variations in distance in both models.

the 2014 and 2017 models; Figure 16 shows the results. Based on the comparison, we found the location of the most significant change in the cliff's geometry. First, we defined a  $10\text{ m} \times 10\text{ m}$  grid in the investigated area to perform a more detailed analysis. Figure 17 shows: (a) the location of the analysed area; and (b) the defined  $10\text{ m} \times 10\text{ m}$  grid. Each grid square was used to compute the volume in order to choose a section to analyse (the geotechnical stability analysis). Figure 18 shows the resulting sub-quantity volumes. In addition, Table 4 present the percentage error in the calculation of this volume (as described in Section 2.3.3). The computation of this error consisted in calculating the quotient between the determined volume, and the volume increased by  $3\sigma$  separately for the data from 2014 and 2017 (the  $3\sigma$  for the flight from 2014 is 0.132 m, and the  $3\sigma$  for the flight from 2017 is 0.149 m). The detailed description of obtaining the  $\sigma$  value is described in Chapter 2, respectively, in Sections 2.4 and 2.4. The idea of showing the percentage error in volume calculation was obtained from Reference [66] where, according to standards, the numerical modelling method can be used to calculate the volume of masses, while the relative error in the volume calculation should not exceed: (a) 6% of the volume for between 0 and 20,000  $\text{m}^3$ , (b) 5% by volume for between 20,000 and 50,000  $\text{m}^3$ , (c) 4% by volume for between 50,000 and 200,000  $\text{m}^3$ , (d) 3% by volume for between 200,000 and 500,000  $\text{m}^3$ , and (e) 2% by volume for the range over 500,000  $\text{m}^3$ . Therefore, the relevant rows A and partially B from Tables 4 and 5 should not be taken into account in the analysis of changes in the volume of earth masses, however, due to the very small volume values in these rows, this does not affect the estimation of the overall mass flow down the slope.

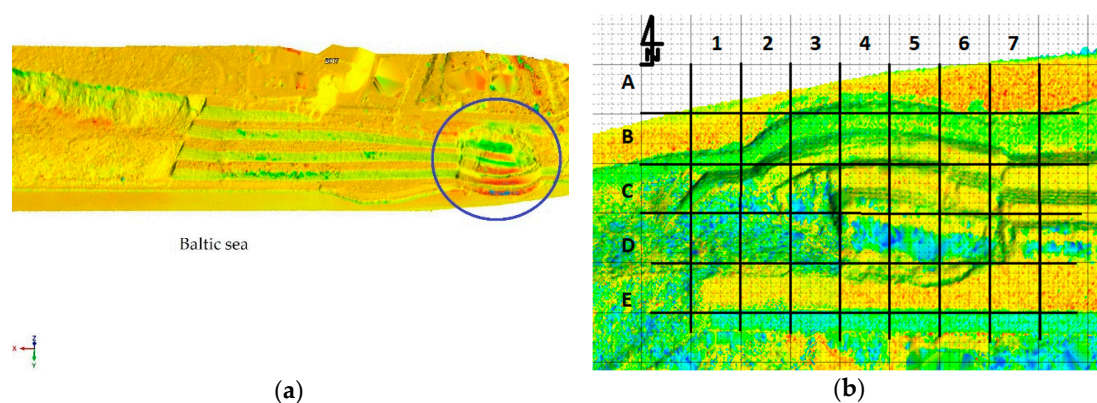
Figure 17. (a) The location of the highest variations; (b) the defined  $10\text{ m} \times 10\text{ m}$  grid.

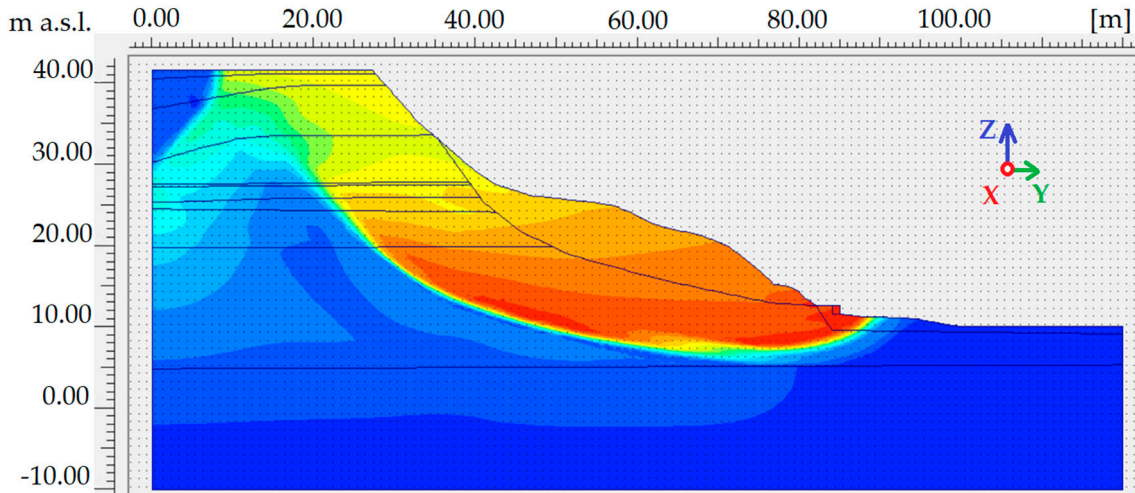
**Figure 21.** The global failure mechanism: calculations for the actual groundwater table (dimensions in meters) (source: Reference [48]). Blue colour: no displacement, red: maximum displacement.

cohesion). The analysis showed that, for the initial case (no elevation in the water table), the most sensitive parameters were the friction angle and the cohesion in the bottom layer (the clay from which the cliff is built). This is logical, as this scenario triggers a path that leads to the cliff's destruction (see Figure 21).

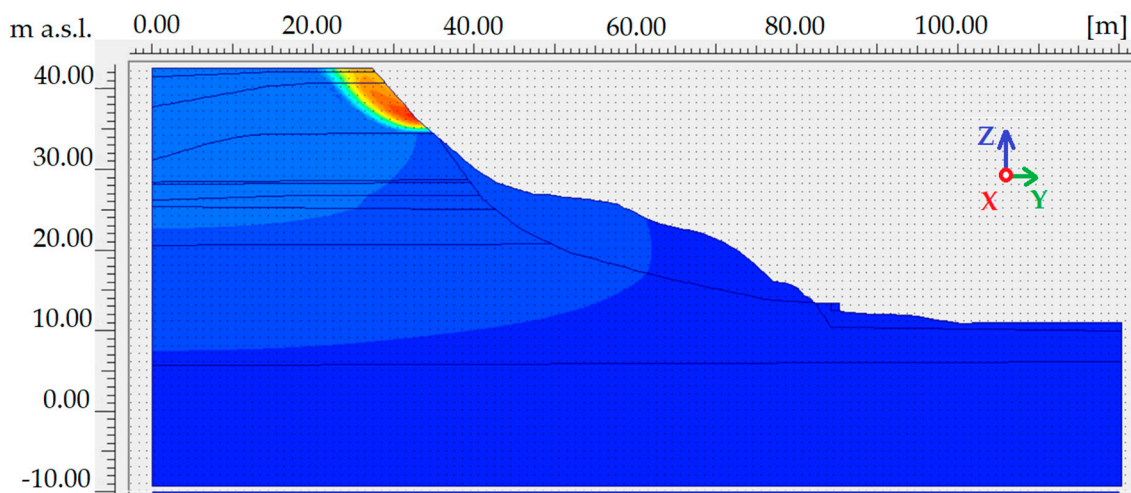
**Figure 22.** The local failure mechanism: calculations for the groundwater table elevated by 0.9 m. (source: Reference [48]). Blue colour: no displacement, red: maximum displacement.

It is worth emphasizing that the cohesion is not constant for a given soil—it reduces with increasing water content. In complicated geological conditions, even a thin layer of sand interbedding the clays can deliver a substantial amount of water into the clay layer and reduce cohesion. It is also interesting to note, that slight water table elevation from +0.8 m to +0.9 m causes failure path transformation from a global (Figure 21) to local one (Figure 22). In this case, the most sensitive parameters are the cohesions of both layers building local slip surface: till and clayey sand, followed by friction angle of both layers. The resulting interpretation is similar to the previous case: The change of geotechnical parameters caused e.g., by a substantial water content increase, can result in a sudden landslide.
